Meeting – REIMS, June 2001, 12<sup>th</sup> and 13<sup>th</sup>

## « LESSONS LEARNT FROM INDUSTRIAL ACCIDENTS

ICPE / IMPEL inspectors

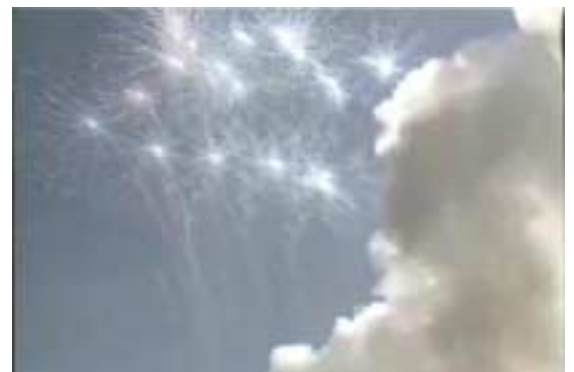
🚒 The fireworks stored in the MAVO boxes then exploded.

✚ The succession of explosions and the resulting shock waves destroyed the doors on the various storage facilities: the central bunker was then next to be invaded by fire. The exploded violently, generating an enormous plume of smoke and devastating effects on the surrounding area,

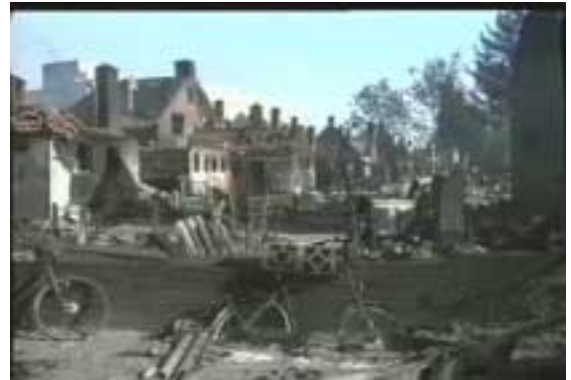
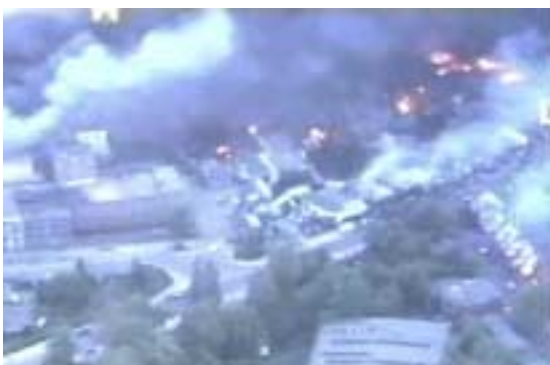
✚ In a radius of 250 m around the site, homes and other structures were obliterated

✚ Buildings within a zone of 750 m were subjected to extensive damage. It was impossible to live in the zone following the accident. The municipality of Enschede decided to remove and demolish everything else that remained. The neighbourhood was temporarily erased from the map.

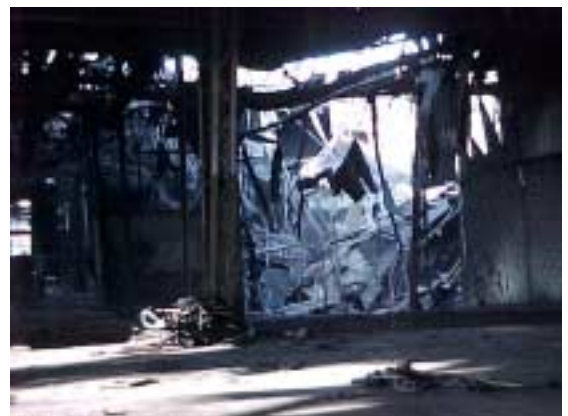
Photo DRIRE Auvergne

The accident was contained in building O 24, as the firemen's immediate and successful attempts to prevent the fire from spreading to nearby buildings (namely a laboratory, oil and storage warehouses, and electricity transformer).

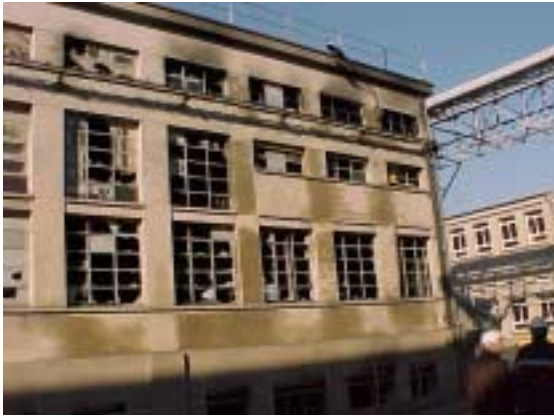
Photo DRIRE Auvergne

Property damage was extensive. The majority of the damaged building will have to be demolished. 1,415 tonnes of gum were affected by the fire. The only important machine in the building, an automatic gravimetric filling machine (MAC BU), separated from the fire by a wall, was protected by the firemen and not damaged, as well as the majority of the chemical products.

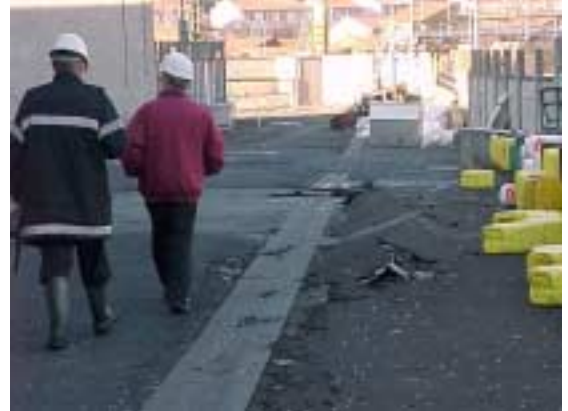
Photo DRIRE Auvergne

A particular attention was given to the underground pipes: indeed, these ones could be damaged by the movements of the ground (expansion of the paving stones as a consequence of thermal effects of the fire).

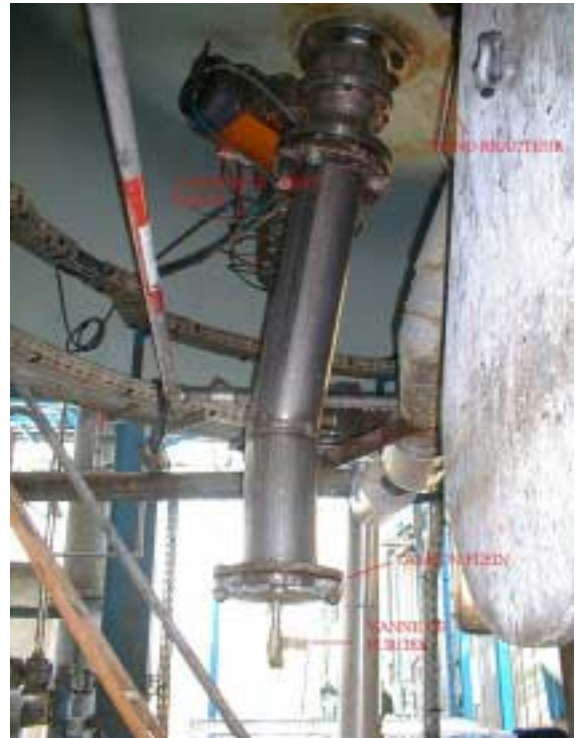
On May 15<sup>th</sup>, around 3.45 a.m., during a butadiene polymerisation reaction which was taking place in reactor R 13, a butadiene leak occurred in the lower section of the reactor at the level of the plug located downstream from the drain valve. The control room operators detected the ill-timed opening of the drain valve by a flashing light indicator. As far as the operator was concerned, the problem could not be serious, as the circuit was closed by a sleeve and a plug.

The operators tried to close the valve several times, without success. One of them made his way towards the reactor to check the position of the valve and close it. The operator, who could not reach the valve because of the foam mist that was being ejected from the lower section of the reactor, smelt the characteristic smell of butadiene. At that moment, the leak triggered the network of gas detector alarms, one of which is located directly in line with the reactor. Some of them exceeded the upper threshold of the alarm (40% of the lower explosive limit).

🔧 Faulty installation of the plug, with several incorrect bolts and inadequate tightening. In addition, the plug had not been subjected to preliminary testing.

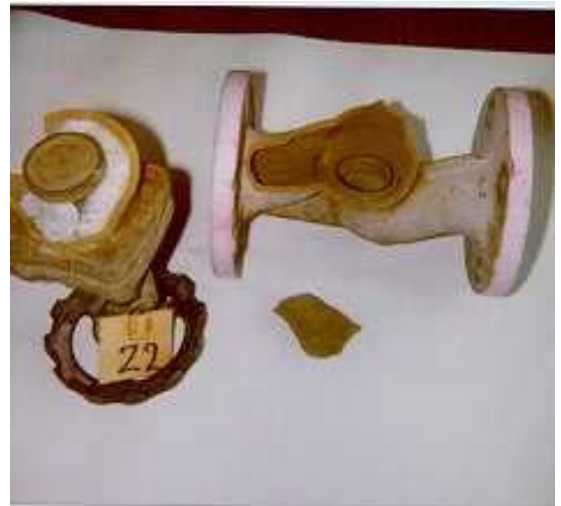
The increase in volume during polymerisation caused the internal pressure to rise sharply, thus causing the brittle fracture of the cast iron valve, the cover of which was torn off.

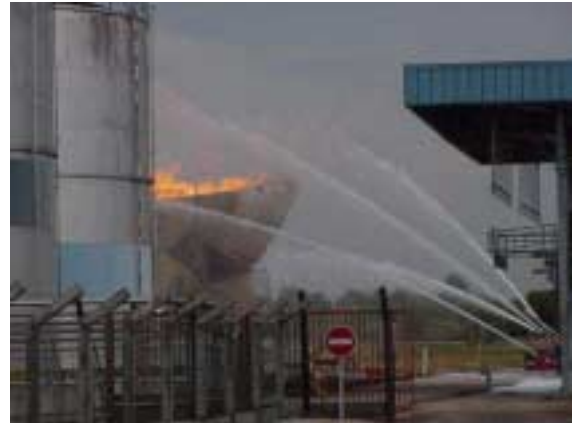
✚ The fire-fighters were no longer able to contain the fires; everything in the direct vicinity having been destroyed by the explosion (including the rescue vehicles in particular).
