# Welcome address

# **Opening address**

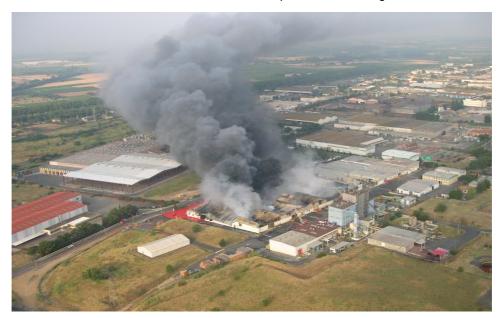
- widespread fire in building A, B, C, D,
- recovery of the firefighting water in the lower portion of the building by pump trucks from the specialised company into the 10,000 ml basin after a back-up pump was put into service,
- the site was secured by special balloons to block the firefighting water and by closing the natural gas supply line,
- significant release of smoke,
- precise list of physico-chemical data and quantities of products in building A,B,C,D not immediately provided by the operator to the intervention services due to the electrical and computer networks being unavailable.

Plume of smoke rising above the site

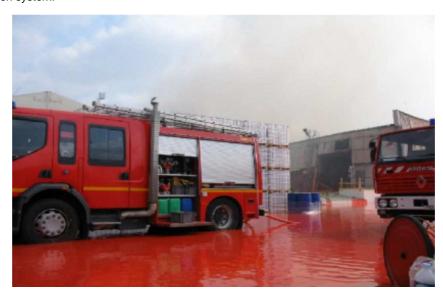
Firefighting water

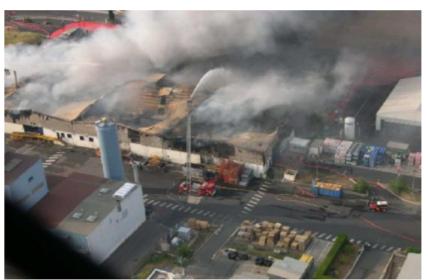
Spread of the fire to several buildings

- ✓ Concerning the measures implemented within the reconstruction framework:
  - the concrete structure's 2-hour fire resistance for walls and frameworks,
  - the partitioning of each building to separate the raw materials from the formulation and packaging area, as well as the finished product storage part by 2-hour fire break walls, rising above the roof at least 1 m,
  - automatic fire extinguishing backed up by foam with a high expansion ratio for each of the cells created,
  - firebreak doors slaved to the fire detection system,
  - installation of anti-intrusion devices,
  - installation of a back-up electrical substation.

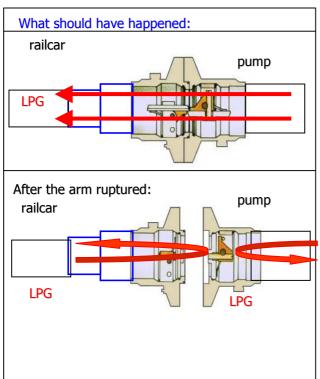
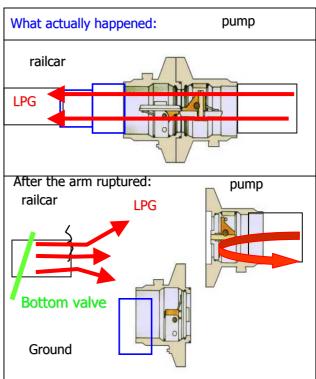
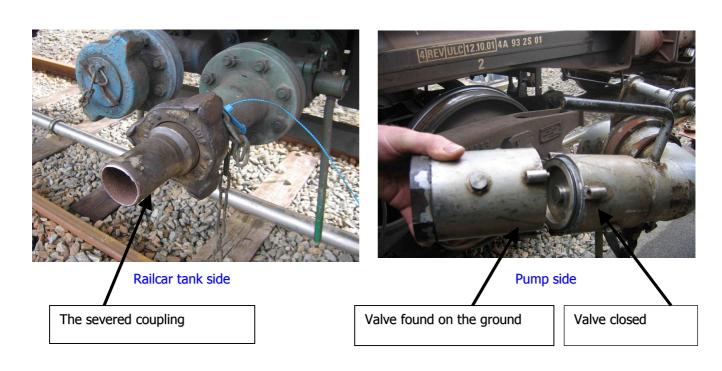
The incident had no consequence for the personnel present. Approximately 8 litres of liquefied propane was released, corresponding to the volume of the coupling that was severed.

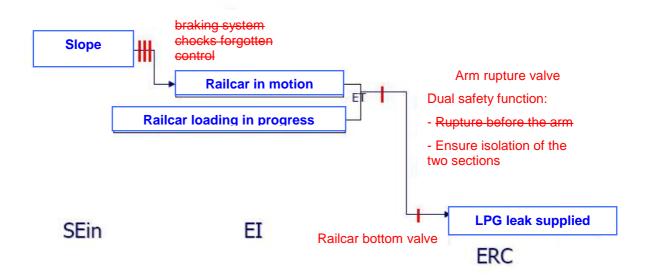
Furthermore, the coupling ruptured on the railcar side. The expert assessment conducted on this element showed an insufficient original thickness and extensive corrosion.

The railcar tank's bottom valve and the rupture valve (sphere side) operated, thus preventing the tank from draining completely and supplying the leak.

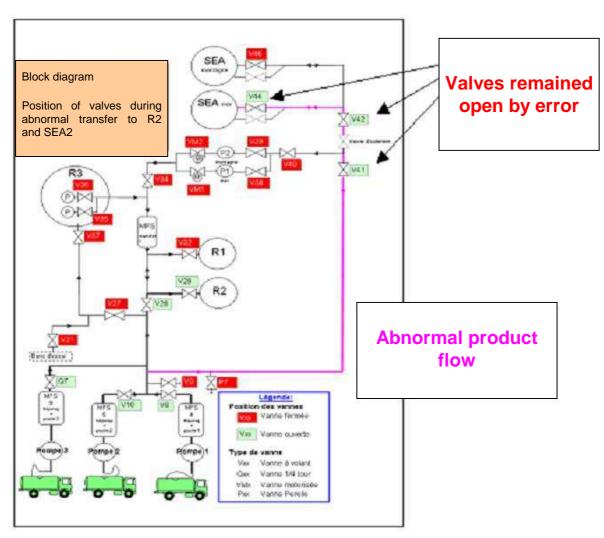
The high level detection safety alarm on the SEA2 tank did not function.

At around 8.30 am, a worker of the depot B noted jet fuel pouring from the two vents on the SEA2 tank: a phone call was made to the facility A to stop the transfer operation. The facility's emergency shutdown was activated which immediately stopped the transfer operation.

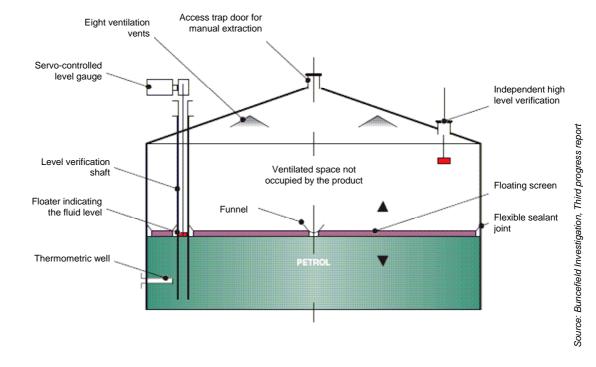
Diagram 2: Control instrumentation present on Tank 912

The tank had moreover been equipped with an **independent, "high level" control system** with both a visual and sound alarm that at the same time closes the pertinent set of valves on the piping network. An alert is sent to the instrumentation consoles and computer monitoring system of the carrier, who must then also proceed with closing the client's distribution valve.

Moreover, a control room switch allows cancelling the transmitted signal sent to the fuel supplier during the "high level" test periods. When placed in the active mode, a red indicator lights up on the control panel.

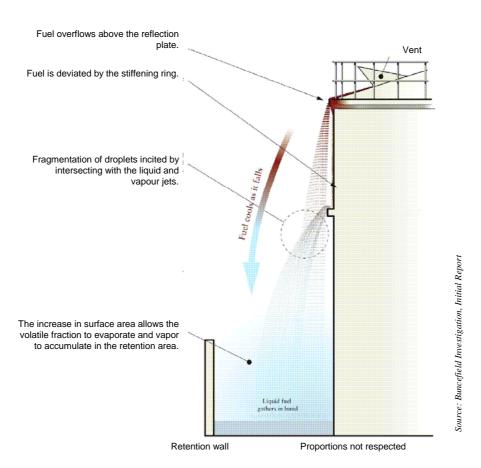
Diagram 3: Tank 912 overflow phenomenon

- Initially, yet to a more minor extent, product flow deviation by means of a tank stiffening ring (see Diagram 3).
- But more importantly, the high concentration of non-stabilized butane (10%) in this type of "winter" fuel incited both
  a high amount of gas evaporation even at relatively low temperatures (high vapour pressure: 70 100 kPa) and the
  formation of a butane cloud (estimated at several tons, given the quantity of gasoline that poured out).

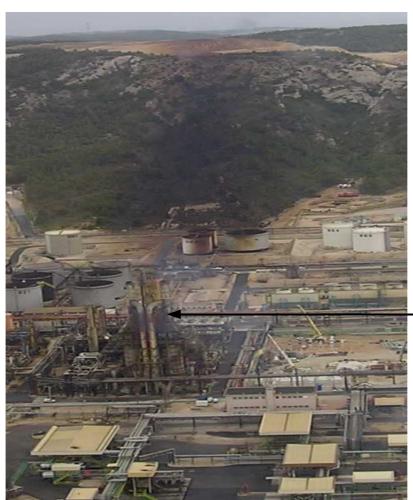
The opening of the valves led to the release of about 10 to 20 tonnes of liquid and gaseous hydrocarbons into the atmosphere (pressure greater than 3 bars and temperature at about 300  $^{\circ}$ C) and a superficial pollution of the soil and vegetation that spread south due to windy conditions to the village of Sausset-les-Pins situated 7 km away. There were violent winds from the north blowing that day.

General aerial view of the unit and traces of spill in the neighbouring environment.

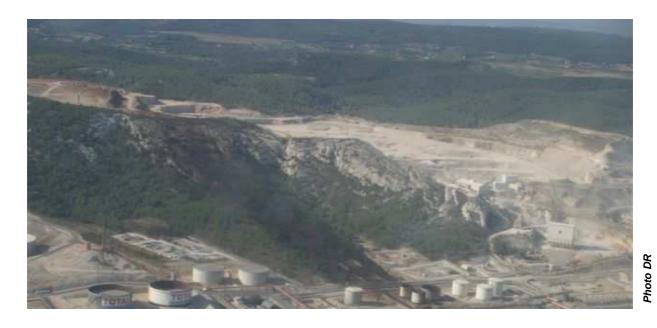
General aerial view of the unit and traces of spill in the environment south of the site

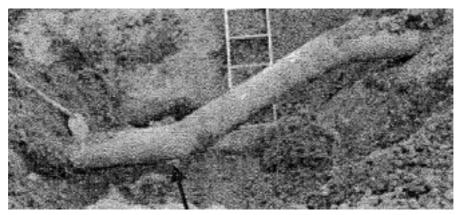
In October 2004, inconsistencies in the material balance between the MTBE sent by the production unit and that received at the port lead to an in-depth inspection on the transfer pipe. The inquiry revealed that 2,500 t (3,000 m³) of MTBE had been released through a crack in the pipe.

Despite annual inspections, the leak appeared to have existed for a number of years; the leak's initially low flow rate most likely increased progressively due to soil movements.

Portion of damaged pipeline Source: VROM-Inspectie (The Netherlands)

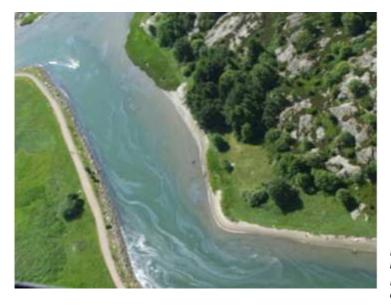
Environmental consequences of the spill of heavy fuel oil in the oil harbour.

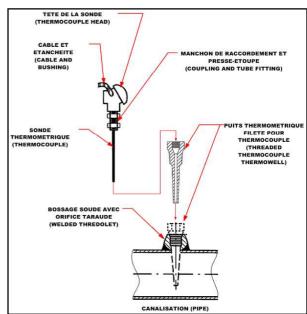
Temperature sensor assembly diagram

The investigations conducted following the incident showed that the thermocouple had been installed without a "sensor pocket", thus without protection. The hot raffinate was thus in direct contact with the sensor. As the quantity of product was excessive and the fluid very hot  $(320~\mathbb{C})$ , the tube fitting was unable to properly maintain the seal, leading to self-ignition of the product released and in contact with the air. The equivalent diameter of the break at the pipe level is roughly 10 mm.

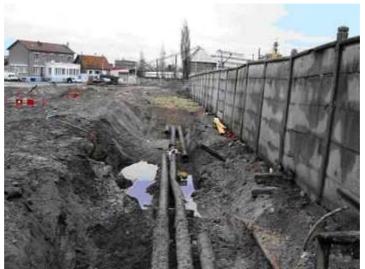
Photo TOTAL

✓ Nearly 370 m³ of gas oil was spilled on the stretch of land being dismantled. The hydrocarbons seeped into the soil to reach the water table that is 4 meters deep. However, no immediate or medium term pollution was observed in the neighbouring docks of the Seine. Pumping equipment was set up by the various players involved and the operation was coordinated by the fire department right from the afternoon of 15 December on the site being dismantled and in the nearest drainage network. On the evening of 16 December, the pumping equipment helped in recovering 55 m³ of spillage. About three months following the accident 70% of the products had been recovered.

✓ The supply of oil products (gas oil, domestic fuel and petrol) by the pipeline to the SEVESO oil depot was suspended for about a month until the three 9 inch pipes running from the pipeline terminal to the oil depot were made compliant again.
