# **Lessons learnt from industrial accidents**

Seminar in Paris - France

3-4 June 2009

**Final Project Report**

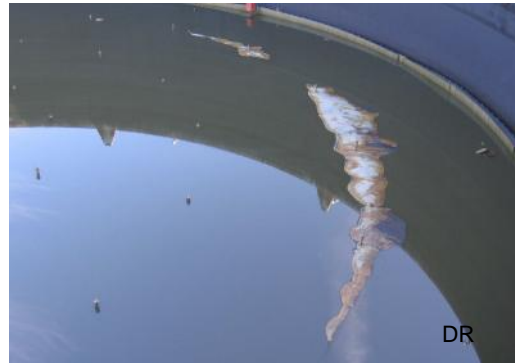
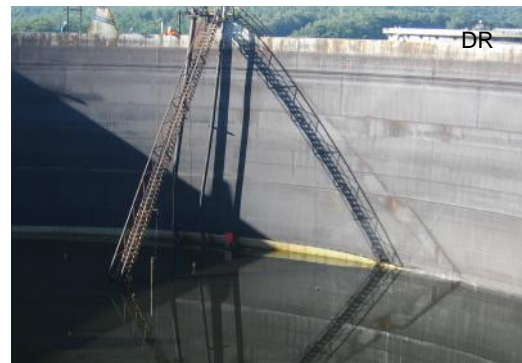
Repeated bending stresses on the caisson seal welds each time the roof lies on sediments had caused the localised break of several welds, as well as the filling of some caissons with crude oil.

The quantities of crude oil trapped inside the caissons and water accumulated on the roof caused the tank to lose its flotation capacity subsequent to the unequal charge distribution and eventually to its irreversible sinking.

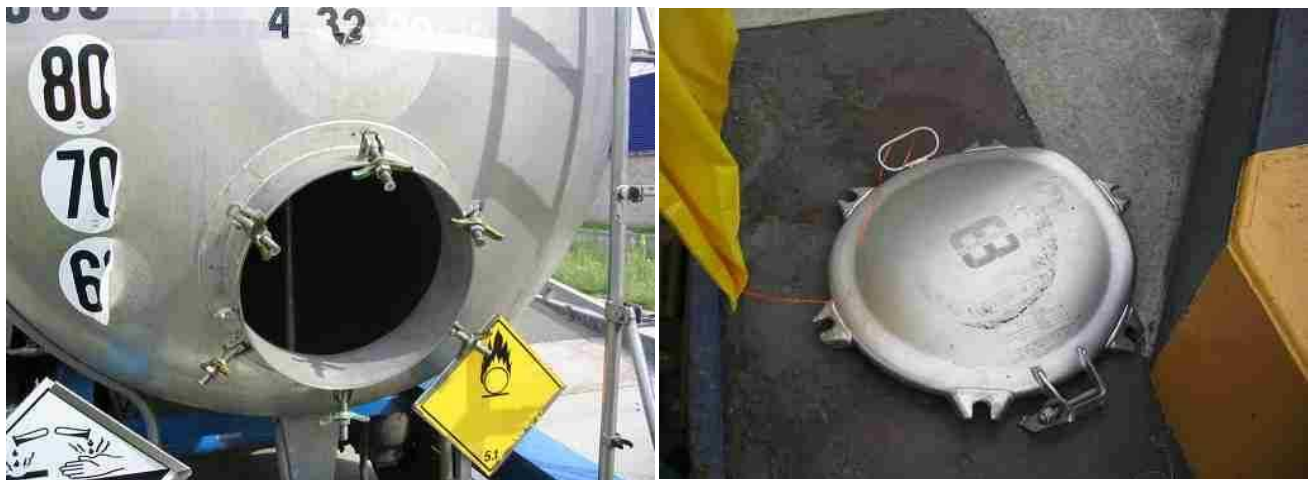
No major property damage was declared (deformation of some metal cladding), except for the tanker truck itself, whose braces and hood were bent.

**Burst manhole cover (Photos courtesy of the site operator)**

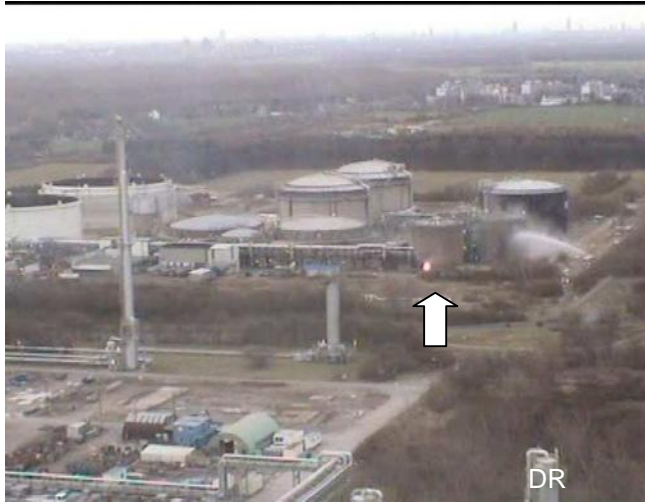
Figure 2: Ethylene flame from the leakage at the insulating flange (arrow) and cooling of the acrylonitrile tanks by the fire brigade

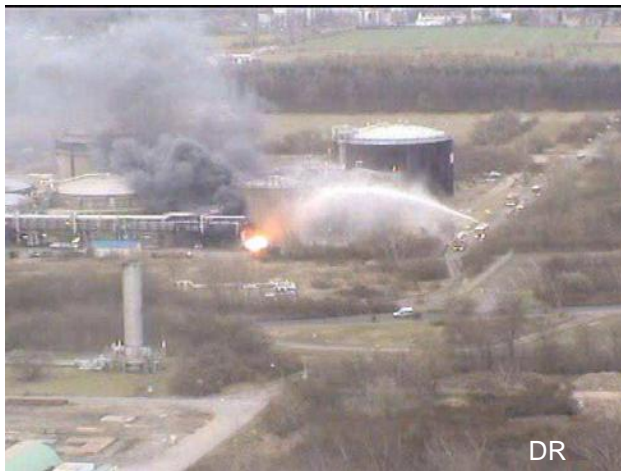
Figure 3: Increasing of the flame in direction of the hydraulic valve and the bypass. Support of the flame by the hot and inflammable hydraulic oil from the broken holding tank of the valve is most likely.

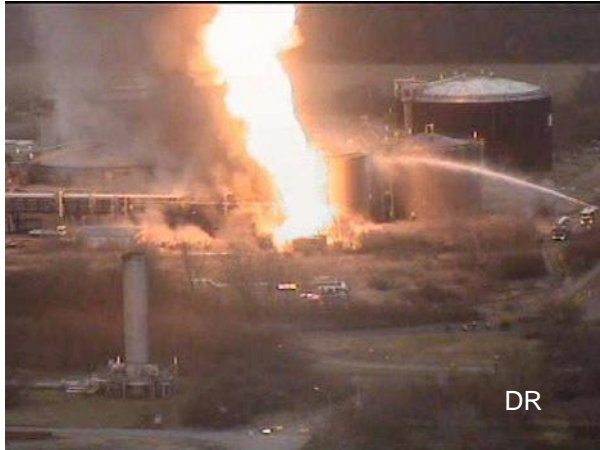
Figure 4: Ethylene jet flame from the broken bypass of the gate valve; gas pressure: 83 bars. Half an hour later the nearest acrylonitrile tank caught fire.

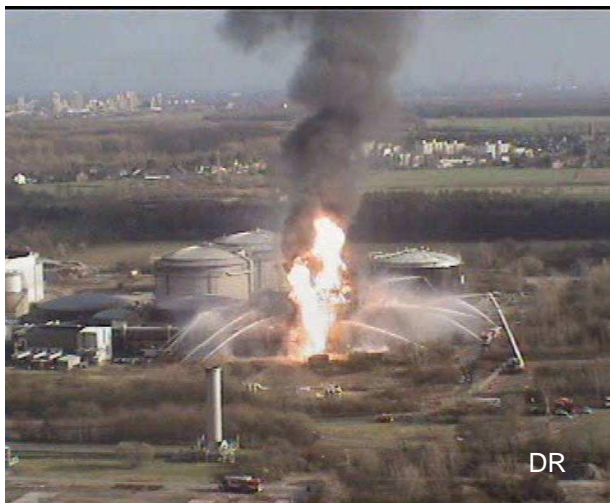
Figure 5: Whole roof area of the acrylonitrile tank is burning at 4:30 pm.

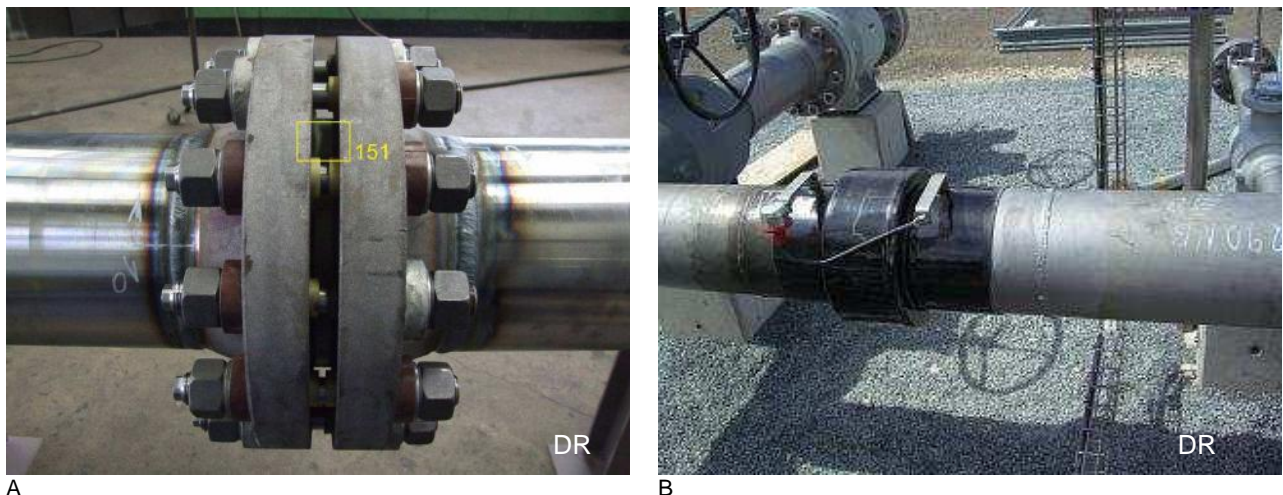
Figure 8: Insulating flange with inserted nuts (A), maintenance-free welded insulating connector (B)

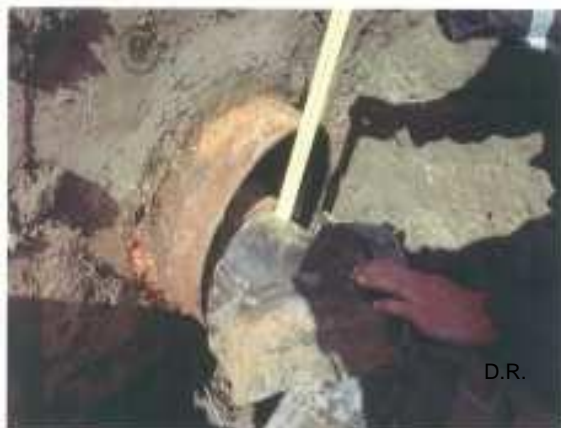
The leakage was caused by a mix of several tension factors executed on the hydrogen pipeline. The predominant stressing factor was the gradual settlement of the pipeline and the earth surrounding it. The settlement took place over a time span of several years and resulted in the bending of the pipeline at a spot where the pipeline got stuck on a fixed structure, e.g. a feed through in which the pipeline enters a building. The bending forces caused tensions on the CP coupling nearby in the pipeline, which eventually started to leak.

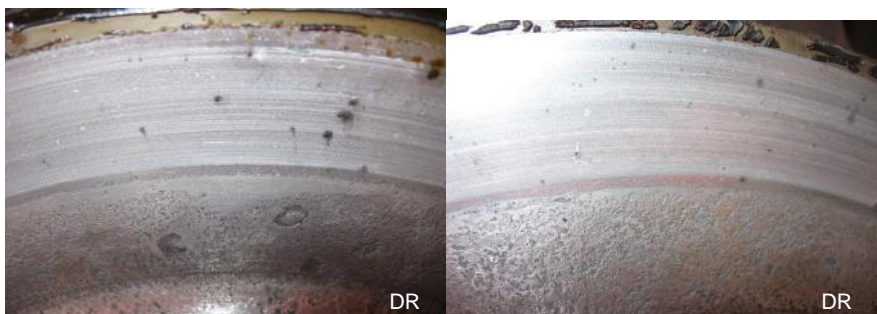
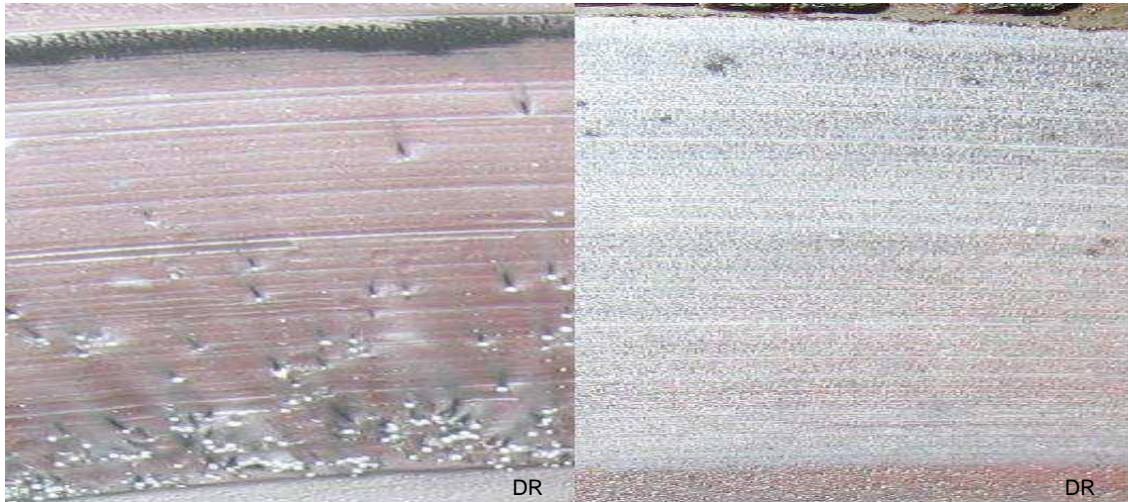
- inadequate clamping of nuts, the subcontracted firm did not follow any pre-established set of procedures or specifications in conducting this operation;
- a metallurgical examination of the valve seal surfaces revealed a degraded surface condition: a sizeable lateral surface groove, presence of particles (though below manufacturer's standards). Also noteworthy was that the particles were apparently of a shape and composition analogous to those of shot blasting material used to clean metal surfaces.

A comparison of seal surfaces on the valve that caused the accident with those of an identically-designed valve clearly highlights the particles responsible for surface defects: the surface roughness of this deficient valve was twice that of a similar valve (see photos below).

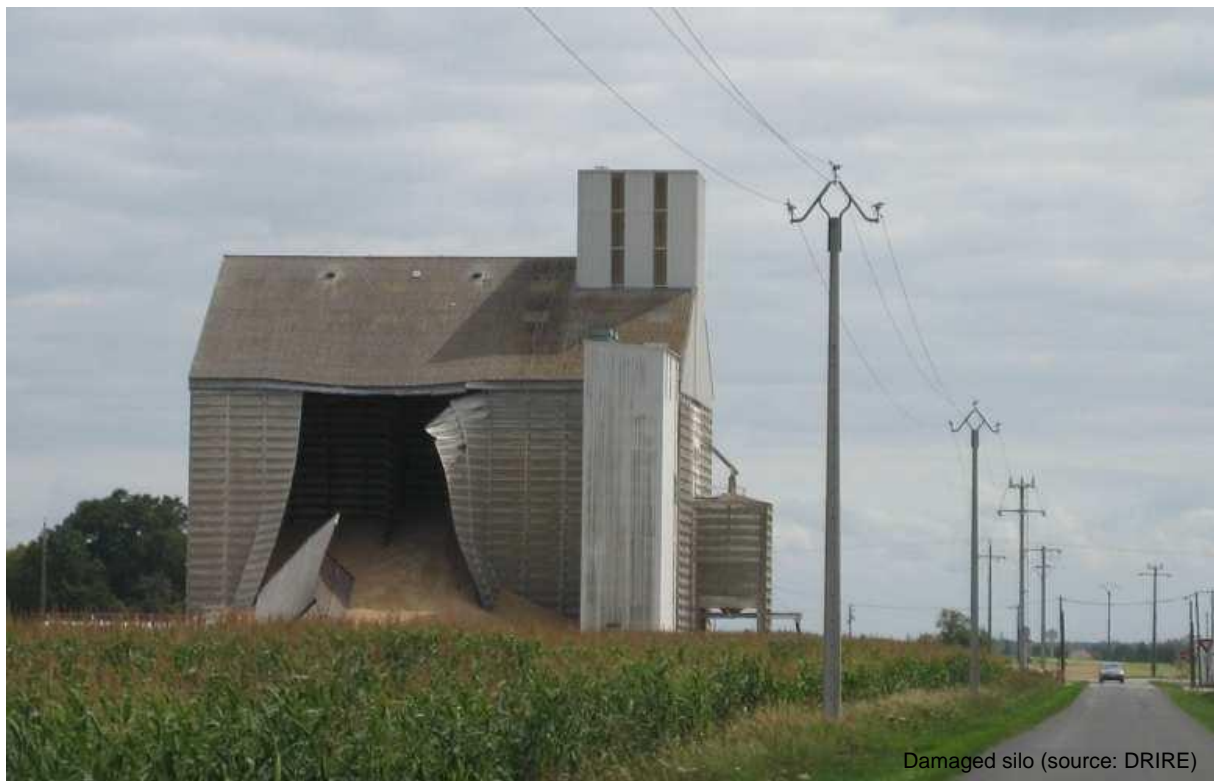
Damaged silo (source: DRIRE)

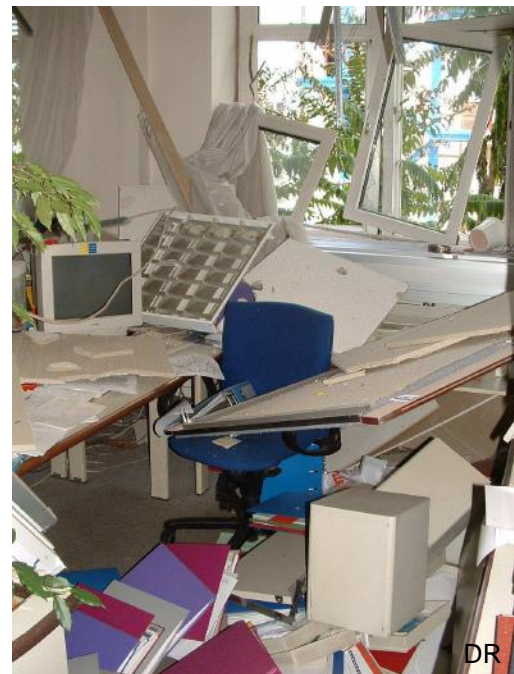
*Office at 40 m from the explosion*

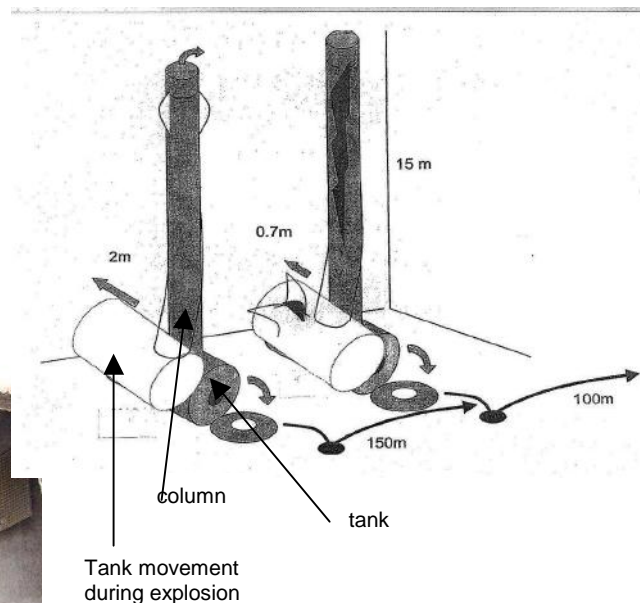
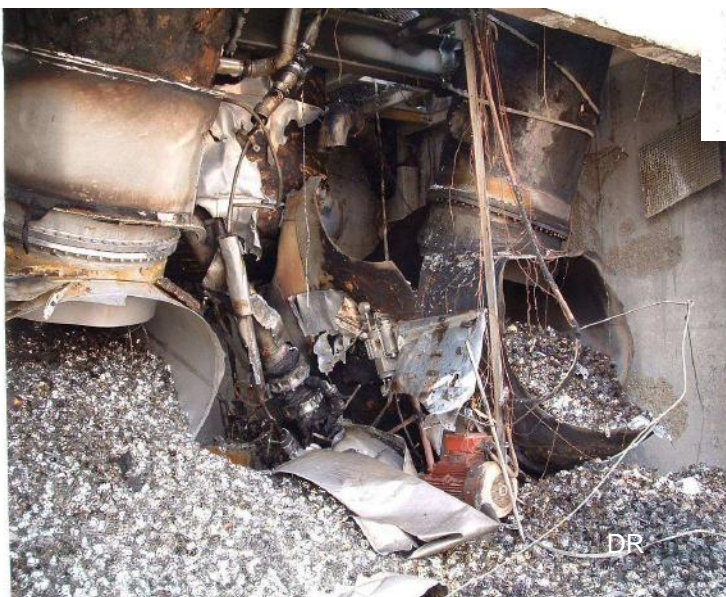
The decomposition of the peroxide started the fire, which then spread and caused the explosion of the first column followed by the explosion of the second column (domino effect).

Damaged columns filled with catalyst

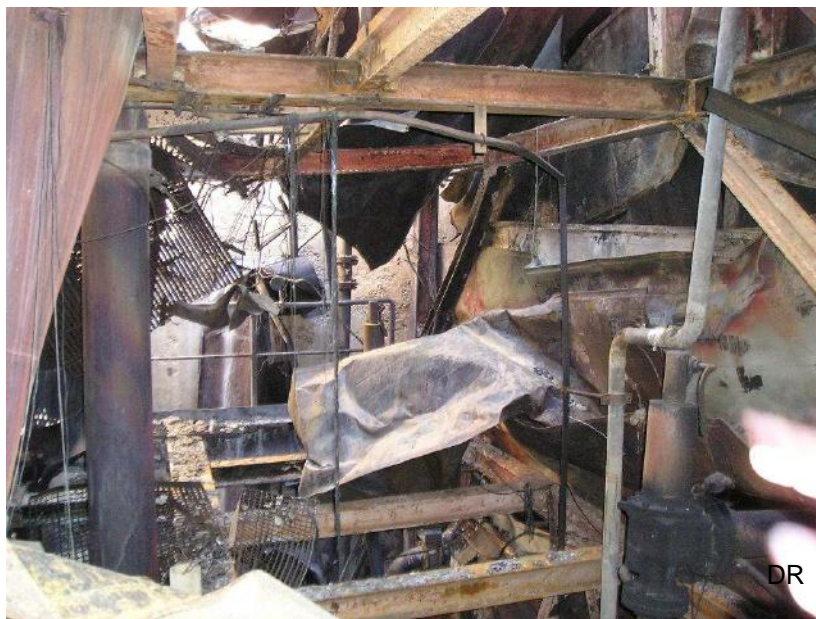
The explosions destroyed the devices in the cold box entirely. There was a big crack in the wall. No one got injured and no building got damaged, but a few broken glasses in the surroundings.

*The destroyed "cold box"*

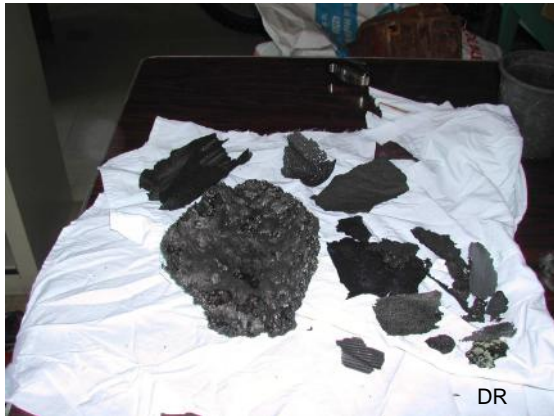
Debris collected in the garden of a residence  
3.8 km south-southwest of the accident

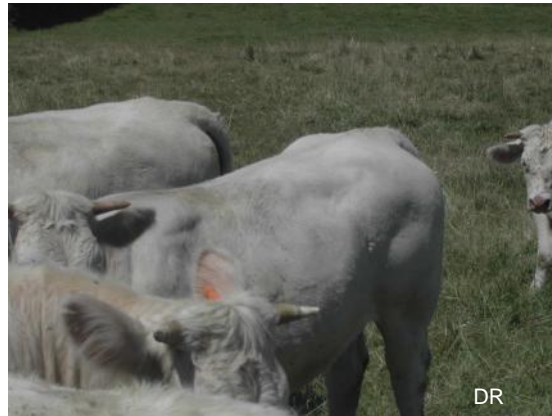
Animals grazing a few kilometres south of the site  
were covered with soot from the fire
