# Lessons learnt from industrial accidents

## 2021 Seminar

### 14th edition

*Report number: 2021/02*

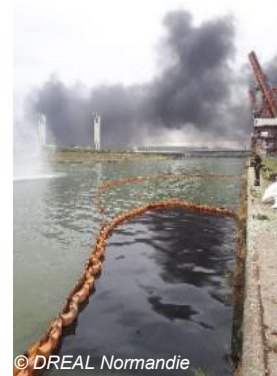
The origin of the accident (exact location, nature) and the underlying causes remain unknown to this day. The expert assessment of the incident is ongoing, and the case has been referred to the courts.

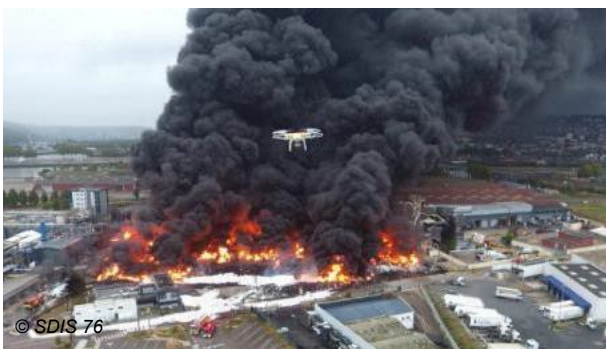
It should be noted that more than 9,500 metric tonnes of combustible products (liquids for the vast majority), packaged in drums and intermediate bulk containers (IBC), were consumed by the blaze. Several aggravating factors were identified. Firstly, non-fire resistant containers contributed to the formation of burning slicks of flammable products which could not be contained due to insufficiently sized retention structures. Secondly, the proximity of the two sites resulted in a domino effect, increasing the amount of material burnt and surface area of the fire. Difficulties with the supply of water also complicated the firefighting operations. The problem was solved using fireboats and the provision of extinguishing means (emulsifiers) by other manufacturers located in the department.

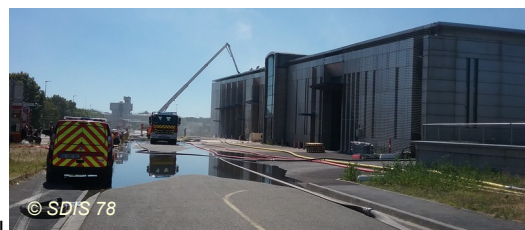
These elements may have led to a shift in human and organisational factors within the establishment conducive to accidents. The Seine-Aval SIAAP had already noticed an increase in the number of incidents in recent years, reflecting shortcomings in risk management.

As far as the technical causes of the event are concerned, the report indicated that maintenance work (cleaning of fire dampers, dismantling of scaffolding, electrical work on the duct between 2 tanks) had been performed near the location where the fire had started on 3 July. That day, workers from an external service provider noticed a burning smell in their work area, although they could not identify its origin. The report specified that the fire had started in the ferric chloride storage room. The most likely cause of the fire was identified as an insulation fault on electrical cables.

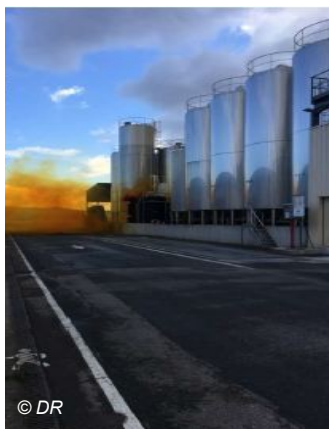
Being of foreign origin and having a poor understanding of French, the truck driver arrived at the site with a load of ammonium thiosulphate intended for an agricultural cooperative in another department neighbouring the Meuse. He had mistakenly entered the wrong site into his GPS and headed for another site of the same cooperative, which was located next to the dairy.

When he arrived at the site, he missed the entrance and entered the dairy instead of the agricultural cooperative; he was met by an operator waiting for a nitric acid delivery. The operator receiving the shipment did not take sufficient care to verify the delivery slip detailing the contents of the tanker truck. He showed the driver where the loading station was located, then left to don his PPE.

- padlocks were installed to prevent drivers from opening valves;
- systematic validation and verification of unloading operations by two operators;

- additional signs and indications near valves for product identification purposes;
- installation of a windsock;
- an audit of the procedures governing the delivery of chemical products and reminders to personnel of the safety rules, notably regarding chemical product deliveries.

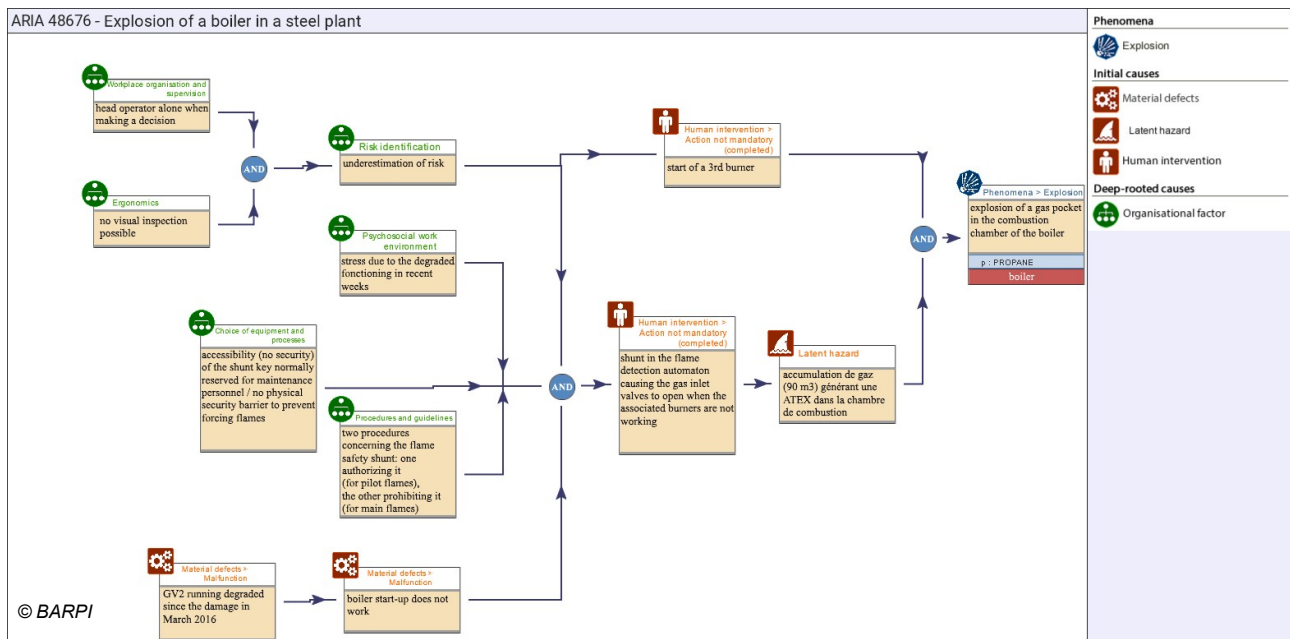
Following work on one of the boilers (SG2), the restart procedure was not conducted properly during the restarting tests undertaken on 10 October. At the time of the accident, the site's production was based solely on a single boiler (SG4) and restarting SG2 was a priority. The shift foreman was alone to make decisions (no supervisory staff is present at night) in a stressful situation like the one described above.

The economic impacts for 2016 included a production loss of 700,000 tons, the cost of temporary installations (in order to continue operations), evaluated at €30 million, and the total cost of repair/reconstruction of the boilers at €50 million.

Another inspection visit was conducted. The recurrence of accidents and incidents encountered over the span of just a few months led to a report proposing that an Emergency Measures Order be issued, requiring:

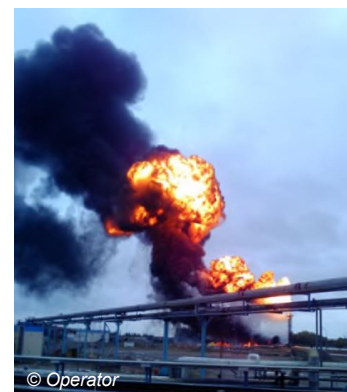
Ignition gas oil flare outlet

While the load operations were underway on HD1, the console operator brought a vacuum drying column on line to finalise the unit's restarting process. Although the operators are familiar with this operation, it is not mentioned in the specific restarting procedure. It was not considered as critical by the operators. However, it is expected that in the shutdown phase, the bottom level of this column will fill up due to condensation following the loss of the vacuum. Its design does not allow it to be purged before being brought back online and the restart procedure does not identify the risk of the flare tank overflowing. When this column was put into service, the high level alarm appeared. The console operator was having to concentrate on several operators at the same time and acknowledged the alarm while increasing the column's discharge rate. However, the discharge rate was less than that entering the equipment. The material balance between the incoming flow and the outgoing flow was not displayed on a single mimic diagram view. The column overflowed and the liquid diesel fuel flowed toward a buffer tank upstream from the flare. The high level alarm on this tank was triggered. At this point, the operator acknowledged the alarm and checked that the drainage pump was in operation. The pump's output was also insufficient. The tank's high level alarm was briefly activated, but then disappeared. The emergency drainage pump, slaved to the very high level, did not start. An external operator contacted the control room to report the smell of gas near the flare. The chief operator, busy with operations on the utilities console, came to check the HD units console for any operational discrepancies. Seven minutes later, another external operator called the control room to report flames and liquid spilling from the flare. The second pump on the buffer tank upstream from the flare was manually started and the column was bypassed, stopping the overflow of liquid from the flare.
