LESSONS LEARNT from INDUSTRIAL ACCIDENTS

12th SEMINAR

31 May and 1 June 2017 – Lyon

LESSONS LEARNT

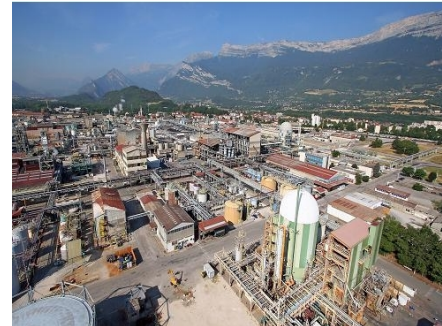
ARIA 42163 © Site Operator

- ARIA 42163: Around 10:30 pm at a Seveso-rated chemical plant, a sensor detected a rapid rise in conductivity inside a heat exchanger. Upon tripping the sensor alarm (at a 50 μ S level), the automated safety controller isolated the circuit. A 2nd conductivity-meter, which had been idled and scheduled for replacement by the maintenance unit, showed a value of 0 μ S. Not informed that this device was inoperable, technicians proceeded with sampling to remove any doubt and notified the duty manager, who analysed the situation, did not wait for the laboratory results, bypassed the conductivity-meter whose alarm had triggered, and restarted manufacturing. Ultimately, only a limited discharge of phosgene into the environment was observed, thanks to an effective 2nd safety barrier.

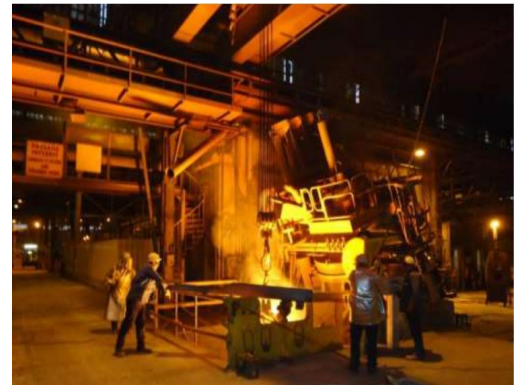
Furnace No. 4, © Site operator

The source of this accident was the contact initiated between molten metal and water or humidity that had accumulated at the bottom of casting pit 4. During the process of pouring metal into the foundry ladle, some 400 kg of molten metal accidentally fell into the pit. The abnormal presence of water at the pit bottom triggered both an explosion, in the form of a dry expansion (yet without spraying any metal), and the release of a large plume of dust. The blast resulting from the explosion, funnelled by the pit walls, damaged the roof made of asbestos cement sheets, which acted like a fuse vent (many sheets landed on the floor or were displaced). No other structural damage to the building was observed.

- Defective pit drainage:
 - the bottom level of the casting pits was positioned at 3.8 m (pit 4) and 3.50 m (pit 3) below ground;
 - since the ground was permeable, the water table level when the accident struck was recorded at -1.2 m, which was significantly higher than the pit bottom levels;

- that assessment did not reveal any major structural disorders yet did report a highly deteriorated concrete surface condition, together with signs of water infiltration (traces of humidity and the presence of water) on the rear faces of both pits. The infiltration was apparently due to the structures (pits) being submerged in groundwater. Subsequent to this assessment, works were engaged to drain the pit walls;

The entire array of proposed active and passive technical systems brought the final risk level to 10⁻⁸. The various RMM dedicated to works and machinery were introduced in order to prevent any recurrence of such an accident (double casing, moisture meters, level probes in the sumps, etc.).

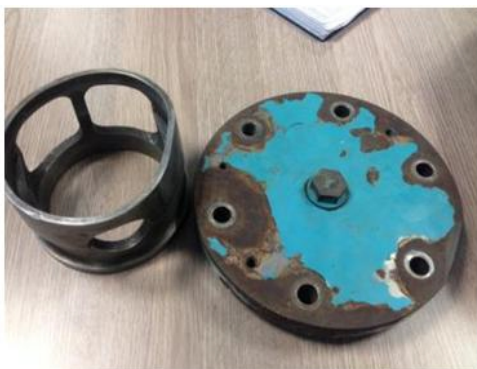
This leak was caused by ejection of the hatch on one of the check valves fitted onto compressor 1. This valve was found lying 6 metres from the compressor.

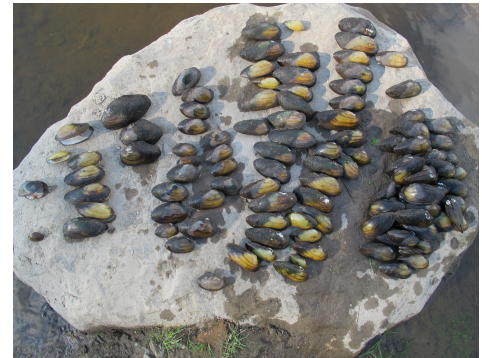
Dead mussels © Southwest Finland ELY-center

Less than one week after the discharge, environmental consequences are observed : millions of dead mussels are floating in the river. One of the four mussel species damaged is the "thick-shelled river mussel", *Unio crassus*, specie protected by the European Habitats directive. According to investigations, up to 1,1 million *Unio crassus* specimen died, i.e. 15 % of the population. Total mussel deaths amounts to about 100,000 kg in biomass. The environmental consequences affected the river on a length of a 35 km, nearly until the point where it flows into the sea.

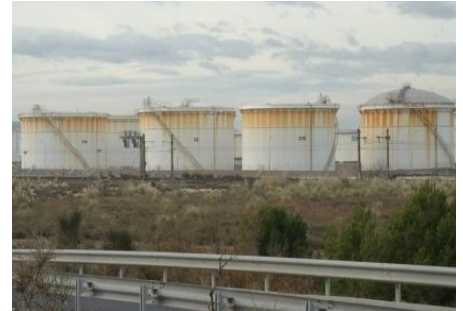
Oil depot © Languedoc-Roussillon press

Around 7 am, during excessive rainfall, the floating roof on a petrol tank within an oil depot gradually subsided. With a capacity of 30,000 m³, the tank had registered a level of 3,900 m³. Many neighbours complained about the pungent hydrocarbon odours. The depot operator, who had also detected a 300-litre leak in the tank's retention basin, activated the site's internal emergency plan.

After consulting with BARPI and emergency situation support unit, the Inspection authorities for Classified Facilities validated the operator's proposal to drain petrol from the tank at a slow rate without producing a foam blanket. This decision was based on the following considerations:

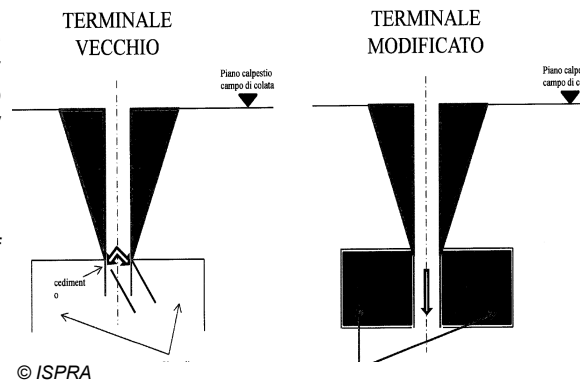
In the post-emergency phase the former draining hole has underwent some structural changes. Indeed the empty area of the vertical discharge channel was filled with refractory cement to convey the cast-iron in a longer obliged pathway hence, reducing the gap from the draining hole to the torpedo wagon inlet.

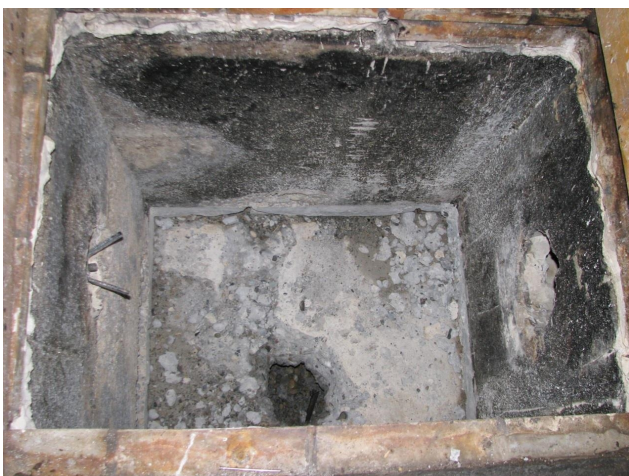
The technical cause of the release was due to corrosion of the chemical waste water system by the chemical effluent stream. The concrete shaft of the system was lined with a lead coating and tiled with ceramic tiles (cleft clinker). Over a period of time the clinker had become porous and the fluctuation of the pH of the effluent dissolved the lead oxide surface and the lead lining itself. The joints between the tiles are the likely points of initial corrosion. Therefore it was only a matter of time before the concrete wall of the shaft was penetrated and the effluent was released to the soil and groundwater. The release was only recognised when an intrusion of liquid into an energy channel was identified during a regular inspection tour.

Damaged chemical effluent shaft © Site operator

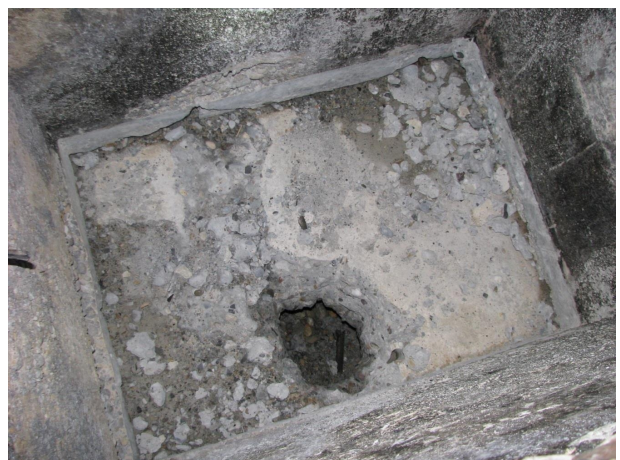
Hole in the floor of the chemical effluent shaft (close-up) © Site operator
