Lessons learnt from industrial accidents
IMPEL 2015 Seminar
11th edition

Final report: 16 July 2015

IMPEL Seminar
Lille, 2 and 3 June 2015

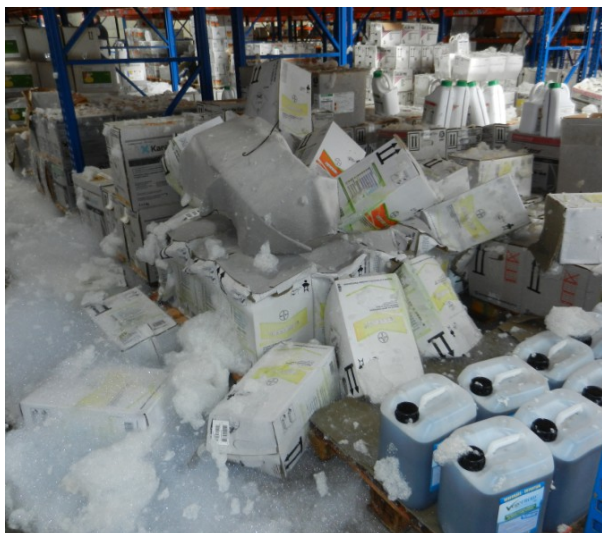
Figure 3 : Cell 1 after activating the foam extinction
(Source Operator - ARR)

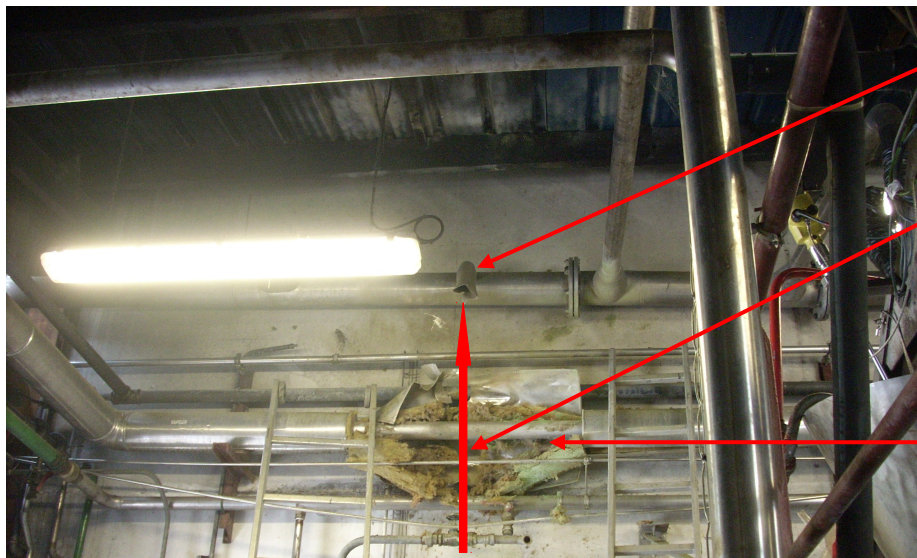
Remainder of the pipe torn off by the explosion

The portion of pipe damaged by the explosion was an "empty" conduit from a larger network responsible for collecting VOC-laden air in various zones of the workshop.

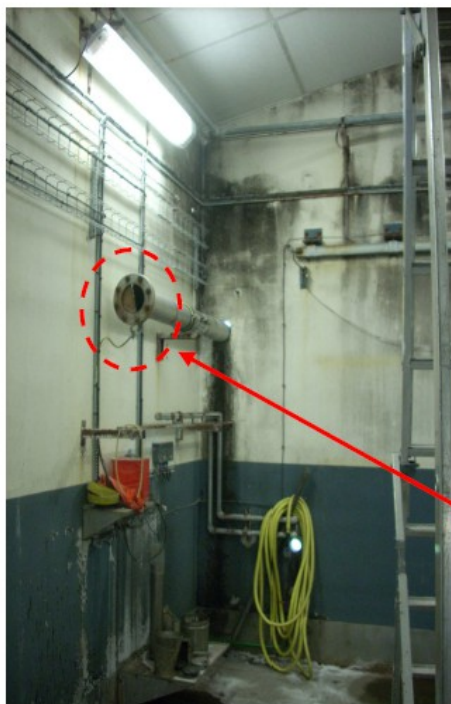
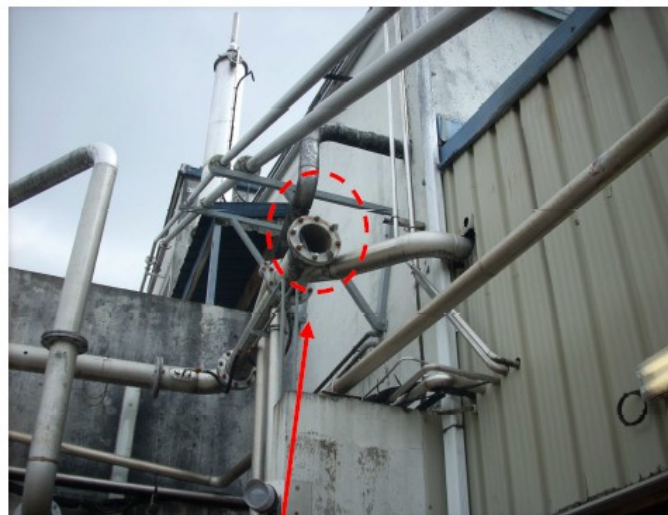
Plugs and/or foil present on the suction network that had opened subsequent to the pressure surge generated by the explosion

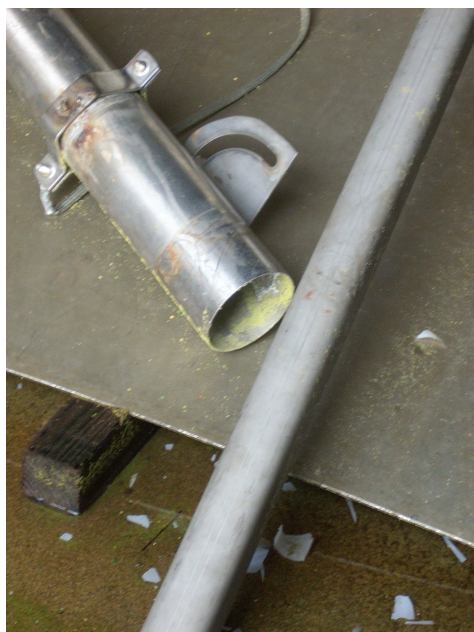
Pyrotechnic dust residue (a yellowish substance with powdery texture) was present on the metal debris of the stripped pipe (found on the floor of the workshop and outside the building, along the path of the foil that had been ripped apart). These observations indicated that **the pipe had not been adequately washed** during preliminary rinsing steps.

Metal debris, from the pipe blasted by the explosion, found on the floor. The picture on the left shows residue from pyrotechnic dust (yellowish) covering the inner pipe wall.

The fire most likely broke out due to ignition of this powder residue and/or pyrotechnic dust accumulated inside the pipe. This build-up was correlated with the **heating produced by friction of the metal saw blade on the stainless steel suction pipe (hotspot).**

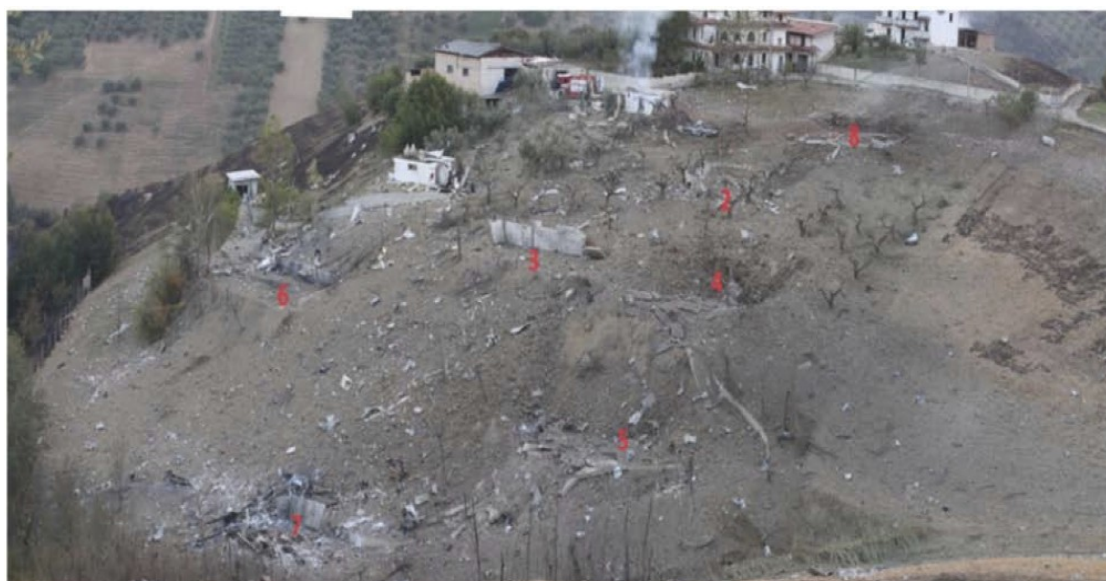
Seven of the eleven buildings of the plant were completely destroyed by the blast combined with the fire : buildings Nr. 2, 3, 4, 5, 6, 7, 8. Buildings 10 and 11 were partly damaged, while buildings 1 and 9 were strongly damaged.

Illustration 2 : The remains of the plant after the accident

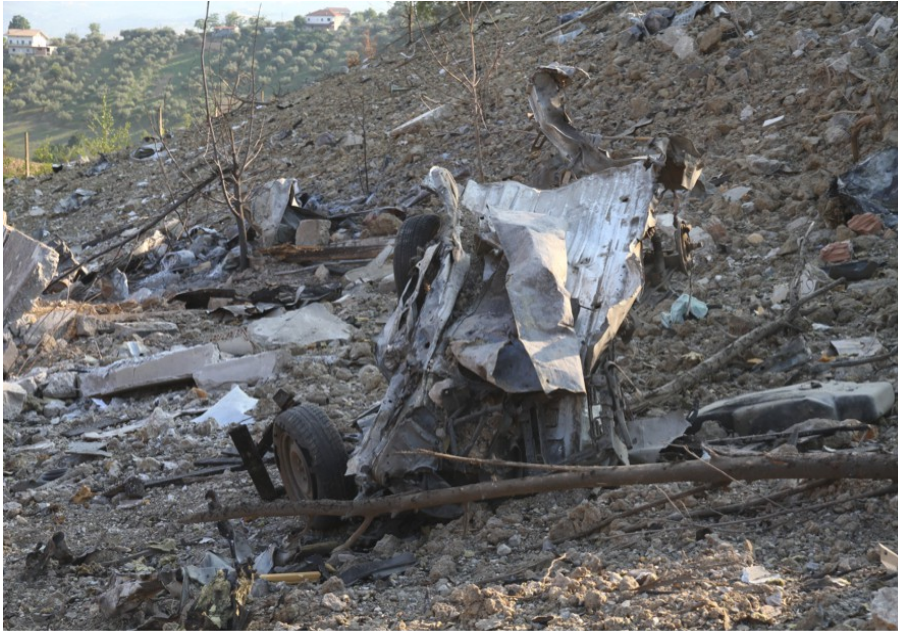
Based on data provided by firefighters, it is supposed that a “pick-up truck” (a small truck with an open body and low sides), normally used for internal explosives transfer, has been involved in the first explosions. The remains of the pick-up were found near the storage buildings Nr. 4 and 5 (illustration 3).

Illustration 3 : The remains of the pick-up truck

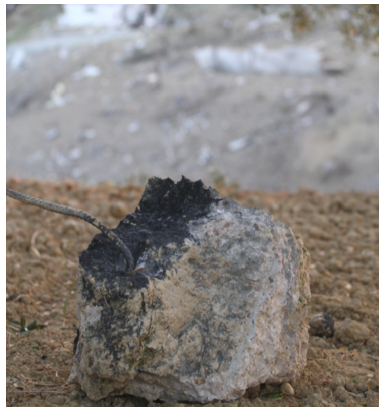
Outside the plant : The blast waves caused damages to several civil buildings (houses, church, factories,...) within a 500 m radius. Debris were projected within a radius of 1 km. In particular, a big piece of reinforced concrete (30 cm x 30 cm x 20 cm) was found 930 m away from the plant. (illustrations 4, 5).

Illustration 4 : Piece of concrete found more than 900 m away from the plant

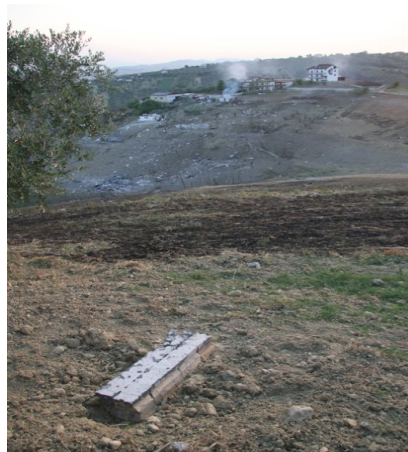
Illustration 5 : Debris projected by the explosions

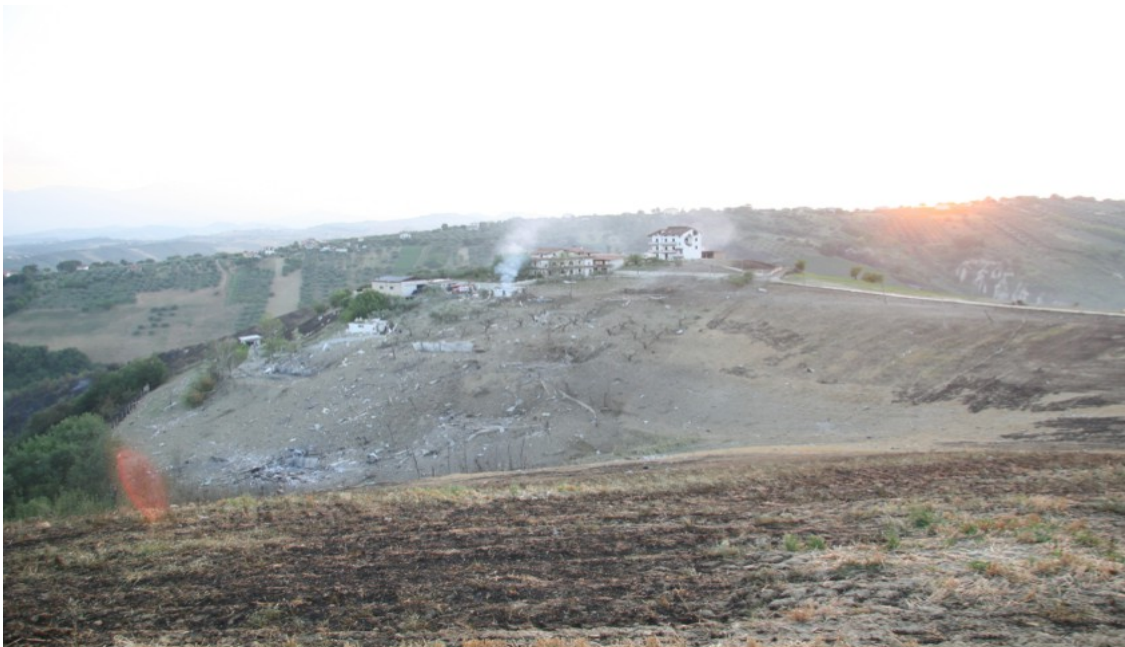
The accident generated a sequence of fires in the rural/natural area surrounding the plant (in a 500 m radius). These fires were controlled and extinguished by the fire fighters. (illustration 6).

Illustration 6 : Fires in the area around the plant

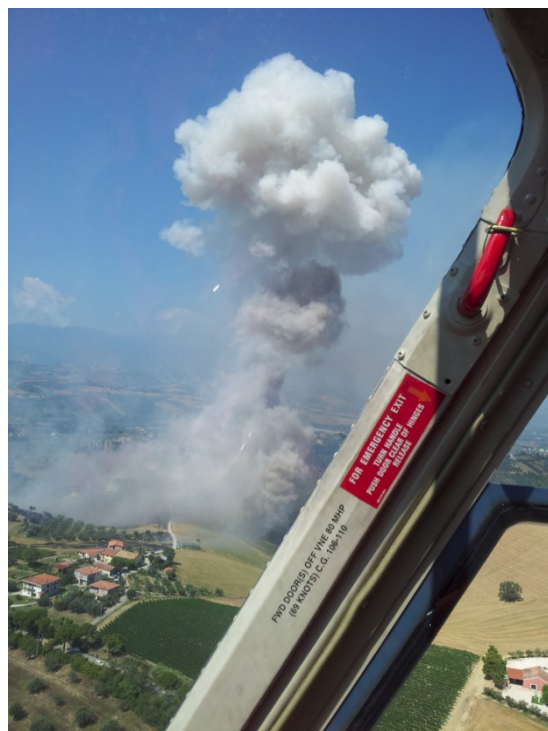
Moreover, a big cloud of gaseous products (including toxic substances) was observed after the explosions (illustration 7).

Illustration 7 : Toxic cloud emitted to the atmosphere

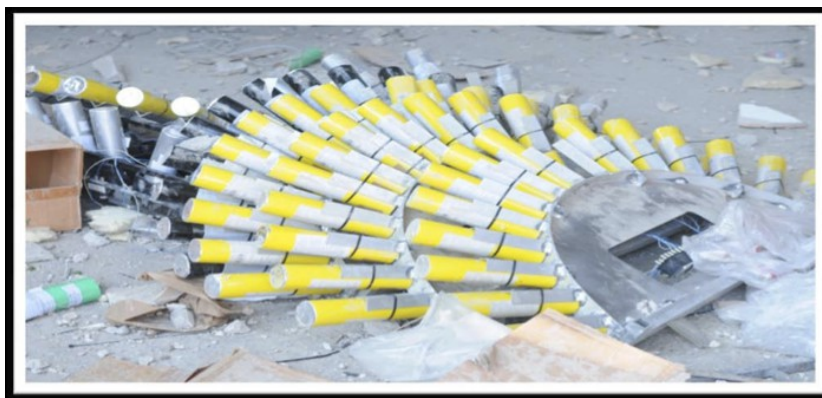
After the accident, explosive products that the plant operator was not allowed to store were found in the remains of the plant. Indeed, fireworks already “armed” with an ignition device were discovered. (illustration 8). Other pre-armed fireworks were found inside the trucks parked just outside the plant, near the operator's house.

Illustration 8 : Pre-armed fireworks

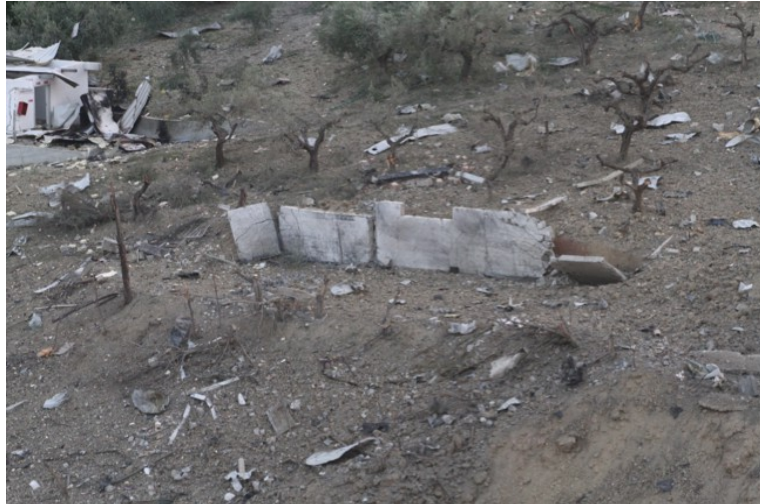
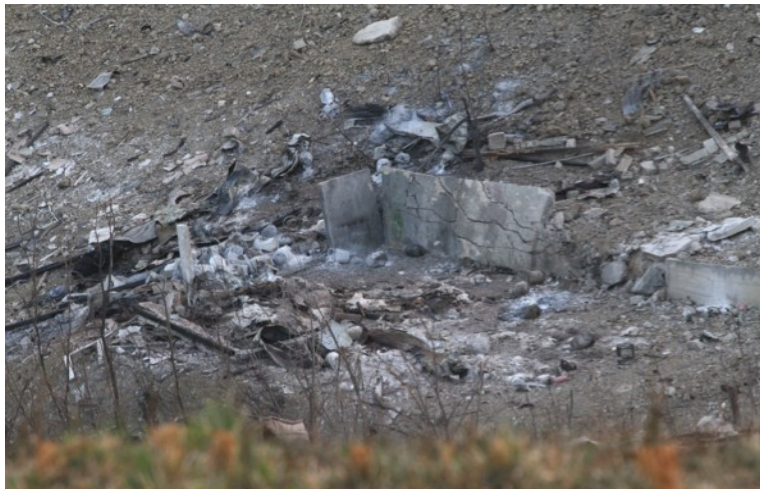
The material damages observed in the storage buildings and their protection walls (illustrations 9, 10) show a real disintegration effect. This is the evidence of a "mass explosion" (the entire explosive amount exploded almost instantaneously). This phenomenon is a further proof of the presence of dangerous pre-assembled explosive products at the time of the accident.

Illustrations 9 and 10 : Damages caused to the buildings and their protection walls

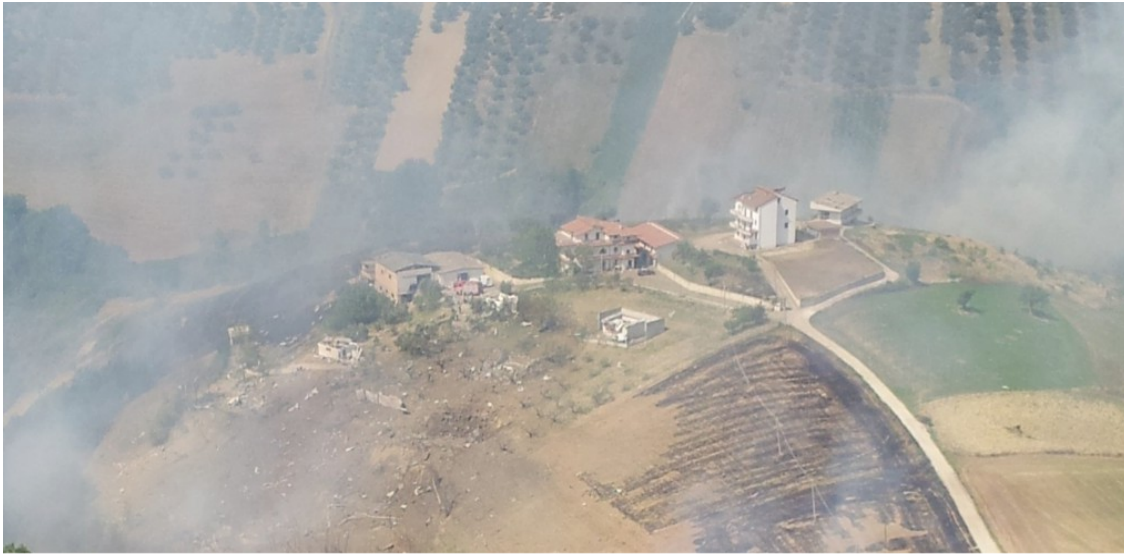
Moreover, a domino effect occurred in building Nr.8 40 minutes after the first explosions. As shown on illustration 11, building Nr. 8 had already been damaged by the first blast wave. The respect of safety distances among the buildings, according to the national regulation, should allow to avoid domino effects. But these safety distances are of course a valid protection method only if the maximum quantities and the authorised typologies of explosives products have been respected (the safety distances are designed based on these parameters). The occurrence of a domino effect leads to conclude that there might have been violations of the regulation in terms of qualities and quantities of explosives stored in the plant.

Illustration 11 : view of the plant after the first series of explosions

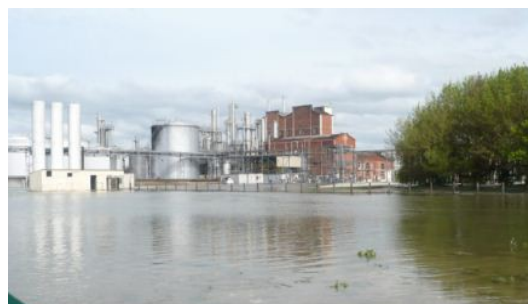
Chemical plant overwhelmed by water
(source: DREAL Champagne-Ardenne)

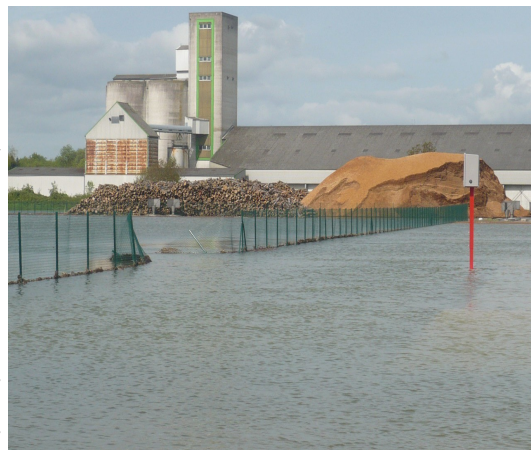
Wood storage at the plant overwhelmed by water
(Source: DREAL Champagne-Ardenne)

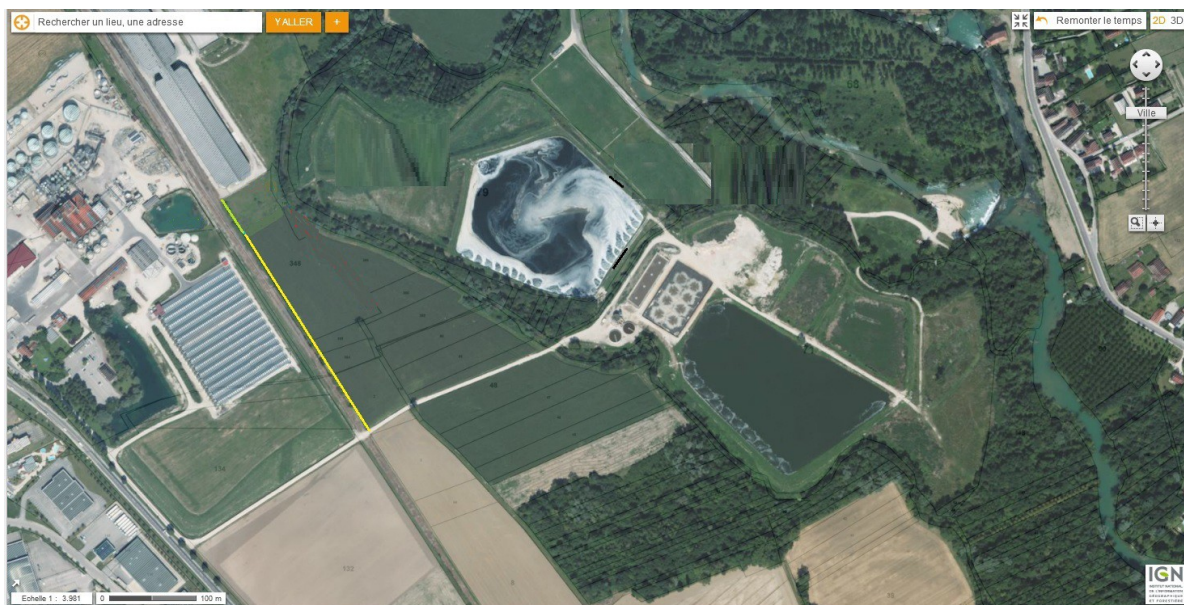
Depiction (in yellow) of the dyke built during this flood episode (ARR operator)

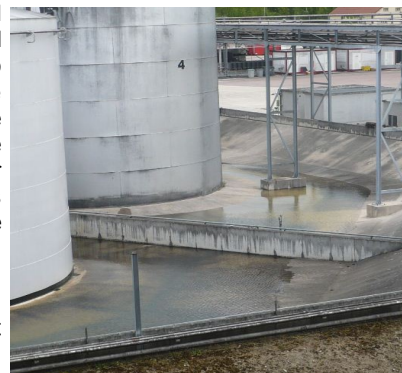
Retention basin for an unsealed tank (Source: DREAL Champagne-Ardenne)

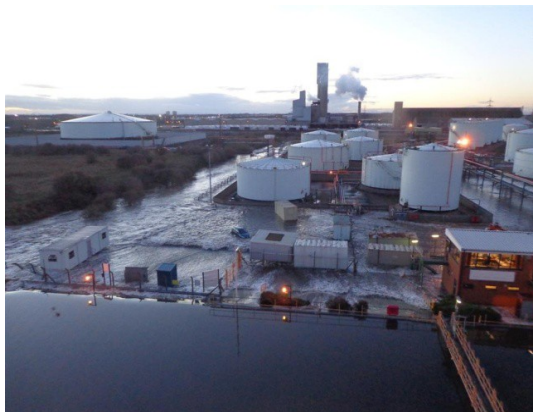
Figure 2 - View of terminal being flooded from ship moored up on jetty, source Cleveland EPU

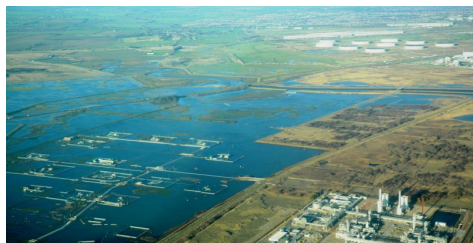
Figure 5 : SABIC Brinefields and the flood defence breach, source Environment Agency

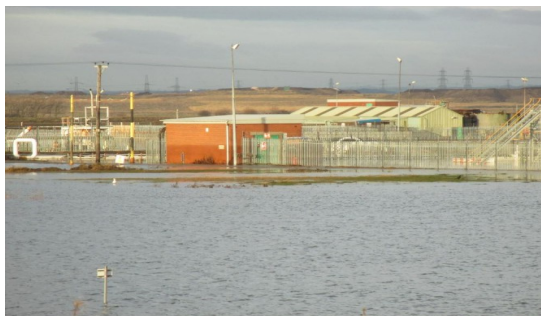
Figure 6 : Control room on the Brinefield – note flood level mark on control room wall, Source Sabic UK Ltd

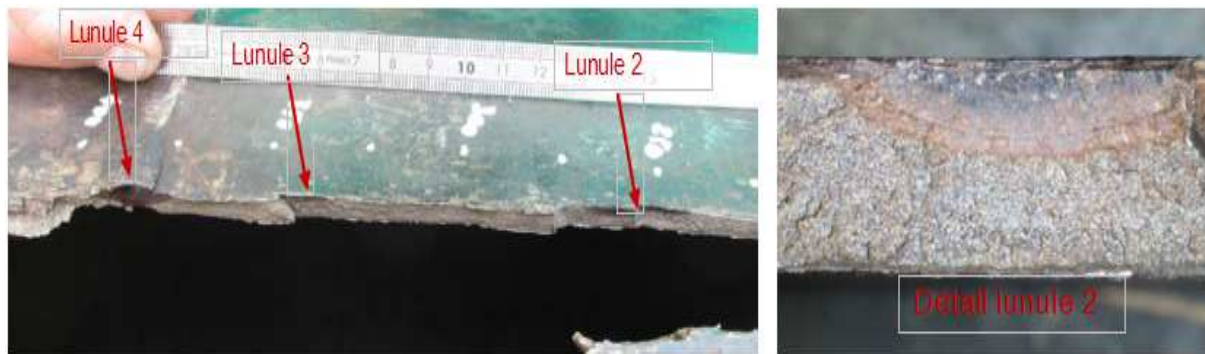
Outside the rupture zone, on the outer surface of the liner and along the upper generatrix, the magnetic particle inspection evaluation revealed the presence of crack-type anomalies associated with the identified mechanical damage that had strain-hardened the metal and caused the tube to flatten over its upper generatrix. Mechanical stresses at the level of the connection with the non-flattened zone had thus formed.

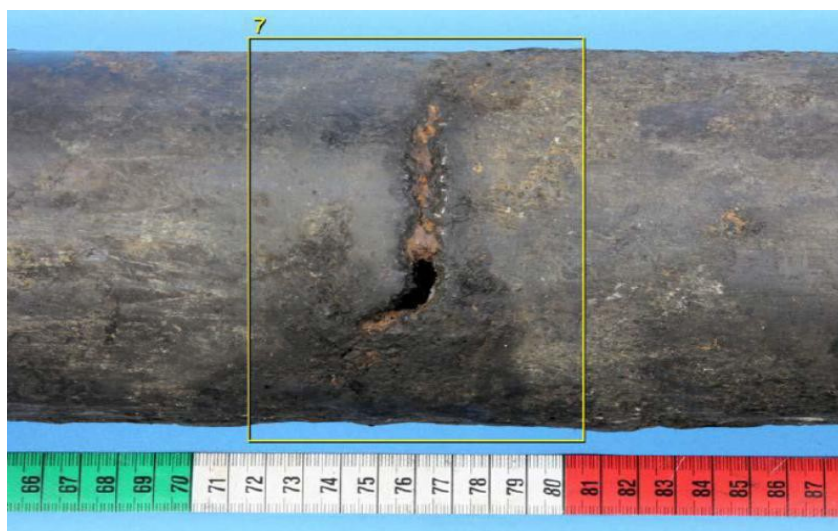
Figure 3: Hole in the steel kerosene pipeline stemming from outside corrosion (copyright: operator)

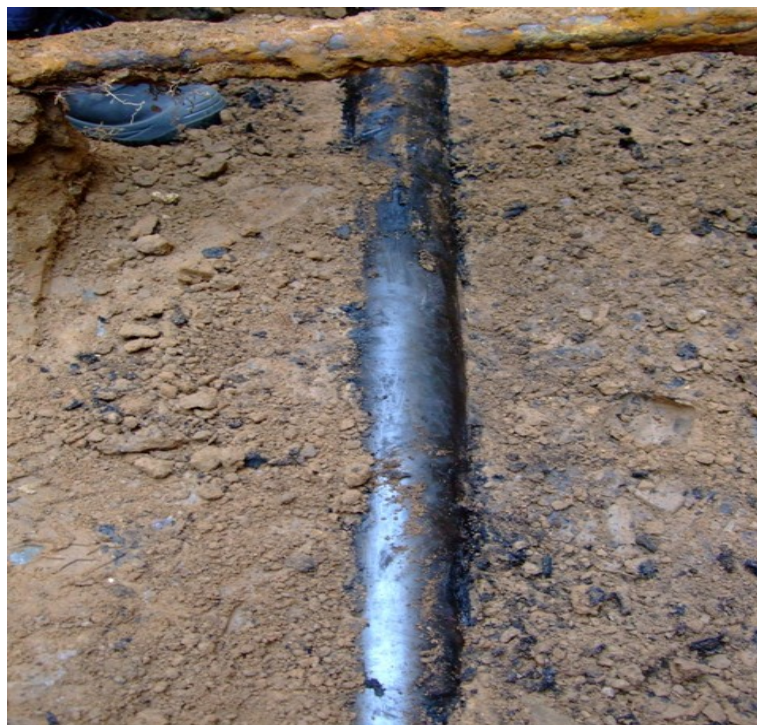
Figure 4: Water pipe (at the top of the picture) crossing the kerosene pipeline (copyright: operator)
