Lessons learnt from industrial accidents
IMPEL 2019 Seminar
13th edition
Final report: 13 August 2019

Title report: Lessons learnt from industrial accidents IMPEL 2019 Seminar 13th edition	Number report: 1
Project manager: Christian VEIDIG	Report adopted at IMPEL General Assembly: [.....]
Authors: Multiple	Number of pages: 1 Report: 1 Annexes: 0
Project team Gauthier VAYSSE, Jean-François BOSSUAT, Christel ROBERT and Christian VEIDIG	
Executive summary: <p>The 13th edition of the IMPEL seminar devoted to lessons learnt from industrial accidents held on 22 May and 23 May in Rennes, France. 293 participants, representing 21 countries, took part to this event. 43 non-french inspectors joined the session.</p> <p>The themes addressed during the 2019 edition were selected for their pertinence in terms of experience feedback, even though, in some cases, the human and environmental consequences of the accidents were limited.</p> <p>In this framework, 14 accidents, three of which occurred outside France, in Belgium, the Netherlands and Germany, were presented.</p> <p>They concern several subject like:</p> <ul style="list-style-type: none"> - controlling the new risks; - preventing multiple

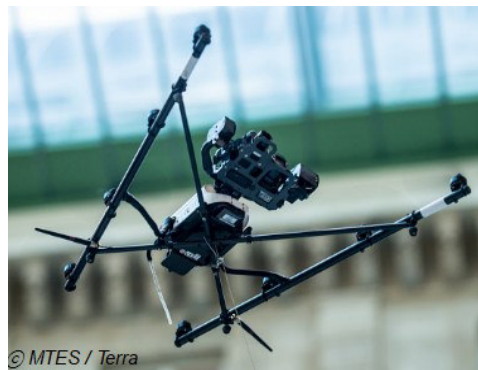
ARIA 51339 - 08/04/2018 - Village-Neuf (Haut-Rhin) - France

Drone crash on a chemical plant

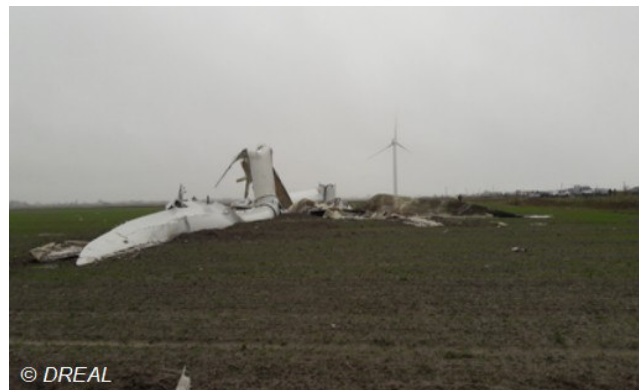
The damaged wind turbine belonged to the first generation of a model marketed in France by the manufacturer. It was commissioned in 2003. The only other identical wind turbines in service in mainland France were the seven turbines still in operation in both wind farms.

- the combination of undetected abnormal wear of the brake blocks and wind speeds in excess of 40 m/s, caused the pitch of the three blades to change uncontrollably and made the turbine automatically stop. The control system had been designed to automatically stop the turbine in the event of a deviation in the blade pitch control system;

- following a misinterpretation of data, an operator used the remote management system to manually reposition the turbine. This caused the rotor speed to quickly increase and exceed the safety limit. Although the overspeed protection system kicked in, the condition of the brake blocks on the pitch control system and the extremely high wind speeds made it impossible to stop the turbine. The mechanical loads acting on the tower greatly exceeded the turbine's design limits, causing it to collapse.

The operator's investigations revealed that the mechanical linkage between the blade pitch motor and the brakes was not covered by the maintenance inspection protocol. As a result, the accumulated wear had not been detected during the annual inspections.

- immediate safety measures;
- filing of an accident report;
- waste removal (collection with mapping and disposal);
- soil pollution (analysis followed by treatment where necessary);
- metallurgical analysis of the demolished wind turbine and assessment of the towers of the other turbines;
- halt in the operation of the remaining two turbines pending a check of the overspeed protection system. The halt is also depending on the metallurgical analysis results for the other towers and the accident report findings;
- conditions for building a new wind turbine.

Both orders were signed on 5 January 2018. Follow-up meetings were held regularly with both operators. Following the replacement of the brake blocks and a series of tests, both farms were allowed to resume operation. They were inspected on 14 June 2018. A final follow-up meeting was held on 13 July 2018. All the solutions implemented were found to be satisfactory on 27 September 2018.

- they revised and clarified the maintenance procedure to be followed in the event of failure of the blade pitch control system and trained their maintenance technicians;
- they updated their maintenance instructions. From now on, all or a portion of the components of the blade pitch control system's brake blocks (gear wheel in particular) are to be replaced every five years and the replaced components are to be inspected by sampling to confirm this frequency;
- since March 2018, they have been using special software that assesses the condition of the blade pitch control system's brake blocks by comparing the actual position of the blades against the setpoints sent electronically;
- a safety warning has been written for operators who have not signed a maintenance agreement with the manufacturer and who own the same type of wind turbine.

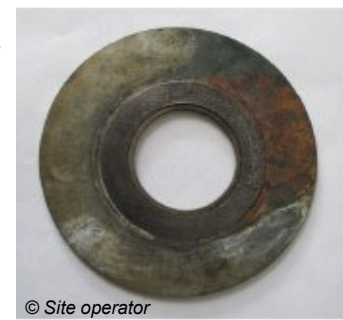
The bypass very closed valve on the scrubber also had a leak, but the leak had not been found because the valve is located between two very closed pipes, making it difficult to access. A portion of the gases to be treated by the scrubber therefore was directly discharged to the stack.

Three phosgene analysers are fitted on the stack's outlet. They use 2/3 voting logic, meaning that phosgene must be detected by two of them in order to activate risk management measure and close the valves leading to the stack. On the day of the accident, phosgene was detected by just one analyser. The flow rate of the sample loop was too low for the second analyser and the third analyser was sampling the ambient air, not the air inside the stack. This 2/3 voting logic did not allow the technicians to stop the flow of phosgene to the stack.

© Site operator
 Flange's seal upline of the flow meter

The analysers were calibrated but the sample loop had never been checked.

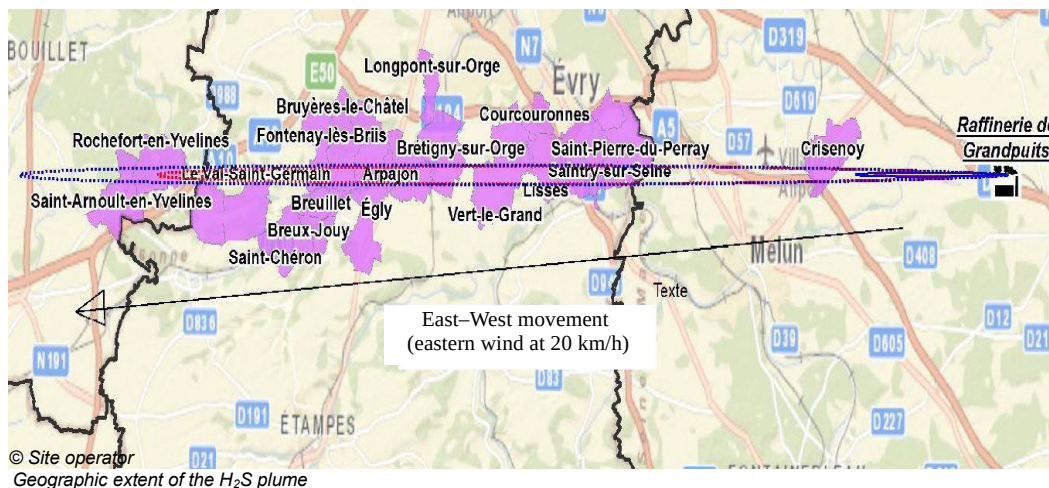
An analysis of the event showed that the leak occurred on a valve on the gas line between the purification column and the gas-flaring system. It was found that the valve's cap had been distorted by ice (outdoor temperatures below -5° C). During normal operation, the gas contained in the line does not flow. Heat tracing is used to prevent the formation of condensation, but the operator noted that it was not working. The expansion of the ice caused a crack to form in the valve. This crack then allowed the gas to leak out when the ice thawed. The lack of insulation and the fact that the valve was positioned at the bottom contributed to the build-up of water in the valve.

An estimated 187 kg of gas was released. The icy temperatures, strong wind, and atmospheric stability that remained very high throughout the event and the area explain why the odour was noticed in three counties. Computer models and air-quality measurements taken near the site show that the H₂S concentrations were very low (less than 1 ppm) and thus there were no offsite toxic effects. However, the significant lethal effect thresholds¹ may have been exceeded in some areas near the leak inside the refinery.

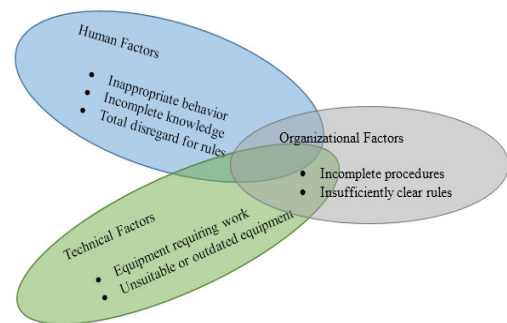
Lastly, the investigation showed that technicians inadequately understood basic safety rules despite thinking that they were following them and that technicians continued performing operations even if they did not go as planned (fear of being singled out as responsible for abnormal situations and for losses in site efficiency). In addition, half the refinery’s technicians stated that they preferred to keep silent about safety incidents out of fear of being punished. Employees no longer gave managers feedback because they feared bothering them and, because of a lack of responsiveness and pragmatism, have little motivation to take part in the process.

© Site operator
 Characterisation of the root cause behind various incidents

Following this assessment, a programme was launched to improve the safety culture at the refinery, focused on human and organisational factors. Using feedback from employees, the refinery’s management committee proposed four areas of improvement:

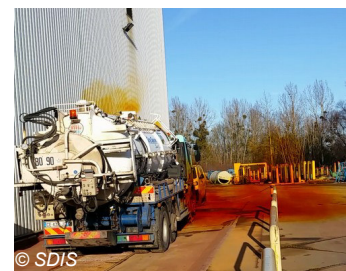
© SDIS
Release of nitrous vapours following an unsupervised unloading operation (ARIA 49018)
