Explosion of a chlorine pipe in Champagnier

ARIA 29864 - 05/21/2005 - ISERE (38) - CHAMPAGNIER

24.1E – Manufacture of other basic inorganic chemicals

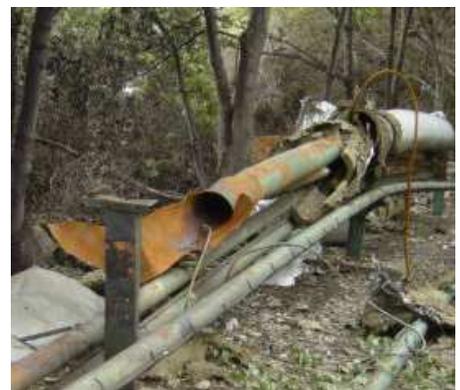
Measuring 200 mm in diameter and 3,600 m in length, the painted, lagged steel pipe was equipped with an external skin effect heating system and operated at 4 bar (relative) and 30 °C. Production operations had been stopped the day earlier for a 10-day maintenance shutdown period, and the pressure in the 'chloroduc' had been lowered to 0.25 bar.

The explosion occurred 150 m from the delivery point, in an area outside the user's site. The pipe ruptured in 4 locations along a 70 m section and showed traces of internal shock waves. The accident did not claim any victims despite a large amount of pipe debris projected in a 150 m radius. An estimated 475 kg of Cl₂ was released following the explosion. The damage observed (helical rupture, pressure wave...) indicates the explosive character of the accident. The 4 other pipes on the aboveground rack (dia. 100 mm) suffered extensive damage: the 2 nitrogen lines (13 bar, 2 to 3,000 m³/h) were deformed although were not leaking, and their pressure as reduced to 10 bar; the oxygen line (10 bar), was also damaged and was drained. The last line was no longer in use and was kept under N₂ at atmospheric pressure.

Analysis of the accident showed that an H₂/Cl₂ explosion caused the damage. The formation of H₂ (20%) can be explained by the combination of several elements: The accidental introduction of humidity into the piping during a previous maintenance operation may have led to hydration of the ferric chloride present in the pipe's environment. According to the operator, the change in the deposit's crystalline phase due to excessive heating of the pipe (80 to 90 °C) promoted corrosion in the steel pipe (by the hypochlorous acid) and the formation of H₂. This heating caused a temperature sensor to lose its electrical power supply after a cable on the user's site was broken when a slab protecting the structure was poorly handled, just 3 days earlier.

In fact, the proportion of hydrogen (20%) released in the gaseous chloride contained in the pipe, which was capped at each end and kept at low pressure (0.25 bar), formed an explosive mixture requiring very little initiation energy to ignite (in the order of a dozen microjoules or so).

The operator cleaned the inside of the structure (2.5 to 3 t of mineral and organic residues were extracted), and had planned to install temperature sensors every 500 m with upper and low safety devices, refurbish and secure the electric (heating) tracing, and perform regular endoscopic inspections...

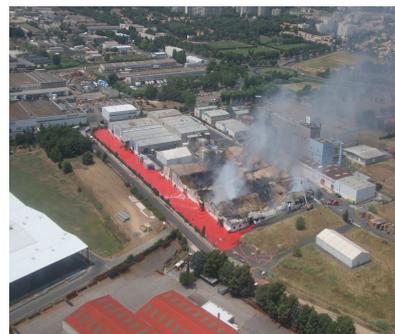
Less than an hour after conducting his round, the security guard sounded the alarm upon confirming that there was a fire in zone D1. The executive on duty and the director made their way to the plant. The firemen noted that 3 of the buildings were on fire upon their arrival at 3.27 am. The utilities were disconnected and the internal contingency plan was initiated, followed by the special intervention plan at 4.22 am. A confinement perimeter of 400 m was set up around the site. A flour silo and lightweight structures were sprayed with water to protect them. The firefighting water (500 m³/h) was recovered in a retaining basin at the lower portion of the site through the use of inflatable balloons. Following a malfunction of the lifting pump, part of the firefighting water was pumped and removed by trucks from a specialised company or transferred to a hermetic reservoir (10,000 m³) provided for this purpose after a mobile backup pump had been set up. Roughly one hundred firemen brought the fire under control by late morning; 5 had been injured or otherwise effected (burns, nausea) during the operation.

The 4 buildings (7,500 m²) and a stock of 1,700 tons of phytosanitary products were destroyed. Property damage and operating losses were estimated at 40 M euros. A sharp odour was noticeable several dozen kilometres away, and 3,000 people were invited to stay at home or their place of work. Although no serious sanitary impact was feared, the smoke caused discomfort among the residents and personnel of companies in the industrial estate. An analysis of the smoke revealed the presence of sulphur compounds (H₂S, CS₂, SO₂) and HCN. Although the concentrations of CS₂ exceeded the toxicity level (OEL 10 ppm) above the fire, none of the various pollutants exceeded the level at the site's borders. Several companies within the industrial estate had to suspend their activities on the day of the accident. The firemen monitored the slow combustion of the chemical products with the release of fumaroles for several days. A mobile measuring station located 200 m downwind from the site monitored the concentration of sulphur products in the air. As the cause of the fire was unknown, a judicial inquiry was conducted and the insurance company appointed a claims expert. The Prefectoral Order of June 29th suspended operations at the site and required that all safety equipment be overhauled prior to the restart of all equipment not damaged in the fire.

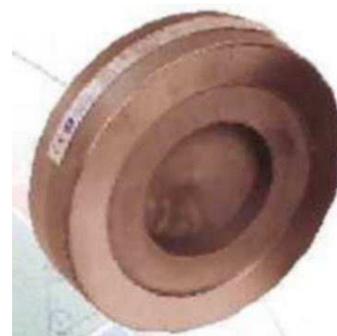
The operator started the primary compressor according to the normal procedure with automatic monitoring of the rising pressure. The pressure measured at the inlet of the secondary compressor was in excess of 300 bar, even though a valve on the discharge side of the primary compressor should have opened at 284 bar. In addition, the primary compressor should have tripped off automatically (standby) at 270 bar. This did not happen. The operator noted the abnormal increase in pressure and switched to manual mode. The operator's belated action was unable to prevent the pressure from rising to 310 bar and the rupture of the disk.

The primary compressor was unable to stop due to partial clogging of the pressure increase regulating gauge ($P_{\text{measured}} < P_{\text{true}}$). The valve malfunction was attributed to a maintenance error: the valve had been replaced by an inappropriate model (Calibration pressure > 310 bar). The fouling of the MPR section resulting from several days of production without being purged of greases accentuated the pressure increase kinetics.

The check valve, obstructed by low polymers was cleaned and checked, the safety PLC and the primary compressor's standby sequence were tested. The rupture disk and valve were replaced. Other measures were also taken: shut-down of the compressor in automatic or manual mode with a fail-safe pressure measurement, review of grease cylinder operating rules to prevent clogging of the MPR, additional training for the personnel, and consideration of this clogging phenomenon in the installation's danger study.

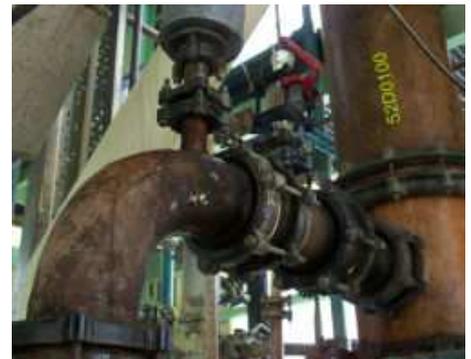
In a chemical plant, a sulphur dichloride leak (SCl_2) occurred on a pipe equipping the distiller of a distillation column hydrolysed causing a significant release of hydrogen chloride (HCl). The column was located in a metal building forming a sort of confined space.

The accident occurred during maintenance on a pressure sensor. The sensor had been identified as faulty after indicating a pressure of 108 mbar on the distiller's outlet (upper alarm threshold = 100 mbar), thus triggering the closure of the SCl_2 supply valve and the steam control valve of the distiller's heating system. Before replacing the sensor, the distiller containing 50 kg of SCl_2 had to be drained after the discovery of glass from the downgraded distillation column. This clogging had been identified 3 weeks earlier without any action being taken. In addition, the pressure sensor's shut-off valve, which could not be removed due to seized bolts, could not be closed; the operator was required to remove the entire assembly, thus leaving the ND25 branch connection exposed to the open air. As the sensor was not fail safe, when disconnected electrically the steam control valve opened and the distiller heater, whose temperature rose from 24 to 120°C in 30 minutes, resulting in the release of SCl_2 .

The measures taken with regard to the feedback notably concern the monitoring and intervention procedures in downgraded mode, the "failsafe" principle on the unit's entire functional safety chain...

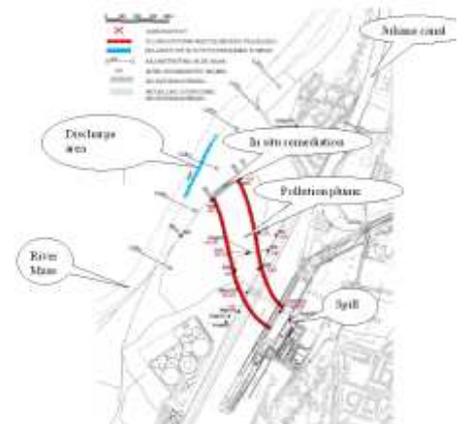
A broken pipe on a harbour-based petrochemical site released 3,000 m³ (2,100 t) of methyl-tertio-butyl-ether (MTBE) causing substantial soil and water pollution. The nearby Meuse River was also concerned; its water is pumped for human consumption and operations had to be shut down. A major clean-up installation was installed following the spillage.

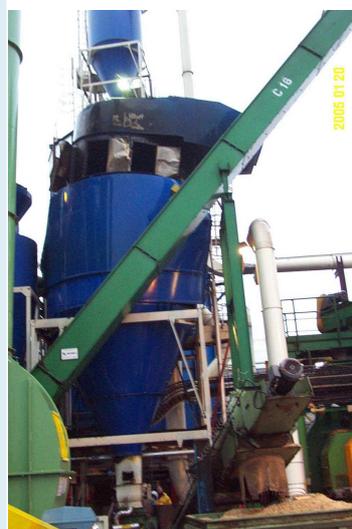
The firefighting water was recovered in a catchpit, then analysed and treated. The chips burned in the fire were disposed of in the plant's boiler but property damage (refiner, cyclofilter, sifting screen, vents, and the refiner's suction system) was estimated at 250K euros and the shutdown of the production line for 36 hours resulted in 750K euros in production losses.

The site's accident procedure manual proved efficient. According to the accident report, a metal part in the refiner had broken, causing sparks which caused the refiner to explode. The operator foresees to uncouple the refiner from the rest of the installations; a third-party expert evaluation of the installations, safety systems and intervention procedures; a thermal imaging camera to check the installations before, during and after an accident and an increase in the surface area of the cyclofilter vents (although already in compliance with current standards). Just five days following this accident, a smouldering fire caused a new fire in silo A.

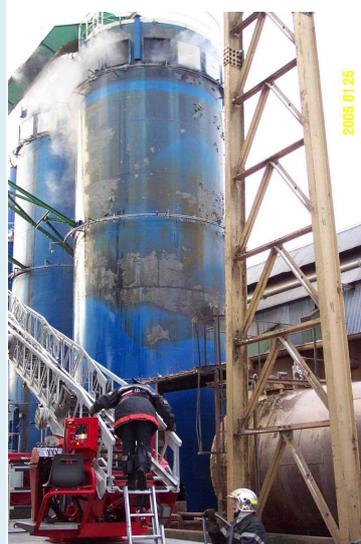
The incident opened the silo's vents and projected dust and flames onto the adjacent production building. The fire spread via the electric wires before it was contained by the building's sprinkler system and extinguished by the emergency services. A thermal imaging camera was used to check for residual hot spots in the silo and emptied silo B, which had caught fire 5 days earlier, in order to perform the same tests. A site fireman monitored the installations until noon the following day. The firefighting water was recovered in a catchpit, then analysed and treated. The shutdown of the production line for 14 hours resulted in production losses estimated at 45K euros.

The silos vents had to be replaced and the production building's electrical installations repaired. According to the accident report, smouldering fires had remained after the fire of January 20th under the extraction unit, a 2-ton piece of bell-shaped equipment at the base of the silo. During this fire, the reservoir had been emptied, flushed and cleaned but this piece of equipment had not been raised. The operator initiated a third party expert evaluation of the installations, safety systems and intervention procedures, and the use of a thermal imaging camera to check the installations before, during and after an accident. Further more, the operator also modified the intervention and silo restart procedures; in the event hot spots (embers) are detected, the extraction unit will be raised for cleaning.

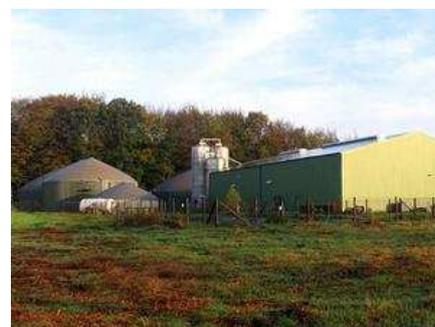
During the production of biogas by means of an organic waste reclamation process, a release of hydrogen sulphide (H₂S) killed 3 employees and a truck driver who had come to unload slaughterhouse waste. The high concentration of H₂S in the facility complicated the fire department's rescue operations. Roughly a dozen firemen were intoxicated to

varying degrees. Extensive aeration (more than 24 hours) was required before access to the building was authorised. The accident occurred while the truck was being unloaded inside a facility that had been kept closed in order to limit the emanation of foul smells. The load was being dumped into a 100-m³ pit equipped with 2 agitators. The pit's cover could not be closed as the electric actuating motor was out of service. The materials being unloaded were essentially pork entrails, viscera and liquid wastes having high sulphur content, pH near 8.5 and temperature of 60 °C. The waste had been loaded into the truck 24 hours earlier and was similar to wastes generally delivered by the slaughterhouse once to twice per week. The reaction between these substances and the material already present in the pit (animal and dairy wastes having a relatively low pH as determined by analyses performed after the accident) generated the release of H₂S. The temperature of the environment and the agitation of the mixture promoted the dispersion of toxic gas throughout the unloading facility. To make matters worse, the extraction system at the bottom of the pit, which directs the foul air to the outside via a biofilter, proved to be insufficient.

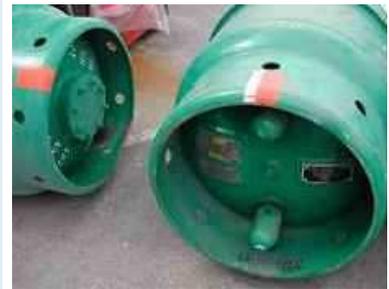
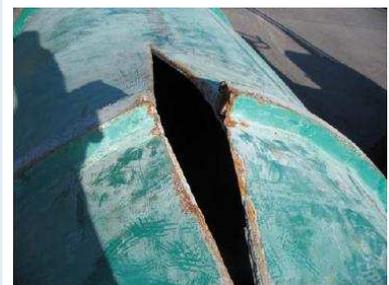
Photos : DRIRE Ile-de-France

An expert evaluation noted that the pressure equipment ruptured as a result of overfilling attributable "inappropriate" operating procedures and recommended that drums be systematically weighed. According to the CII (Classified Installations Inspectorate), the procedure is particularly difficult to perform: careful positioning of the "multi-purpose" drum on its side at an angle of 40° so that the 85 or 100% top-up limiting tube can serve its purpose. In addition, these drums are liable to contain liquefied gases or liquids according to 2 marks painted on its side... This setting is nevertheless imprecise as the end of the tube, based on its design, can vary in distance from the wall of the cylinder. The mixing of products (water / NH_3 ...) can also not be disregarded due to the multipurpose nature of the arrangement. Finally, systematic weighing may also be difficult: cramped machine rooms... A room adjoining the machine room and connected to the latter's stack, capable of resisting a heat flux and equipped with an appropriate detection system, shall be built to store the containers. The internal contingency plan has been reinforced. A more formal approach has been taken in developing the mobile tank filling/draining procedures.
