Explosion of a wood chip refiner and fire

January 20 and 25, 2005

Corbenay – [Haute-Saône]

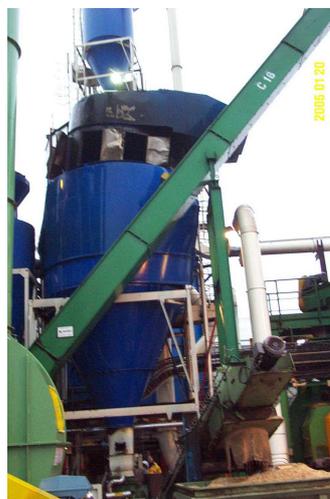
Material losses were evaluated at 250,000 euros, attributed to the replacement of the refiner (at the origin of the accident), and the damage caused to the sorter and cyclofilter. The silo and cyclofilter vents also have to be replaced. The plant also reported 750,000 euros in production losses due to the production line being shut down for two days.

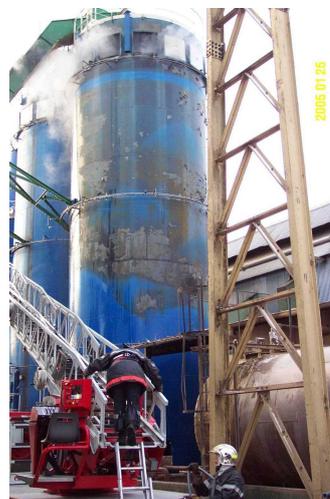
The consequences were minimal in comparison to the first accident. The production shut-down was limited to 14 hours; the storage silo's explosion vents and electrical cable that melted during the fire must be replaced.

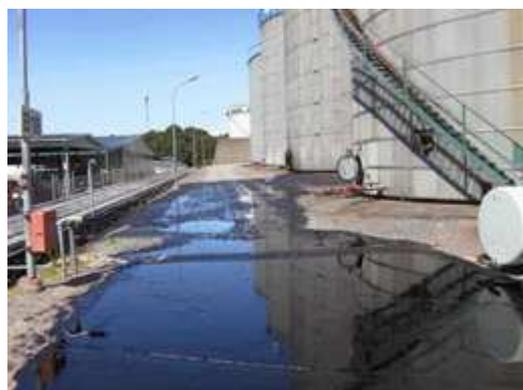
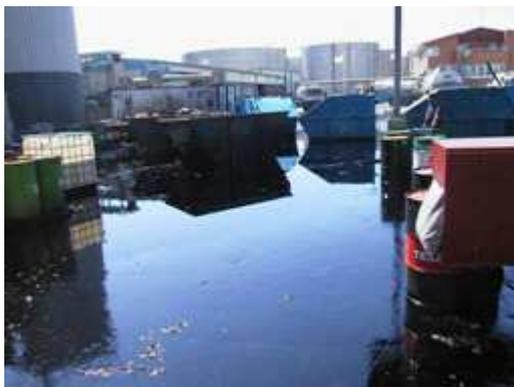
Oil spill outside tank No 375 was spread on the surrounding ground. Under the pipe rack (in the left) there was a rain water drainage sewer.

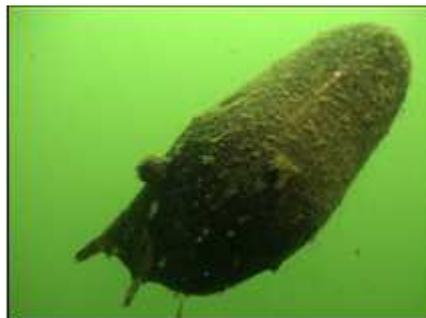
*The oil formed clusters that did not float on the water.
The diameter of the clusters was 3 to 10 centimetres.
Photo: Swedish Coast Guard.*

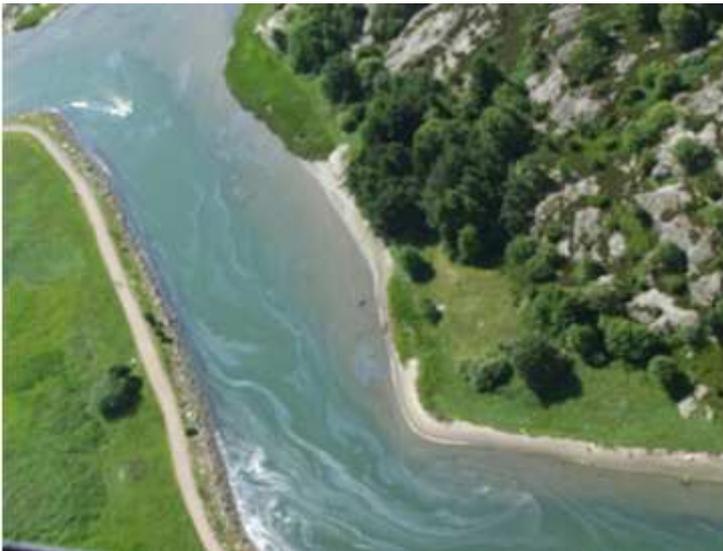
Environmental consequences of the spill of heavy fuel oil in the oil harbour.

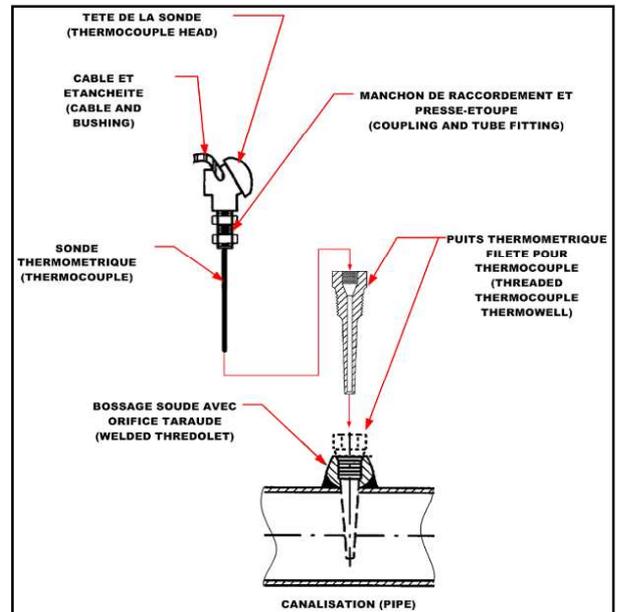
Temperature sensor assembly diagram

The investigations conducted following the incident showed that the thermocouple had been installed without a "sensor pocket", thus without protection. The hot raffinate was thus in direct contact with the sensor. As the quantity of product was excessive and the fluid very hot (320 °C), the tube fitting was unable to properly maintain the seal, leading to self-ignition of the product released and in contact with the air. The equivalent diameter of the break at the pipe level is roughly 10 mm.

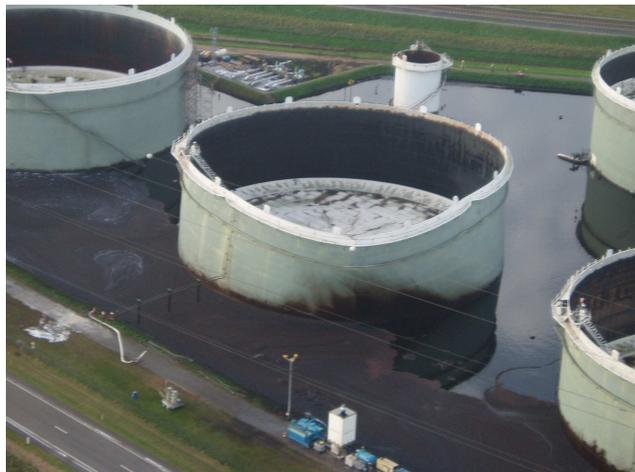
Figure 1 shows a picture of the situation in the bund the morning after the major accident happened.

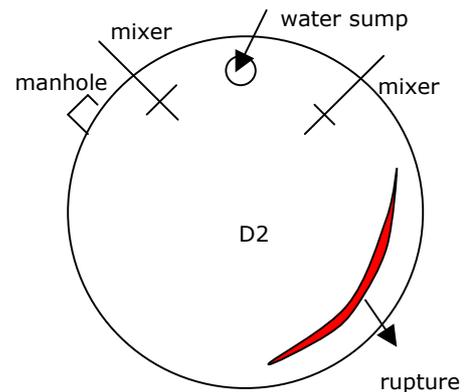
Figure 3: Schematic view of the bottom of storage tank

In this band the bottom of the tank formed a gutter. In this gutter uniform, internal corrosion was found and no pitting corrosion.

The bottom plates showed no external corrosion in the long, small band. The other bottom plates indicated no extreme corrosion.

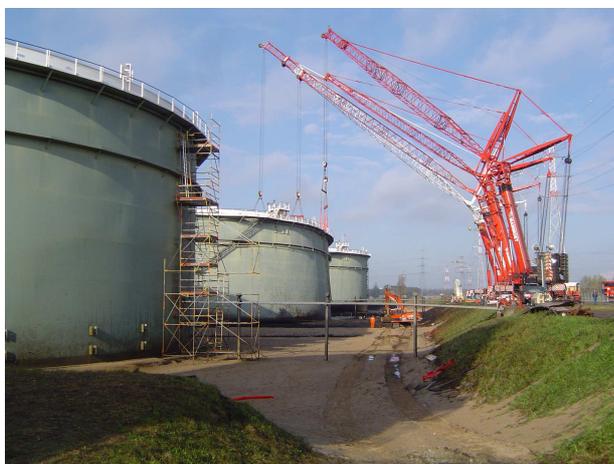
Figure 4: Major cranes stabilising tank D2

The stability of all storage tanks was periodically measured. The stability of storage tank D2 on the place where the foundation was blown away, was achieved by hanging the storage tank on 4 large cranes (figure 4).

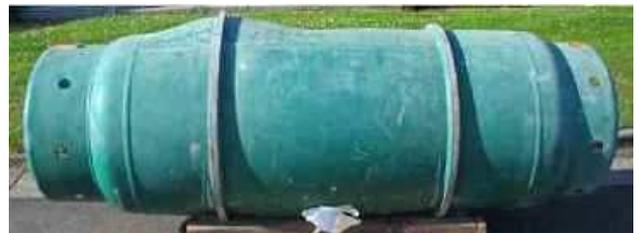
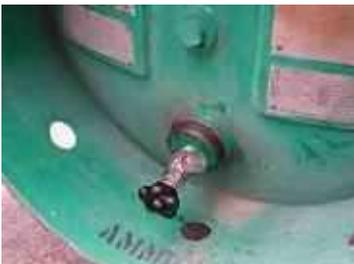
The tank was equipped only with filling and drainage valves and was not equipped with any pressure accessory such as a "pressure gauge" or "safety valve" (see photo).

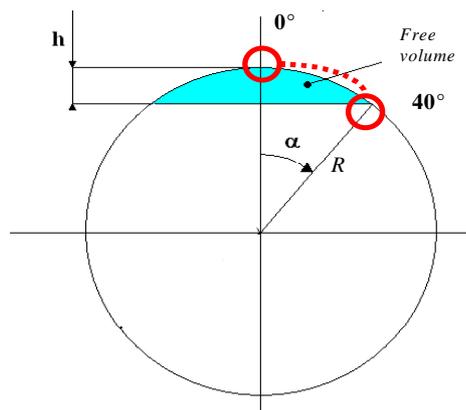
It was noted that, due to the design, the end of this discharge tube is a variable distance from the cylinder wall: It cannot thus fulfil its role with precision.

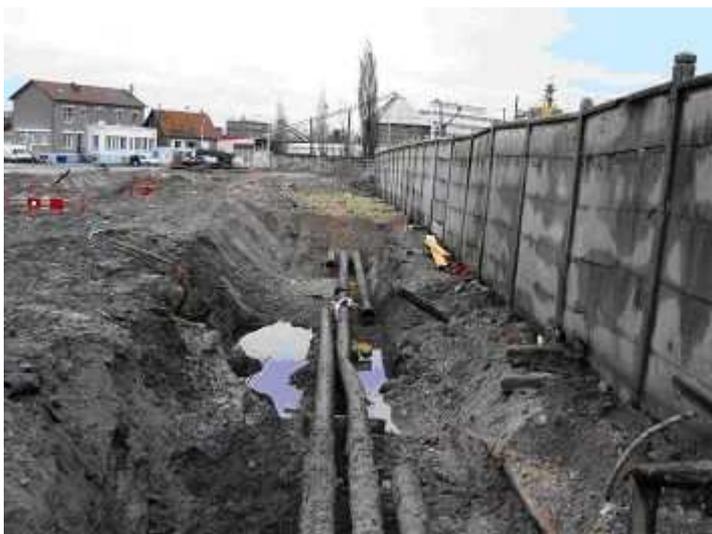
✓ Nearly 370 m³ of gas oil was spilled on the stretch of land being dismantled. The hydrocarbons seeped into the soil to reach the water table that is 4 meters deep. However, no immediate or medium term pollution was observed in the neighbouring docks of the Seine. Pumping equipment was set up by the various players involved and the operation was coordinated by the fire department right from the afternoon of 15 December on the site being dismantled and in the nearest drainage network. On the evening of 16 December, the pumping equipment helped in recovering 55 m³ of spillage. About three months following the accident 70% of the products had been recovered.
