## >Welcome address

DRIRE ILE-DE-FRANCE (the Regional French Authority on Industry, Research and Environment)

## Opening address

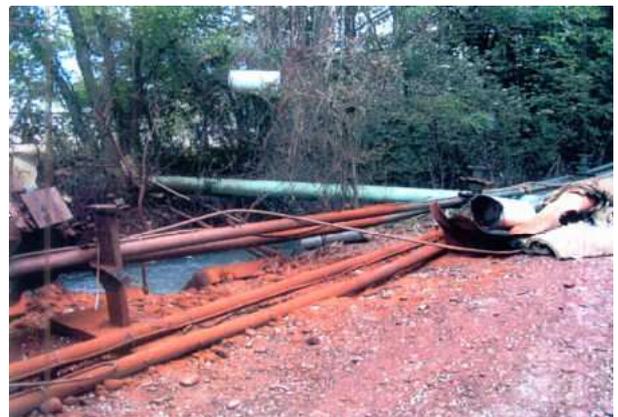
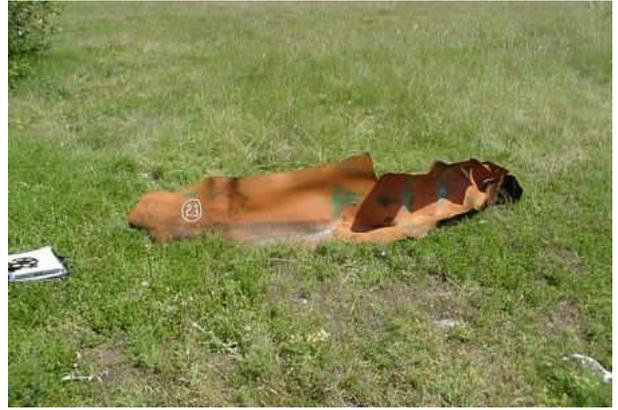
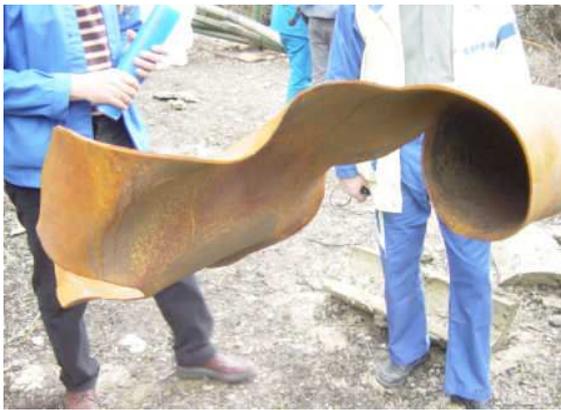
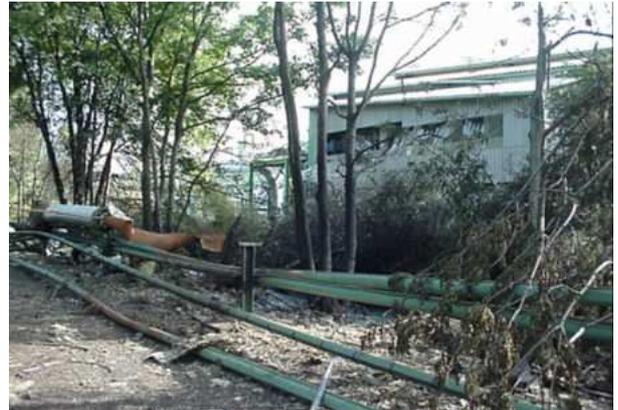
was severed at its end at a length of 64 m into 3 segments and fragments were projected mainly into:

- The user site:
  - ✓ a 20 to 30 kg fragment at 180 m from the severed zone of the chlorine transport line ,
  - ✓ a 10 to 20 kg fragment at 150 m.
- In the field where the chlorine transport line is located :
  - ✓ a 30 to 40 kg fragment at 85 m,
  - ✓ a 10 to 20 kg fragment at 70 m.
- On the road heading North:
  - ✓ a 10 to 20 kg fragment at 60 m.

Near the rupture zone closest to the manufacturer site, the immediate environment was covered with a dark red powder mainly comprising ferric chloride ( $\text{FeCl}_3$ ) contained in the passivation film of the pipeline.

The damage recorded (helical shaped fragment, pressure wave, etc.) confirms the explosion's detonating nature.

The operator replaced the last 400 meters of the pipeline damaged by the accident, with the new part of the pipeline subjected to several inspections especially a weld test and inspection. After assembly, the inside of the whole chlorine transport line was cleaned and dried.

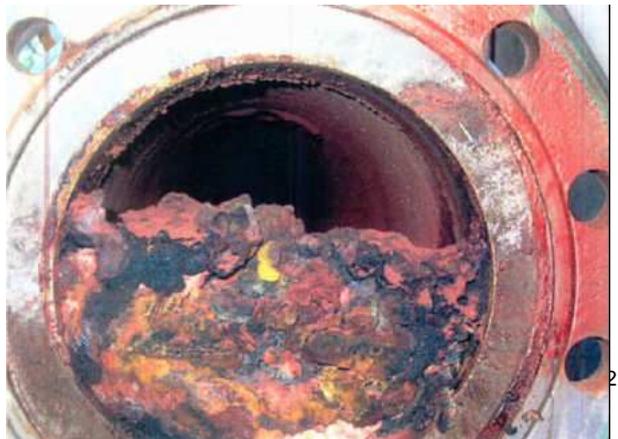
Among the several observations made during the enquiry, one of them included the presence of considerable amounts of solid deposits in the exploded pipeline.

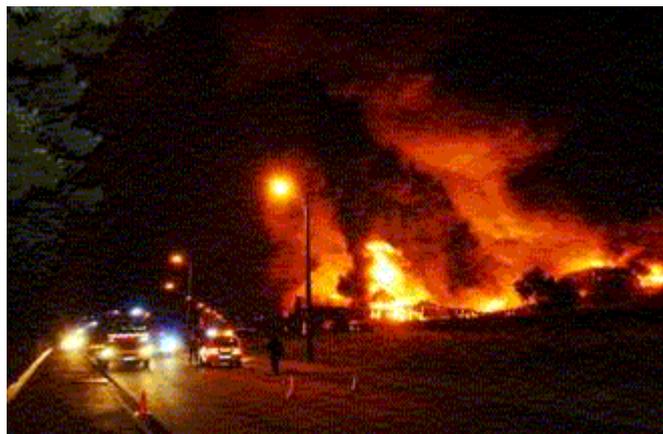
The slow combustion lead to more or less important wisps of smoke with the fire restarting occasionally.

Buildings on fire

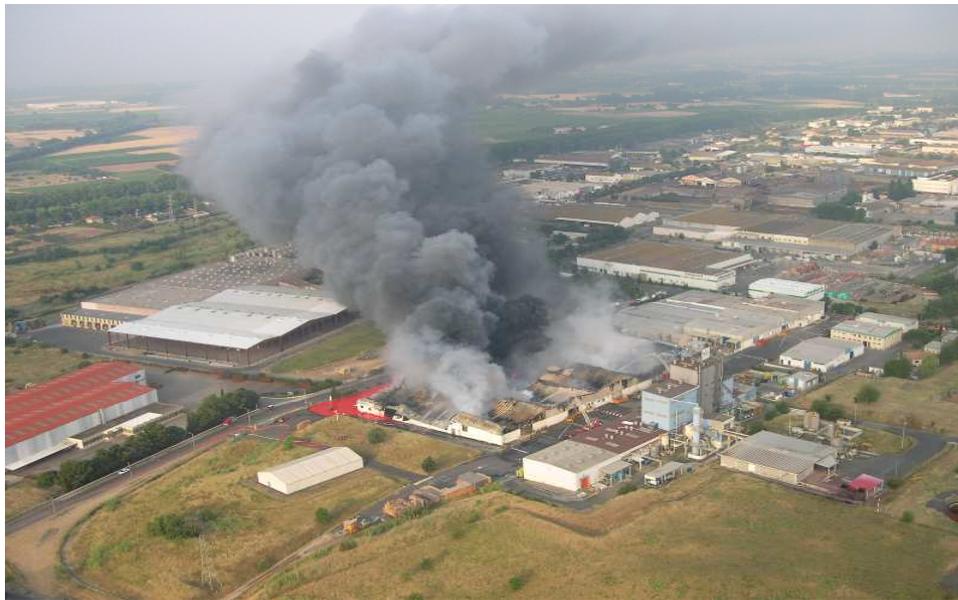
Plume of smoke rising above the site

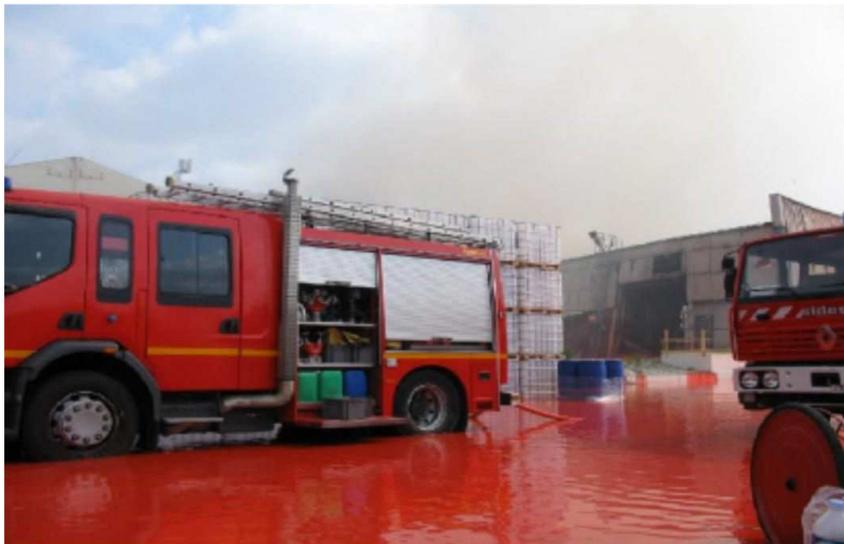
Firefighting water

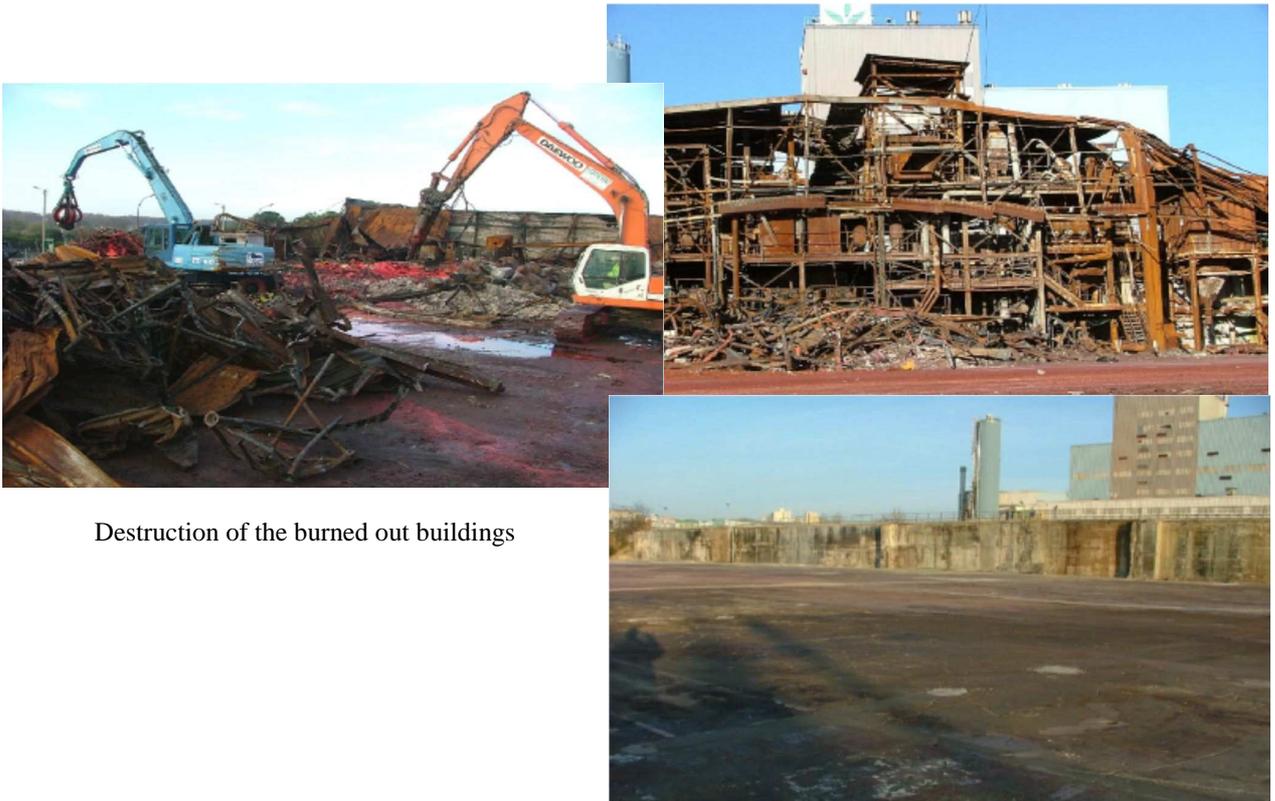
Destruction of the burned out buildings

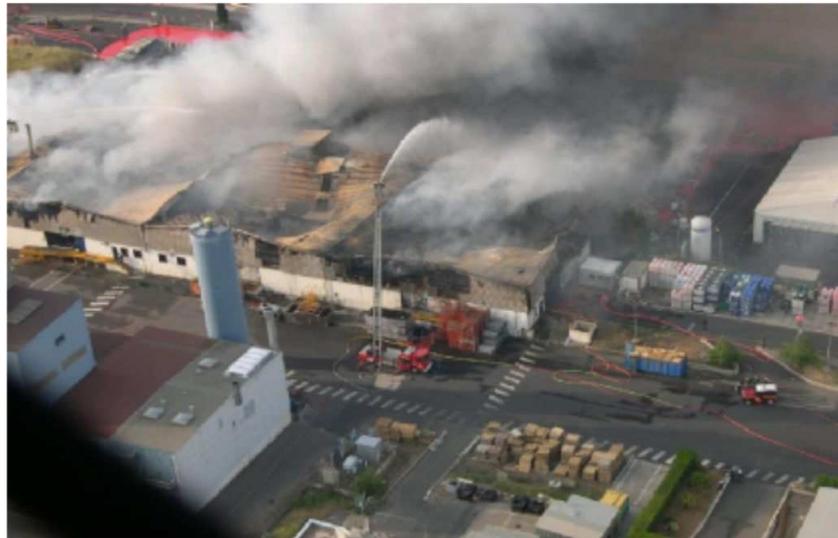
- the fire's extremely rapid propagation to all the buildings placed side-by-side, while the products being stored were considered to be "flammables",
- the non-pollution of surface and underground waters; the measures in place functioned correctly despite the failure of the lift pump,

Spread of the fire to several buildings

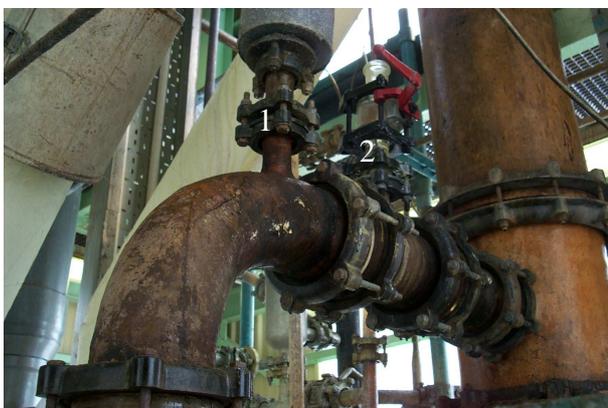
At 11.30 am, with the installation still shut down (heating setpoint at 0%, valves closed), the maintenance technician observed that it was impossible to drain the boiler when attempting to remove the pressure sensor in place.

Branch connection exiting the boiler (Sources: DRIRE Picardie)

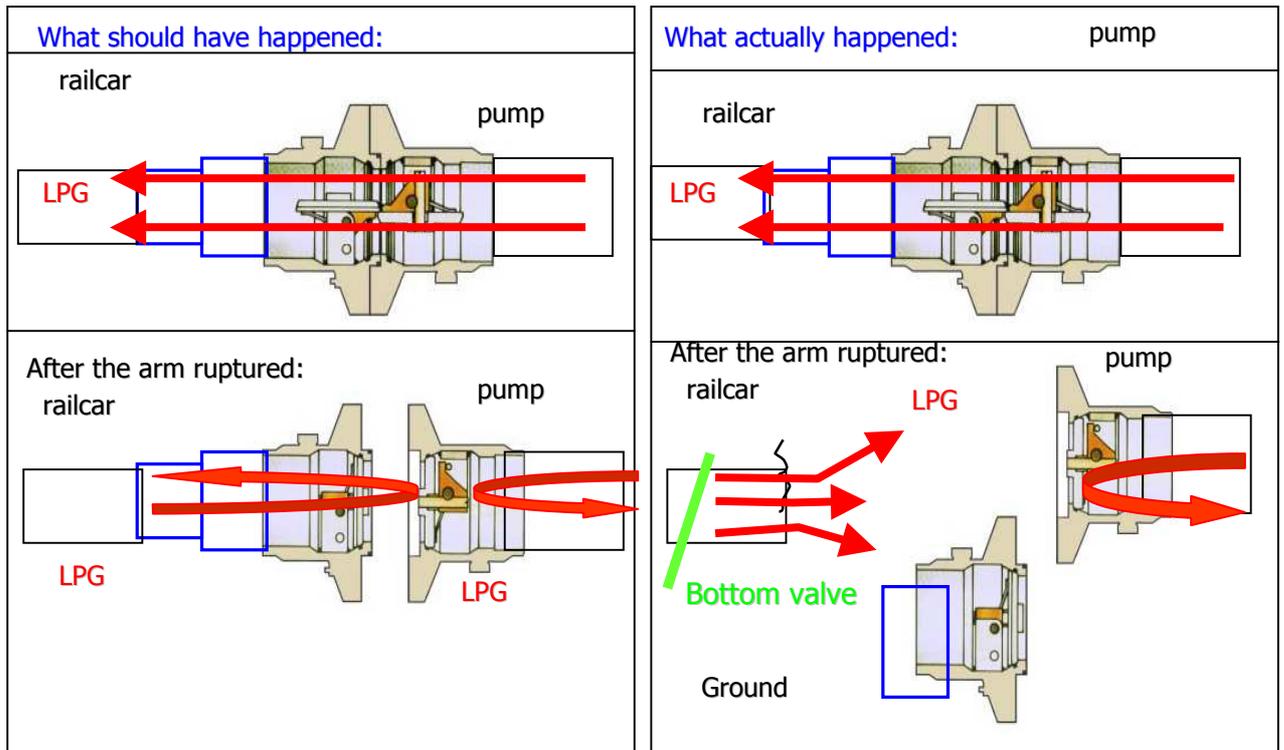
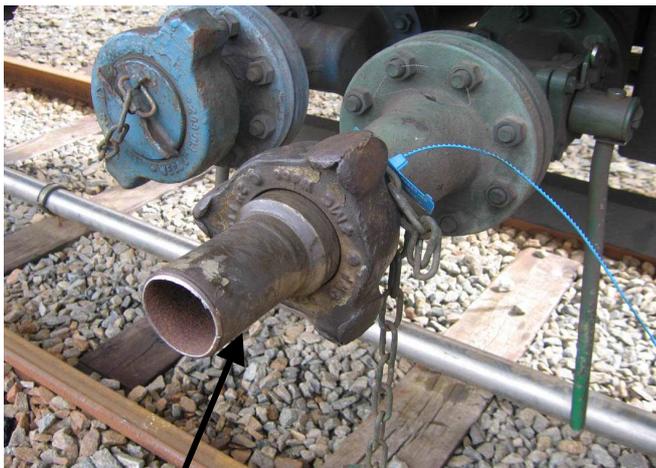
Railcar tank side

The incident had no consequence for the personnel present. Approximately 8 litres of liquefied propane was released, corresponding to the volume of the coupling that was severed.

The severed coupling

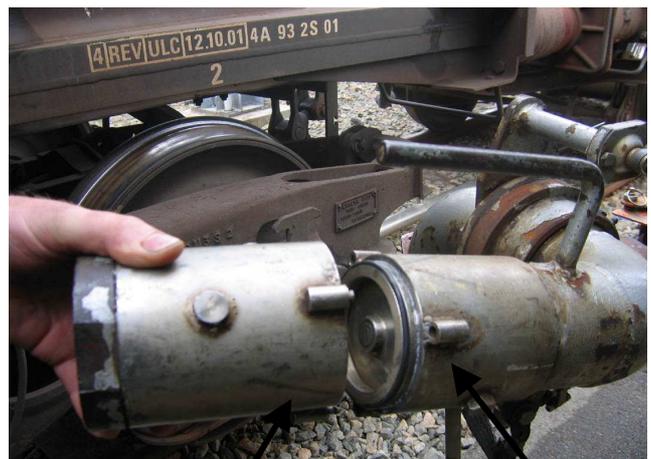
Pump side

Valve found on the ground

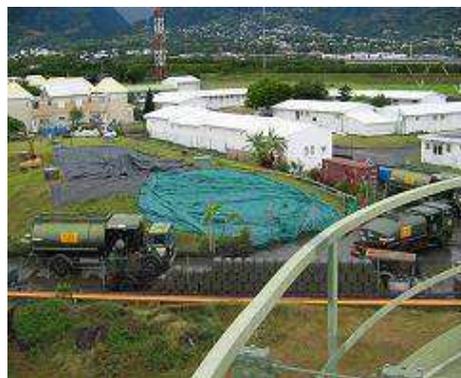
▲ Product infiltration zones ©

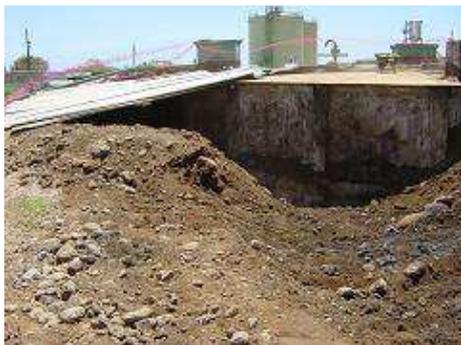
▲ Digging operations round the SEA2 tank ©

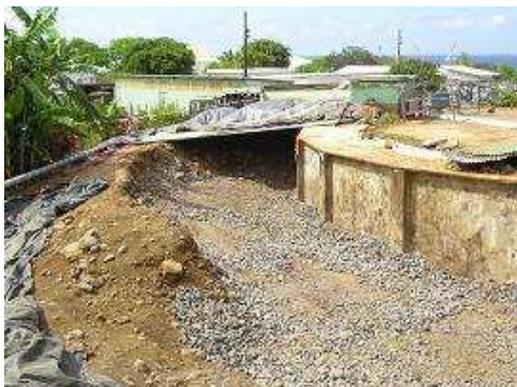
▲ Backfill around tank SEA2 ©

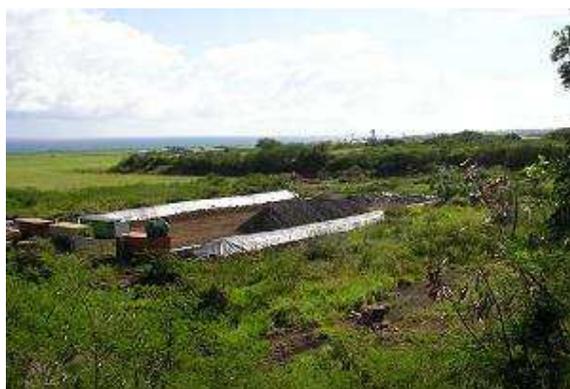
▲ Treatment of polluted soil ©

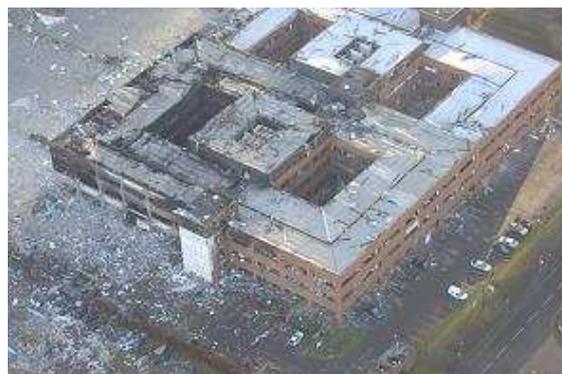
Photograph 1: Devastated building at the terminal site

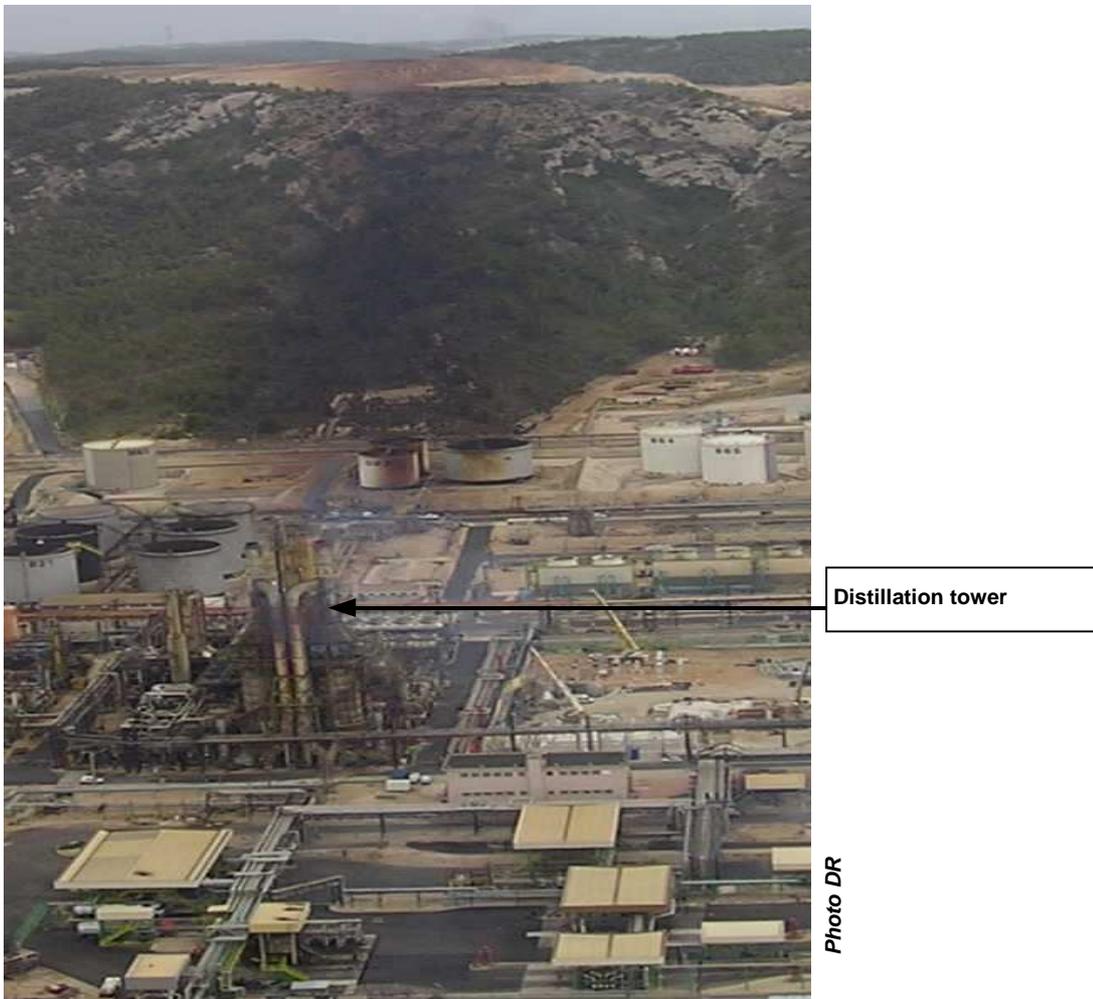
General aerial view of the unit and traces of spill in the neighbouring environment.

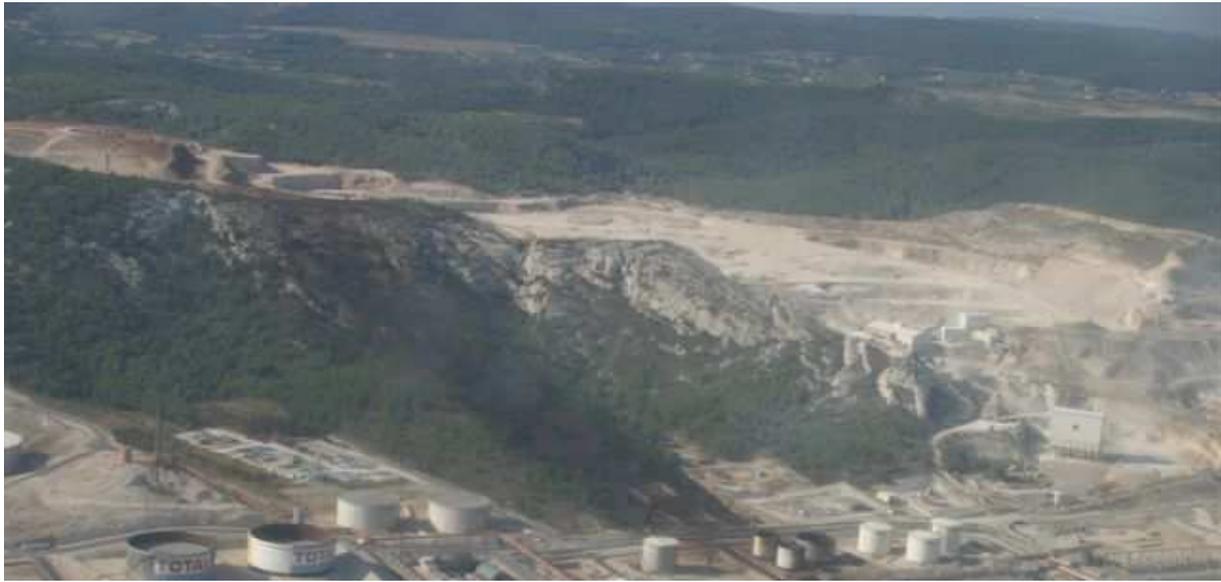
General aerial view of the unit and traces of spill in the environment south of the site

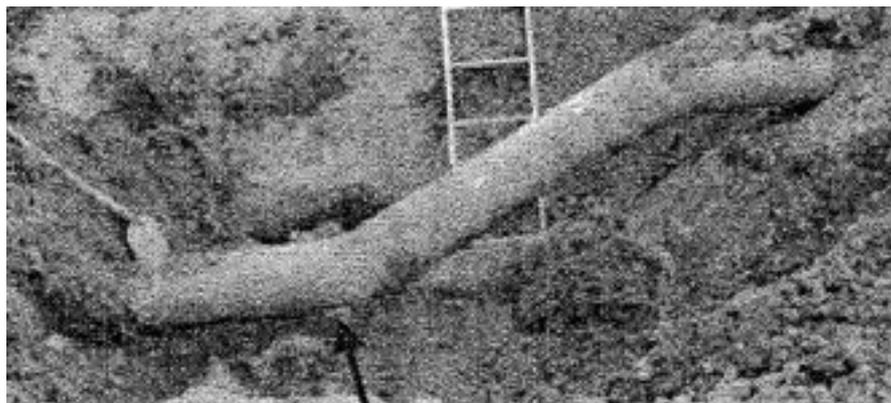
Despite annual inspections, the leak appeared to have existed for a number of years; the leak's initially low flow rate most likely increased progressively due to soil movements.

Portion of damaged pipeline  
Source: VROM-Inspectie (The Netherlands)

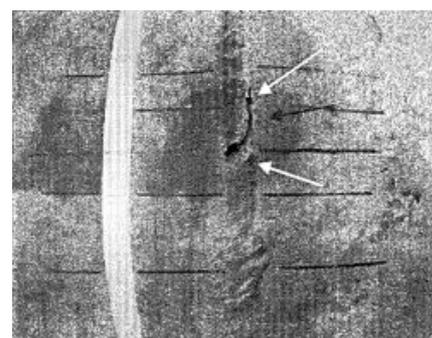
Crack on the weld  
Source: VROM-Inspectie (The Netherlands)
