LESSONS LEARNT
from industrial accidents

IMPEL Seminar
Aix-en-Provence, 16 and 17 November 2011

Table of contents

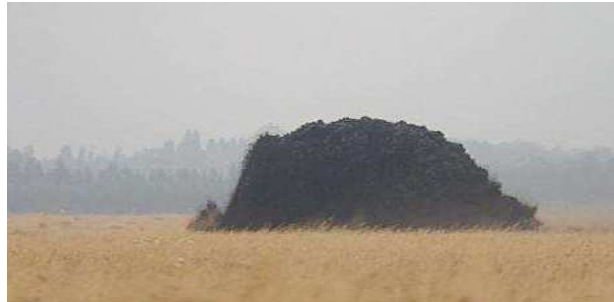
- 7:32 am : A pressure drop was detected in the control room (pressure stall causing a loss from 38 to 2.5 bar). The pumps were shut down automatically. A technician left the premises to inspect valve positions on the line.
- 7:35 am : The pipeline operator received a call from a warden stationed at the *La Crau* Nature Reserve to notify the operator of a leak. However, the information transmitted was insufficient to easily locate the exact spot where the leak had occurred. A rapid procedure for draining the pipeline was initiated.
Since the pipeline had already been shut off, the internal pressure depended solely on the level of relief (i.e. hydrostatic pressure).

Discharge of hydrocarbons (RR)

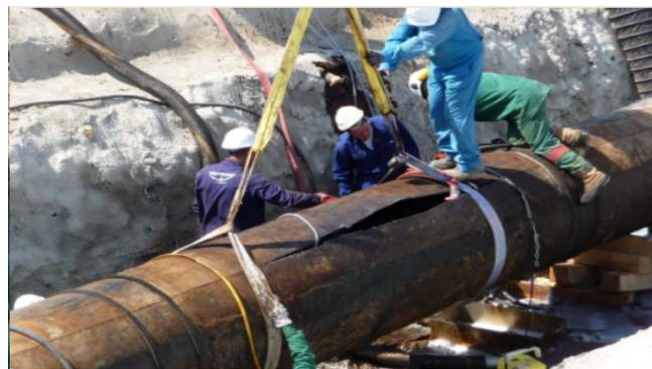
A "button-hole" opening 15 cm wide and 1.8 m long on a longitudinal weld was the source of this leak. Several hypotheses were forwarded to explain such a pipeline break.

"Button-hole" opening of the 40-inch pipeline (RR)

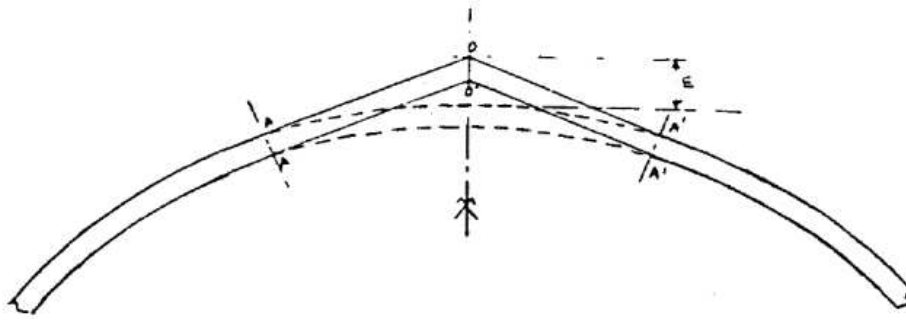
The 40-inch pipeline was composed of 5,190 tubes built by the same manufacturer and capable of exhibiting the same defect. These tubes were located along the southern part of the facility alignment, yet were not necessarily contiguous. Following a measurement campaign using an instrumented scraper, the roof effects associated with these tubes turned out to lie between 0 and 4 mm.

Diagram of the roof effect – RR

A specialised laboratory had modelled the behaviour of tubes displaying a roof effect of no more than 3.5 mm, which were dependent on loading variations caused by pressure variations over time. Tube sections featuring a roof effect above 3.5 mm were singled out for onsite inspection. On the basis of these studies, a strength test designed for 150% of the maximum service pressure was scheduled to be conducted at the beginning of 2011.

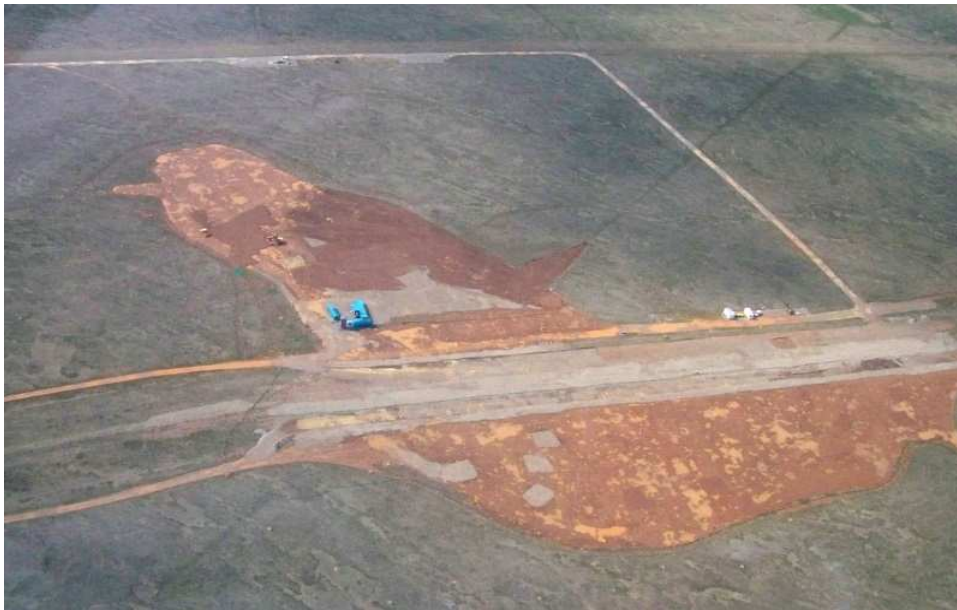
Over the observed 5-hectare zone, backfilling over a depth of approximately 0.40 m was performed using local materials transferred from a nearby quarry in conformance with the soil's original structure. The surface layer was reconstituted by means of directly transferring some of the "*coussoul*" steppe material extracted on zones not yet quarried. A scientific monitoring campaign had been scheduled to observe the re-composition of this material. These works were completed on 15 April, 2011.

Aerial view - March 2011 - RR

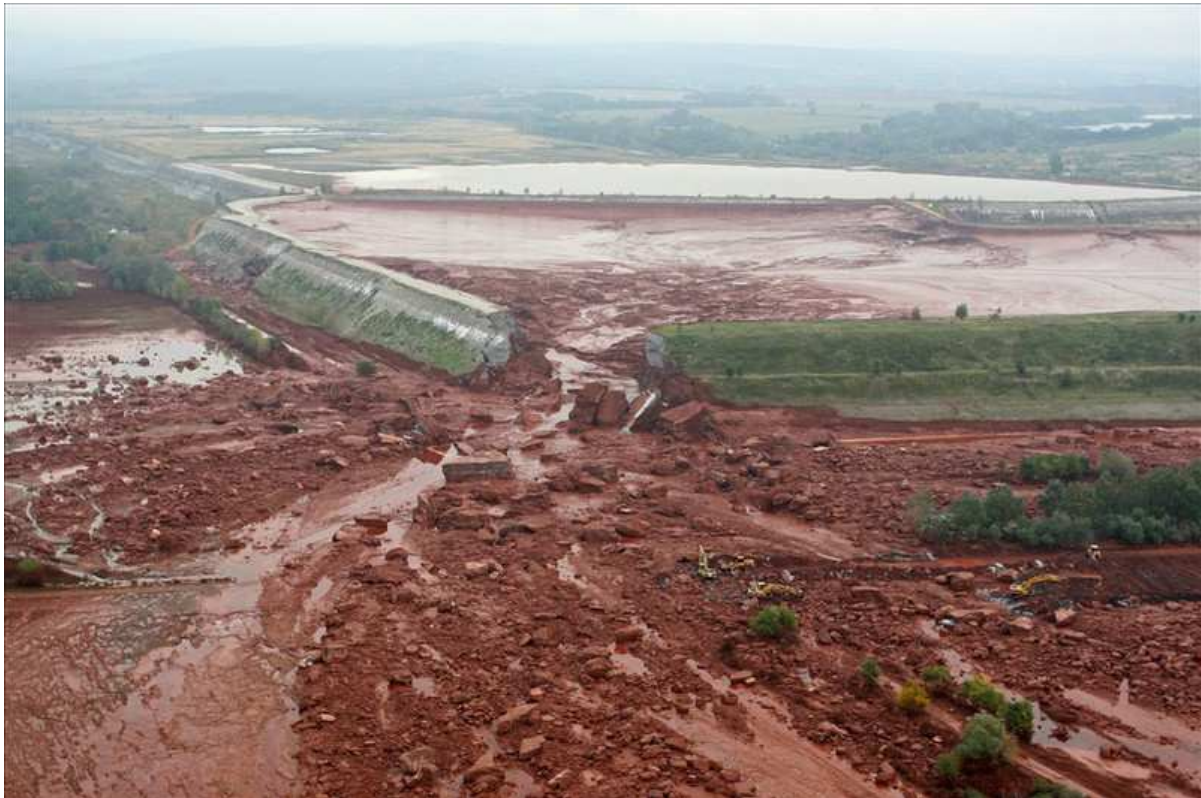
As the result of the rupture of the dam wall, the Torna Creek and its valley were contaminated by the estimated amount of over 1 million m³ of alkaline red sludge. The pollution plume reached the MARCAL River at 6:00 pm on the same day, in which the recent flood wave was already decreasing, therefore the transport of the pollution fortunately slowed down. In the morning of the 5 October a warning message was sent out to the DANUBE basin countries by Hungarian national centre (PIAC) through the Accident Emergency Warning System (AEWS) of the DANUBE Protection Convention. The head of the plume passed the village of Mersevár at 3:00 pm on the same day.

3. Dike breach

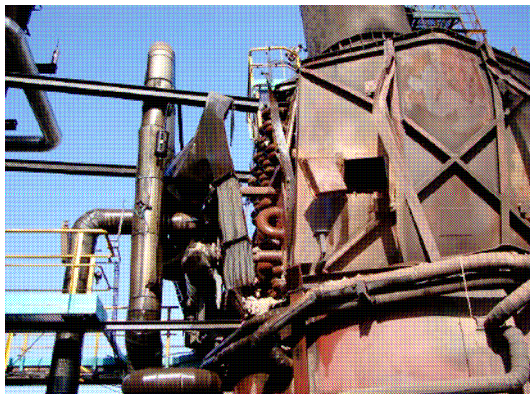
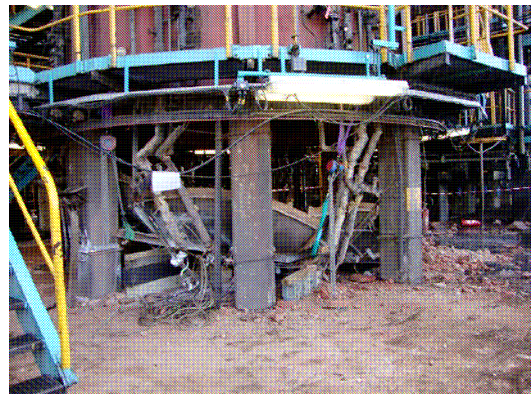
Property damage was confined to the superheater and its immediate vicinity (Fig. 4).

Figure 4 : View of damage sustained on the upper part of the superheater and collapse of the floor plate (DREAL Lorraine)

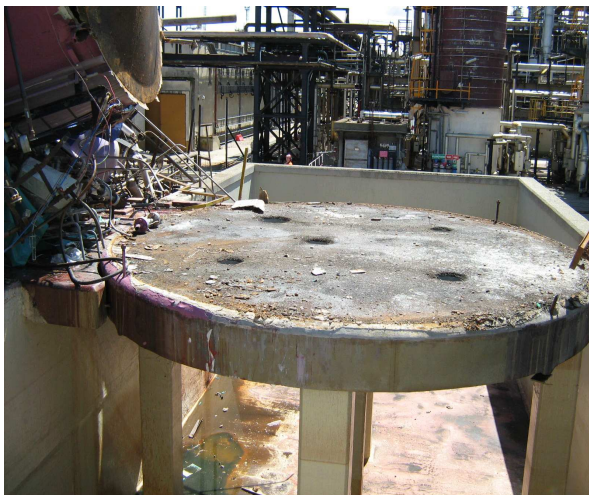
The damages were limited to destruction of the tank and all connecting piping; the unit was shut down. The tank was torn apart over half the shell/bottom junction circumference. Its anchorages were also ripped out.

Photos courtesy of DREAL:
Concrete base where the tank was positioned

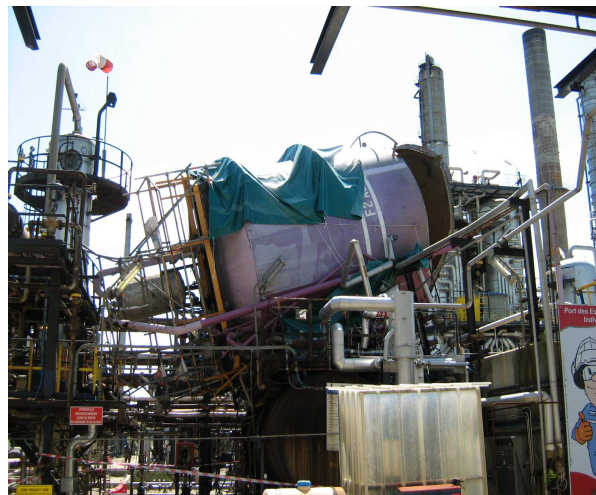
Damaged tank

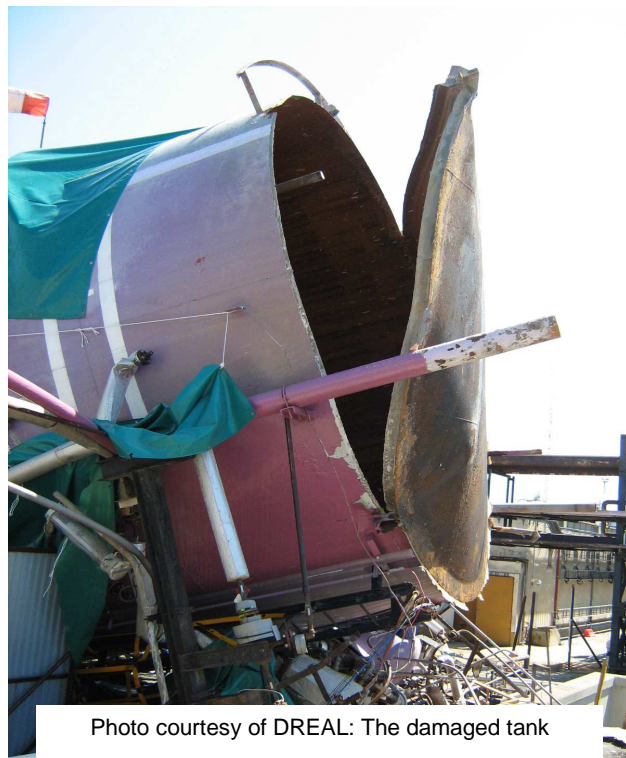
The metallurgical assessment performed on this tank indicated the presence of extensive internal corrosion over the lower part of the structure. This observation confirmed the sudden onset of corrosion at the tank sidewall due to diluted acid, thus generating a source of hydrogen production.

Photo courtesy of DREAL: The damaged tank

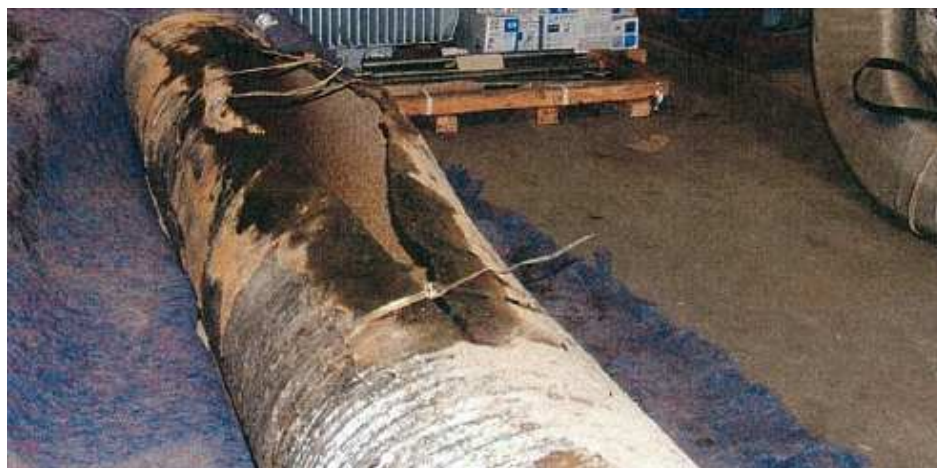
Damaged part (DREAL PACA)

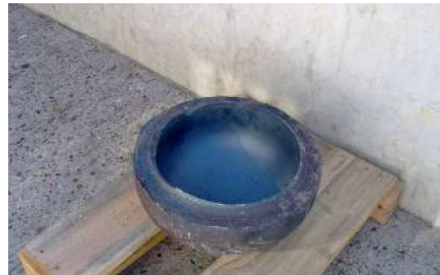
Figure 4 : Photograph of the dished bottom projected on the day of the accident (source: GPN)

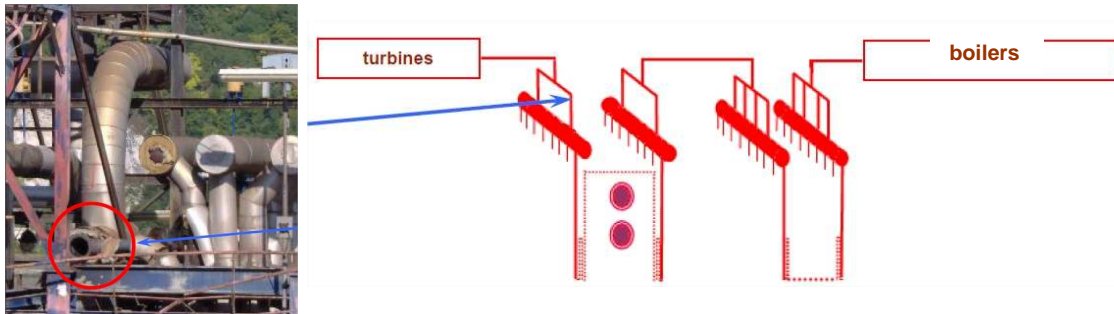
Figure 7 : Localisation of the damaged pipe (source: GPN)
