Ignition of a cloud of wood dust in a manufacturing facility

May 11th, 2004

**Allouville-Bellefosse –
[Seine Maritime]
France**

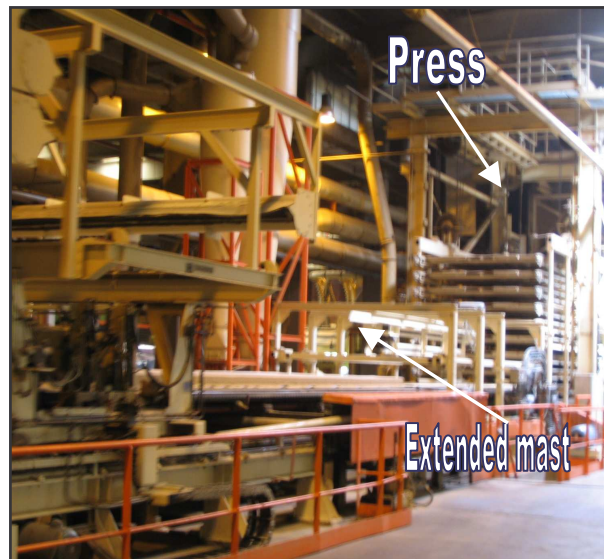
Felting line and press

Initiator

An incident was reported in the report of the crew's electrician. On the eve of the accident, at roughly 10am, the control room operator noticed excessive temperature in the "counter-heating platform" (temperature above 200 °C). The electrician and the mechanic reported that the temperature regulator was operating correctly but not the 3-way valve which remained partly open on the hot reservoir. The thus manually closed the 3-way valve and, for safety reasons, a manual valve and the zone's circulating pump.

An expert evaluation of the 3-way valve conducted later showed that its blockage may be the result of a hard spot, as the servomotor used to drive it is low-power.

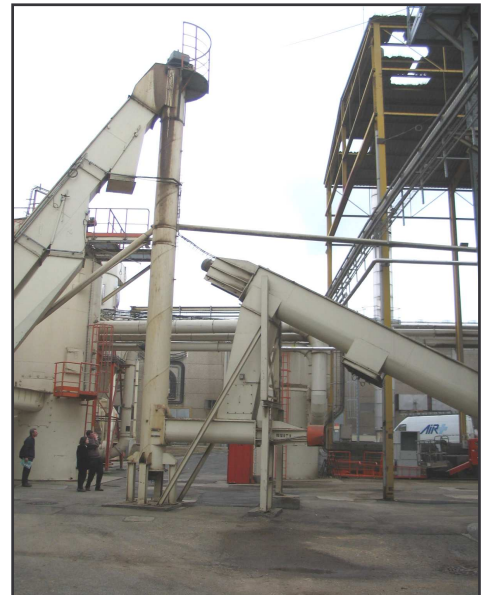
Mechanical transport with decoupling by screw

The danger study defined several modifications that should be undertaken, including moving a dust silo and resizing of overpressure vents. It also stresses the hazards presented by the sawdust transport installations via pneumatic means. The slow mechanical transport which enables an uncoupling system to be implemented must be given special consideration as it limits the effects in the event of an explosion.

The installations have now been modified so that dust is no longer deposited on the press. The cleaning of the facilities has been facilitated by the installation of a centralized vacuum system.
