Accidental spillage of a reaction mixture in a busy area

March 4; 2003

Clamecy – [Nièvre]

Projections
Chemistry
Reactor
Alkaline sulfone
Batch
Burst disk
Manufacturing
tolerance
Fatigue
at high temperature

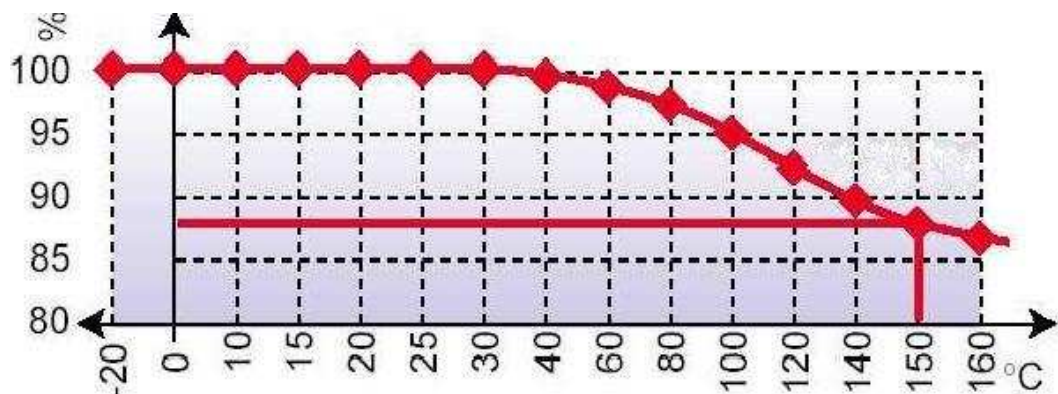
- **Temperature 140 °C.** According to a chart published by the diaphragm's manufacturer, the burst pressure at 140 °C is equal to 90% of the nominal pressure given for 20 °C.

- **Manufacturing tolerance +/- 10%:** this tolerance generally varies between 3 and 10% depending on the nature and the price of the diaphragm.
- **Fatigue coefficient 85% of the minimum bursting pressure.** On a batch process, a diaphragm is subjected to repetitive stresses that weaken it. The fatigue coefficient or service rate enables this phenomenon to be taken into account. It can vary from 70 to nearly 100% depending on the type of diaphragm.

Thus on the incriminated diaphragm, the **nominal burst pressure of 3 bar at 20 °C** is no more than 2.7 bar at 140 °C with a tolerance of +/- 10%. In the unfavourable case, the burst pressure of the new diaphragm is thus 2.43 bar. After being commissioned, however, and subject to fatigue, **the diaphragm may rupture beyond a pressure in the reactor equal to 2.07 bar.**
