Overpressure in a chemical reactor in an organic synthesis workshop

March 23, 2004

Montluçon – [Allier 03]
France

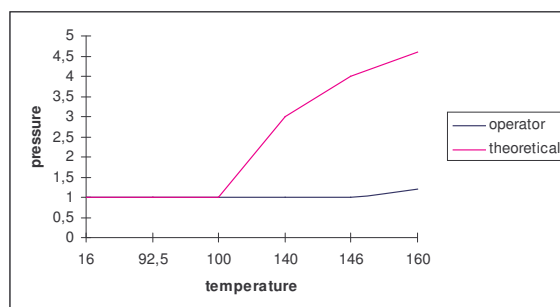
- ◆ 3.40 pm T= 16°C P = P atmospheric
- ◆ 5.00 pm T= 95.2°C P = P atmospheric
- ◆ 6.30 pm T= 146°C P = 1 bar
- ◆ 7.30 pm T= 160°C P = 1.2 bar

As the pressure setpoint had not yet been reached, the operators did not stop the steam heating of the reaction environment. As shown on the graph, they did not react to the inconsistency of the values between pressure and temperature.

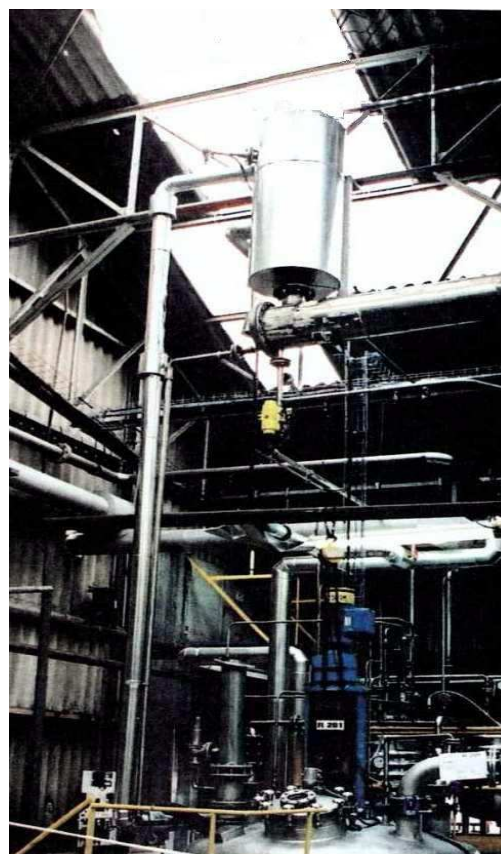
During the 7.30 pm reading, just prior to the accident, an operator noted a leak on the reactor's manhole and tightened its bolts without giving any thought to this indirect alarm signal. The burst disc ruptured 3 minutes later, releasing steam into the workshop; part of the fibrocement roof was blown away.

- ✓ one rupture disc destroyed,
- ✓ some pipe jacketing was destroyed,
- ✓ a few m² of fibrocement roofing blown out (see photo).

Roof damage

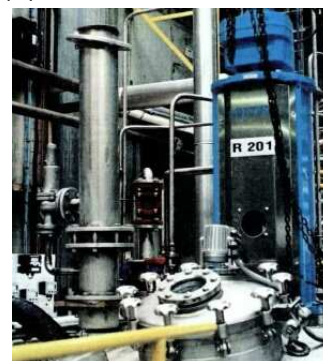
- ◆ a valve (6.3 bar) (at this pressure, the saturated steam output is 1,800 kg/h, or approximately 30 kg/min).
- ◆ a rupture disc (6 bar, ND 150 mm) (at an operating temperature of 20°C).

As the two triggering threshold values are very close, it is difficult to predict, in the case of a pressure increase, which equipment will operate first, considering the precision of the calibrations and the variations of the rupture disc thresholds with the temperature.

- ✗ The trip thresholds of both devices are close and no preventive reflective thinking about their operation was carried out, thus no clearly established defensive strategy was established.
- ✗ The trip thresholds of both devices are near 6 bar, although the nominal pressure of the reaction is two time less (3 bar).
- ✗ The rupture disc's discharge pipe must be connected to the workshop's discharge network.

Finally, the operator undertook in-depth reflective thinking on the defensive strategy against overpressure in the reactors. As such, for reactor R201, after having analysed the operating conditions under pressure and temperature through laboratory work, the operator defined the rupture disc [bursting pressure: 6 bar at 120 °C] as the reactor's ultimate protective barrier. The valve calibration, defined at 5.3 bar, is used to discriminate the trip thresholds. The valve must thus operate first and limit the internal pressure thereby giving the operators enough time to intervene. The design work of the safety accessories thus had to be performed *a posteriori*.

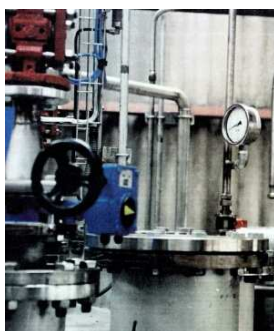
- ◆ As the pressure gauge used by the operators to control reactor steam heating was plugged in an elbow, they did not have correct pressure information. As reactor heating was controlled from this information, the operators didn't stop the heating, letting the pressure increase in the reactor.
- ◆ As the valve was calibrated at a value greater than the burst pressure of the rupture disc, the reactor was not decompressed by the valve prior to the burst disc rupturing.
- ◆ The lack of a collection pipe from the burst disc aggravated the situation.
