Chlorine leak in a liquefaction workshop of a chemical plant

January 13, 2004

Vieux-Thann – [Haut Rhin]
France

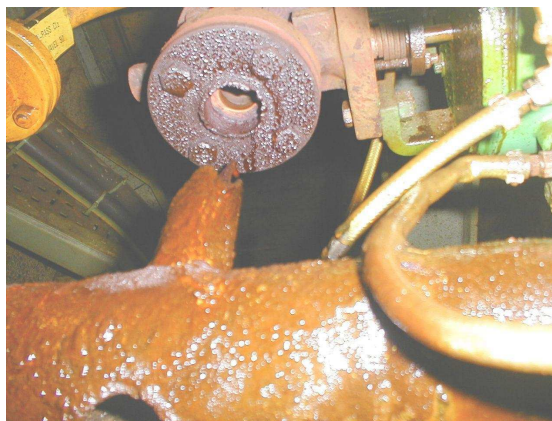
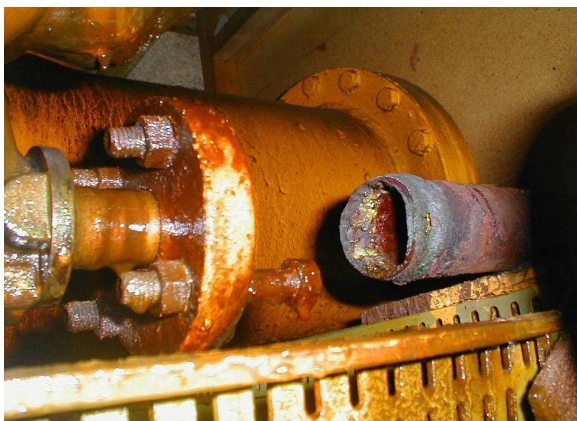
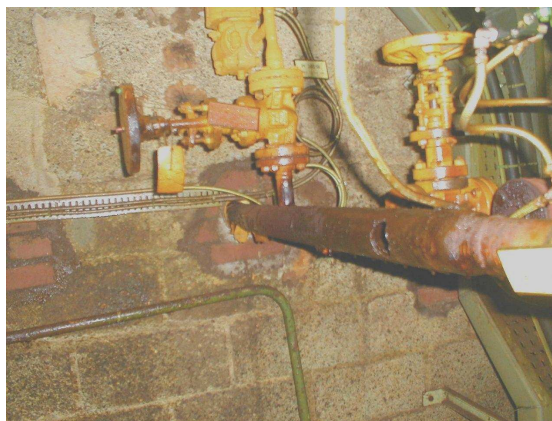
The expert assessment conducted immediately following the incident showed that the leak, located along the limit of the confined zone, resulted from the combustion of the steel in the chlorine on a pipe transporting the gaseous chlorine: at two locations (located near zones in which the pipe size was reduced: valve and venturi), the pipe had disappeared over several centimetres, including a flange. A hole of diameter equal to that of the pipe (8 cm) was created in a third location.

The combustion of steel in chlorine is a process that is initiated when the steel is brought to a temperature above 130 °C. Once this reaction begins, it is self-sustaining until all the chlorine has been consumed.

The operator identified the cause of the iron/chlorine combustion process as a hydrogen-chlorine fire whose ignition energy is sufficiently low to start spontaneously due to an output restriction or a significant flow rate. The increase in the output to 1,000 kg/h could have also supplied the ignition energy required.

Besides the verification of the installations and the replacement of damaged parts, several actions were implemented to prevent the incident from happening again:

- A material assessment was set up to monitor the hydrogen concentration in the residual gases according to the liquefaction rate and the hydrogen content at the electrolysis facility's outlet.
- Implementation of two continuous hydrogen analysers that can be used in the presence of inert gases (cost: 150,000 euros).
- Supervision of start-up phases by a manager.
- Modification of the instructions.
- Re-examination of post-accident actions.
- The installations are shut down if the hydrogen concentration is exceeded by more than 3.5%.
