# LPG release and flash in the LPG road-tanker Loading facility of a refinery

23<sup>rd</sup> of April, 2004

Germany

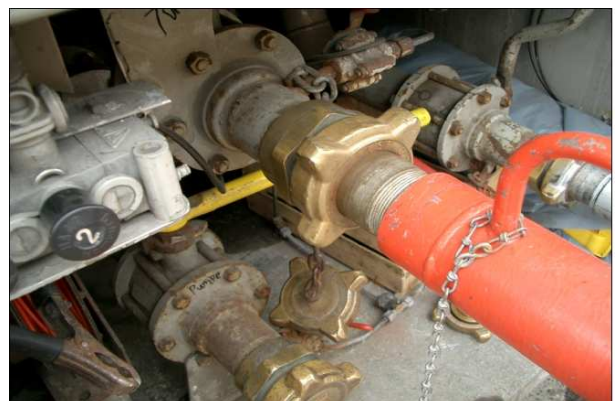
At 7h30, as 15 t of LPG had already been loaded, there was a spontaneous separation of the connection between the loading-arm and the vehicle at the threaded coupling. This led to a release of LPG, which ignited and engulfed the driver. The force of the separation was sufficient to propel the loading-arm backwards until it impacted with the housing of the loading station. This led to the activation of the “pull-away” quick release coupling and the flow of LPG from the refinery was stopped.

The fire melted the pneumatic hose for the foot valve of the road-tanker and the pneumatic valve closed, stopping the release of LPG from the tanker.

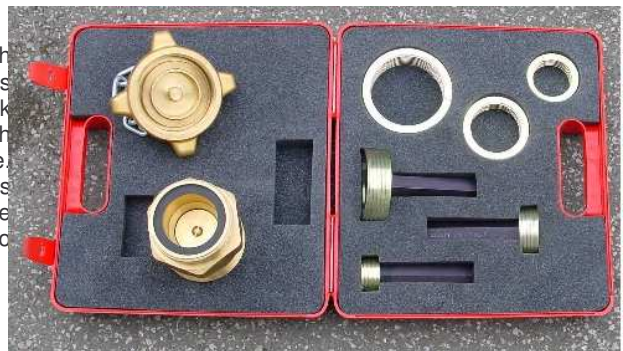
In the course of the investigation and communication with the UK LPG Association a further testing possibility was discovered. The use of Go / No Go Gauges allow a quick assessment of the degree of wear of the threads of both halves of the coupling. The function is extremely simple. The gauges allow maximum 1 turn of the thread for threads which are OK, worn threads allow more than one turn. The threaded ring which was involved in the accident was so badly worn, that the gauge could travel four turns.
