# Explosion and fire of a reactor in a chemical plant

April 17, 2003

## Oudalle – [Seine-Maritime] France

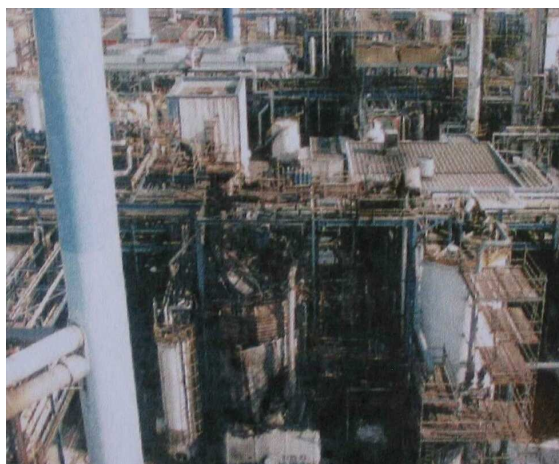
The explosion resulted in very localised property damage. The effects were observed up to twenty metres from the accident (projectiles and broken glass). The reactor had opened up (see photo) despite the overpressure protection device installed.

Overall view of the reactor

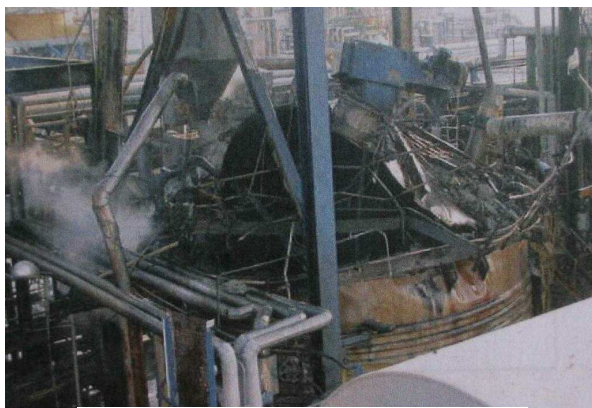
View of the damaged reactor from above

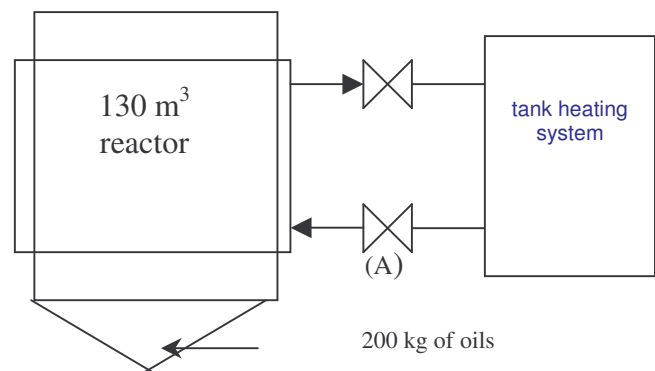
- temperature rise tests were being conducted on the reactor's heating system,
- the reactor was not disconnected from the heating system. The inlet valve (A) on the reactor's heating coil remained open,

- the atmospheric temperature of the reactor thus increased and caused the mineral oils in the bottom of the reactor to evaporate and decompose,
- the unit's monitoring parameters were reported in the control room although no specific action was taken by the operators as the unit was shut down and the production personnel did not consider that the unit presented any danger, a priori.
