Explosion of a tank in TDI production unit

November, 28th, 2002

Mestre – Italy

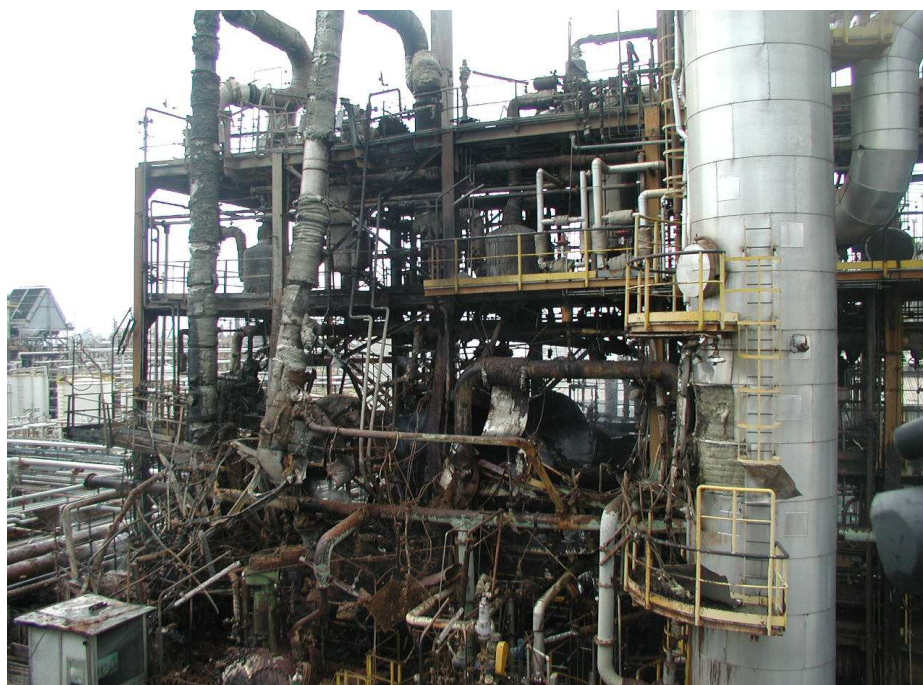
Fig. 2 - TD5 department damaged

The explosion of tank D 528/2 generated a pressure wave with an extremely rapid expansion speed and the release of the hot liquid contained in the tank which solidified at ambient temperature. The pressure wave had a destructive effect on equipments and plant parts in the vicinity of the tank with projection of metal fragments, damage to the support frames of the plant equipment, rupture/damaging of connection pipes and electrical cables and utilities. TD5 department damaged is shown in fig. 2.

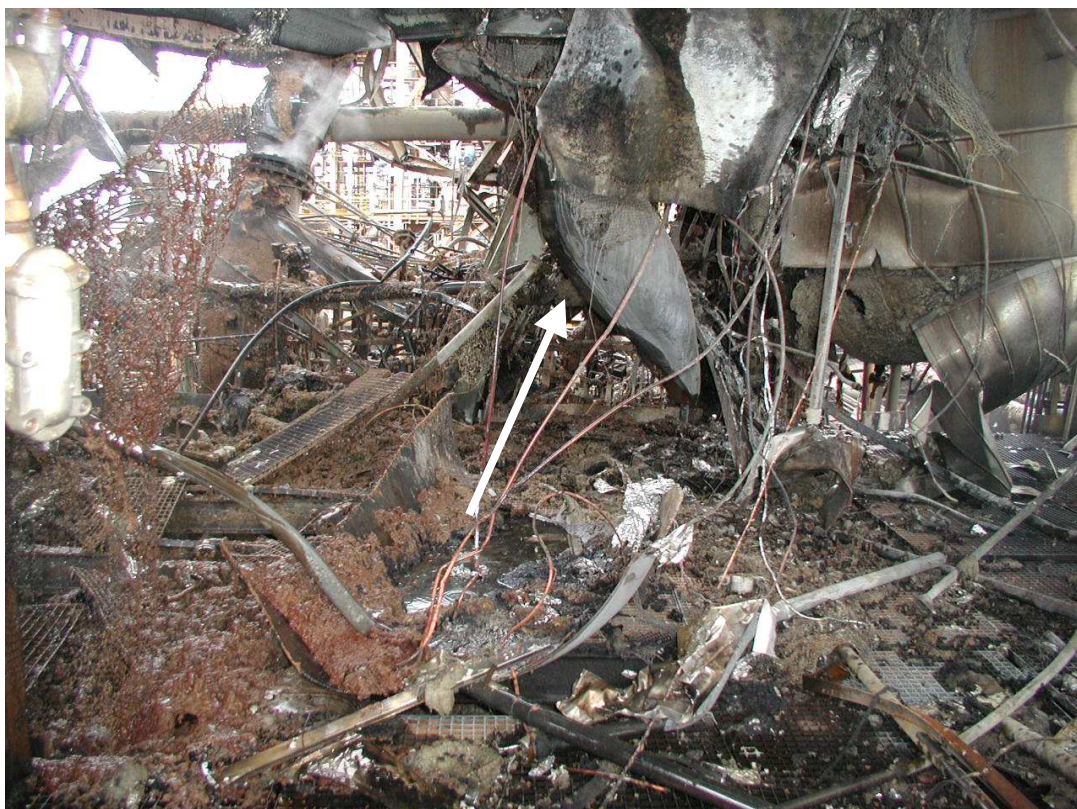
Fig. 3 – tank D 528/2 : 1st explosion

The associated effect of the pressure wave, generated by the explosion of tank D 528/1 followed by the strong air movement generated by the blast wave, and the effect of the carbon dioxide formed by the chemical reactions described above, caused the displacement of the flame sources, extinguishing most of the fires, avoiding the creation of domino effects to other plants, which could cause major damage to the plant structures. Damages due to 1st and 2nd explosions of tank D 528/2 and tank D 528/1 respectively, are shown in fig. 3 and 4.

According to the information given by the operators and from the analysis of the plant data on the section involved in the accident, it is assumed that the accident was caused by an unwanted condensation reaction between the high-boiling tars and TDI, thermally activated first in tank D522 and then developed in tank D 528/2, with the release of heat and carbon dioxide causing the mechanical explosion of tank D 528/2 due to overpressure.

When the explosion occurred the internal temperature of tank D 528/2 was above 220°C and clearly the tank was in extreme overpressure conditions. When the event occurred the tank was filled to 60% of its design capacity of 10 m³.

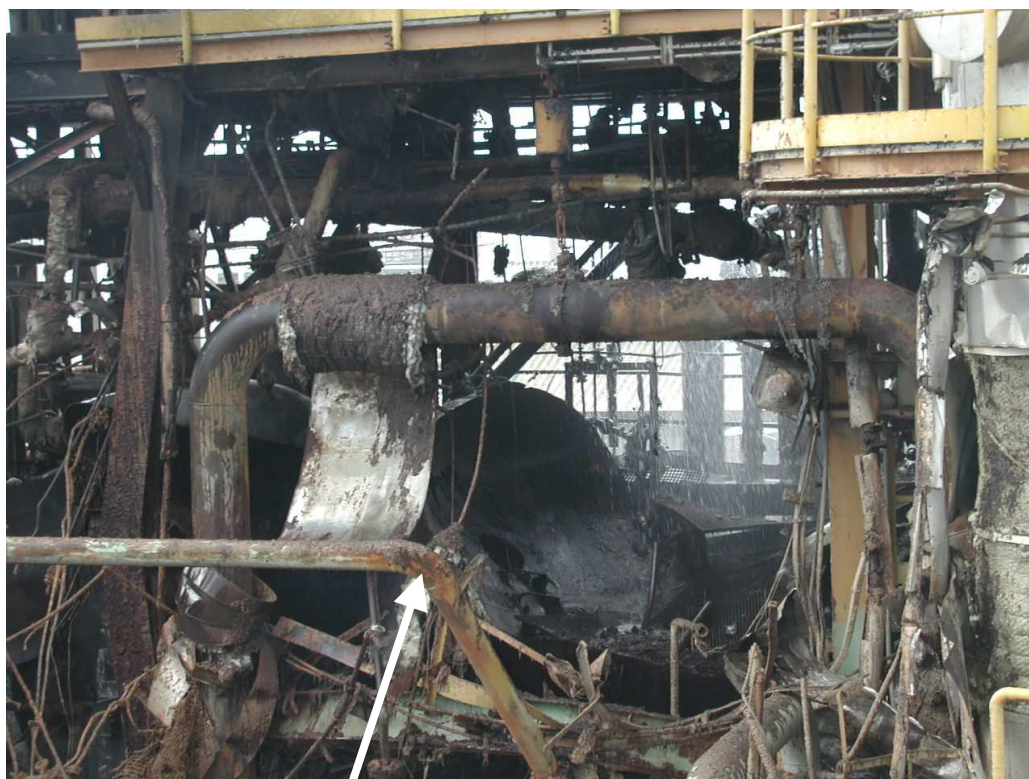
Fig. 4 – tank D 528/1 : 2nd explosion

The fire was fed by the rupture of the toluene pipe and by the rupture of the diathermic oil (Aerthem) pipe installed at a height of 8 meters, and propagated to tank D 528/1 containing TDI - high-boiling tars which was 85% full when the explosion occurred. It is assumed that the explosion of tank D 528/1 was caused by overpressure generated from the decomposition reactions of TDI, thermally activated by the temperature of the flames and thermal radiation hitting the tank. As for tank 528/2, the high temperature triggered and accelerated the same exothermic decomposition reactions between TDI and high-boiling tars, releasing carbon dioxide.
