Vinyl chloride leak in a chemical plant

February 3, 2004

TAVAUX (Jura - 39), France

Polymerisation

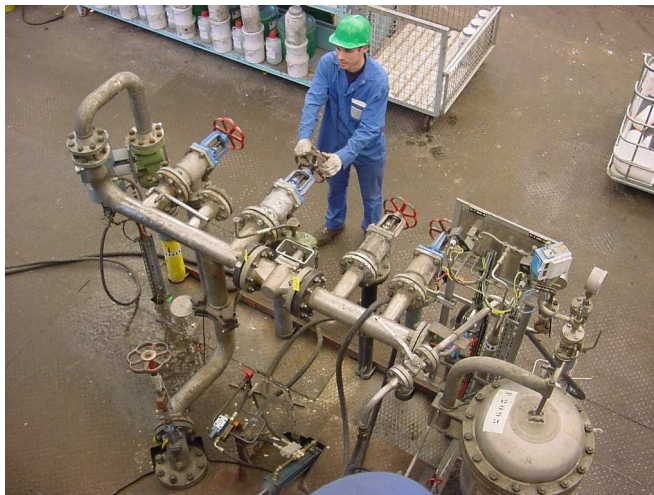
The part of the installation concerned, which dates back to 1969, consists of a set of thirteen 27m³ autoclaves in which the polymerisation process is carried out according to a discontinuous "batch" process. This process requires that they be opened between 2 polymerisation operations. The installation is only slightly automated, notably in terms of the autoclave filling, drainage and cleanup processes. The accident took place between one of the VCM inlet/outlet pipes:

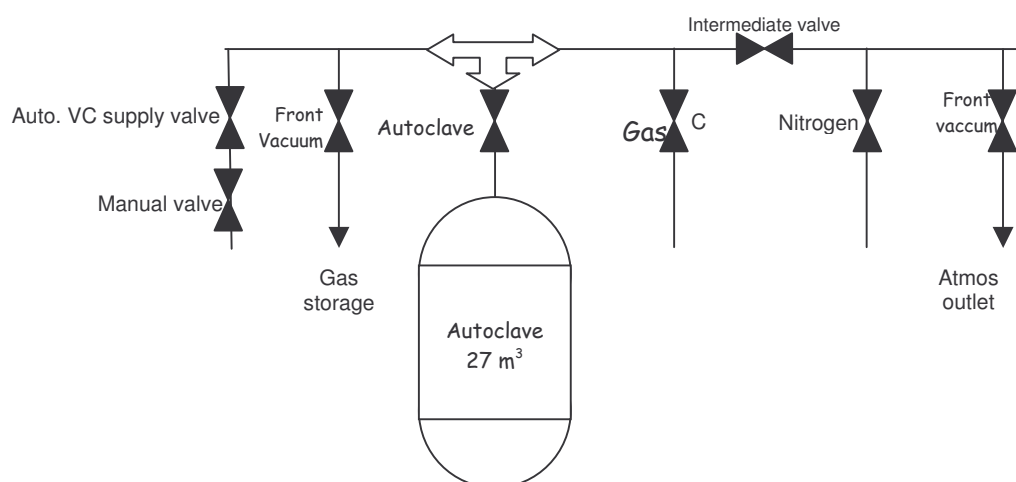
There is thus no instrumentation on the shut-off valves of the other systems (Front Vacuum, Back Vacuum, Gas storage, nitrogen, ...) that is taken into consideration in the VCM loading sequence. There are procedures to check the position of these valves prior to the VCM filling operation. These procedures require that the operator allow the automatic VCM filling valve to be controlled by the PLC. However, the interruption of the operator intervening on autoclave No. 13 caused the sequence of the preliminary manoeuvres of autoclave No. 11 to be lost and authorised the operation when the employee returned even though the "intermediate" manual valve and the "Front Vacuum" valve were not closed.

The diagram below shows the set of shut-off valves and their position at this moment:

- Cause No. 1: poorly qualified preliminary manoeuvres prior to VCM supply authorisation,
- Cause No. 2: permanent monitoring fault of the "Front Vacuum" network.

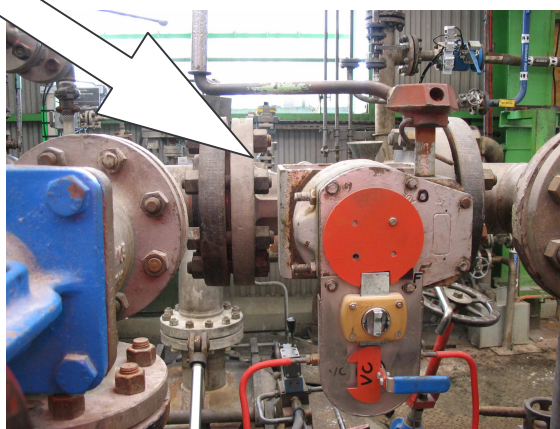
VCM filling authorised

Valve allowing the
pneumatic supply of the
automatic valve of
completion of CVM
