# Fire in an electrical service room in a chemical plant and release of toxic gas

October 25, 2004

Lannemezan - [Hautes-Pyrénées]  
France

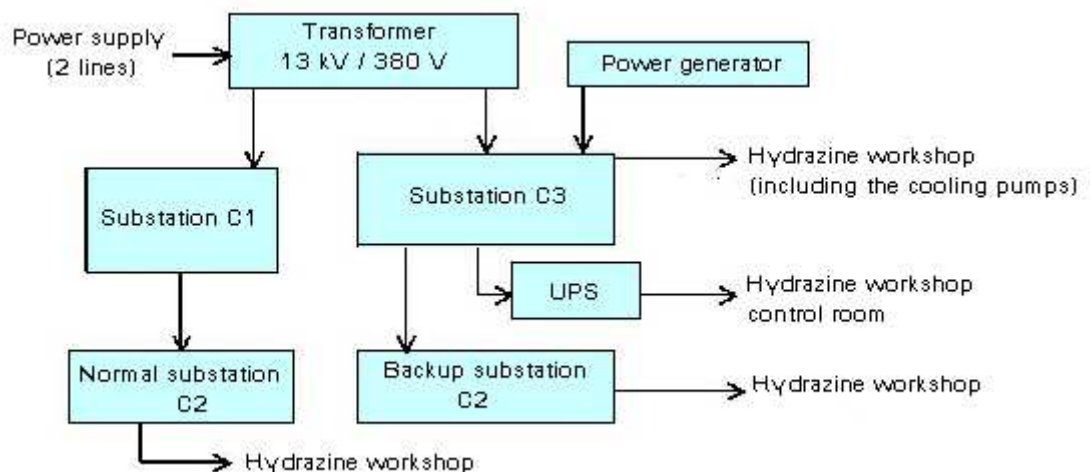
Figure 1 - Workshop electrical supply circuit

- a 13kV/380V transformer, in a separate building,
- an intermediate switchboard C3 which includes certain hydrazine outgoing feeders, the 2 UPS supply lines, the incoming generator line and its tripping device, the outgoing line to the back-up C2 switchboard. All this equipment is located in the same building, but in separate rooms.
- an electric switchboard C2, in a room adjacent to the control room and the hydrazine technical room, which supplies the majority of the hydrazine outgoing lines made up of a normal C2 switchboard and a backup C2 switchboard (supplied from station C3)

The electrical fault on one of the hydrazine unit's cooling pumps led to a short circuit on one of the columns of the switchboard C3 and started a fire. The fire then spread to all columns of table C3 via the sub-floor (electrical cables).

The circuit breaker upline from the switchboard did not function as it was "stuck".. The electrical problem then shifted to the transformer.

The 13kV/380V transformer caused a homopolar fault which shut off power to all C substations.

The electrical generator started, but the switchover to the "backup" switchboard couldn't take place as the electrical cables had been damaged in the fire. The hydrazine unit then secured itself as a result of the loss of electrical power.

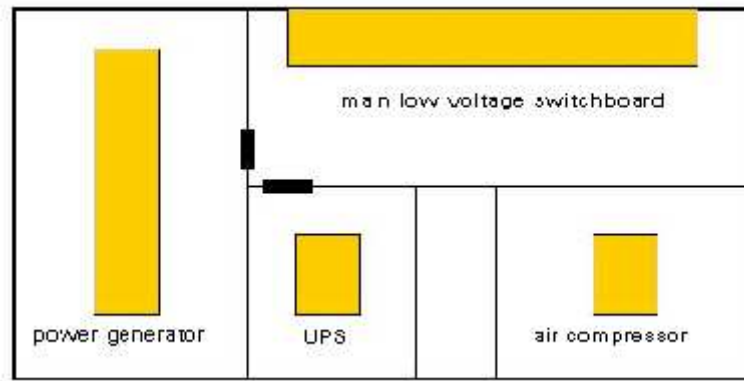
Figure 2 - Electrical service room C3

The electrical column where the short circuit took place was destroyed by the fire and the entire electrical switchboard C3 was badly damaged.

As the smoke from the fire had entered the room via the open door and the sub-floor, the UPS, located in the neighbouring room, switched to standby (as soon as T=40°C), disconnecting the power of the SNCC ("Système Numérique de Contrôle Commande", digital monitoring and control system) and the programmable safety controllers. Electricity was lost in 4 minutes time.

- An expert assessment was conducted shortly after the accident,
- A fault tree was drawn up,
- In order to restart the installations, a temporary switchboard was installed to replace panel C3, in a room geographically separated from the UPS and power generator rooms. The UPS was replaced, the power generator cleaned and the circuit breaker overhauled,
- Definitive replacement of switchboard C3 was programmed for the plant's major shutdown in April 2005. This operation was preceded by a study bearing on the reliability of the power supply and how the common modes, insulation of the UPS / power generator /switchboard rooms are handled, the opportunity of a dual UPS power supply, and the connection of MV Bucchols transformer safety devices.

The UPS is kept in the existing room, physically separated from the substation (door closed and hermetic sub-floor) and its backup power supply (2<sup>nd</sup> network) rendered independent from that of the hydrazine workshop.
