Fire in a hydrodesulfuration unit of a refinery

June 26, 2004

Feyzin – [Rhône]
France

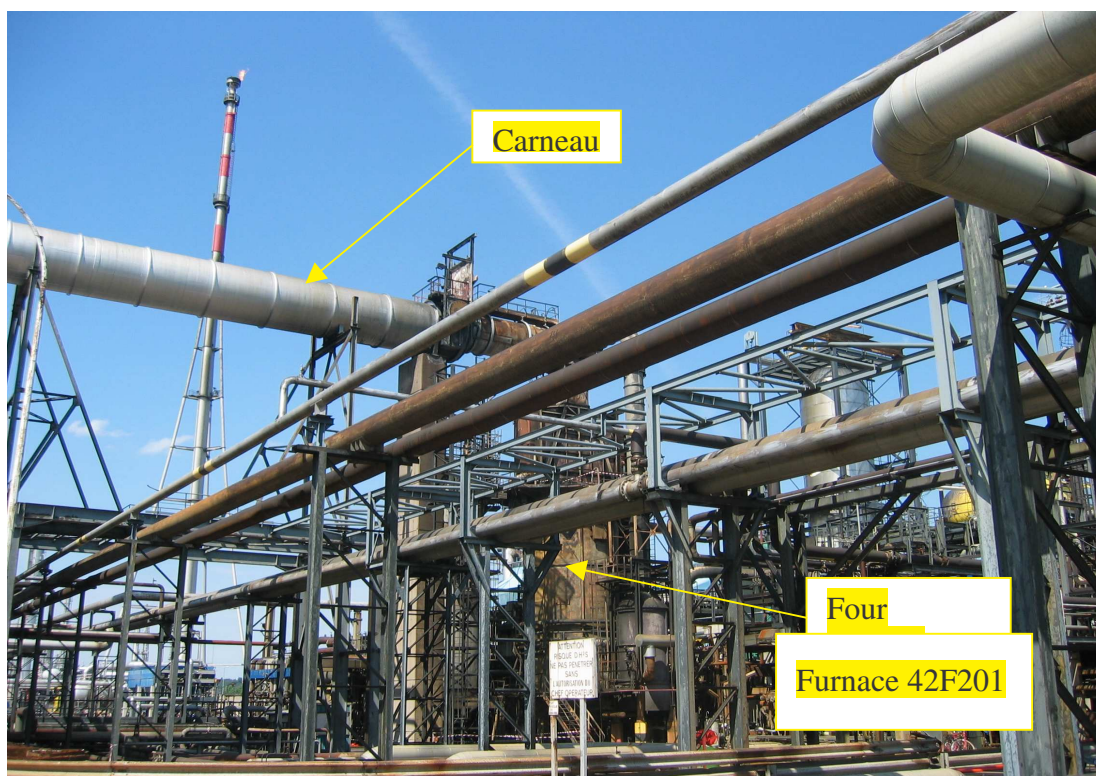
Overall view of the HDS unit (after the fire)

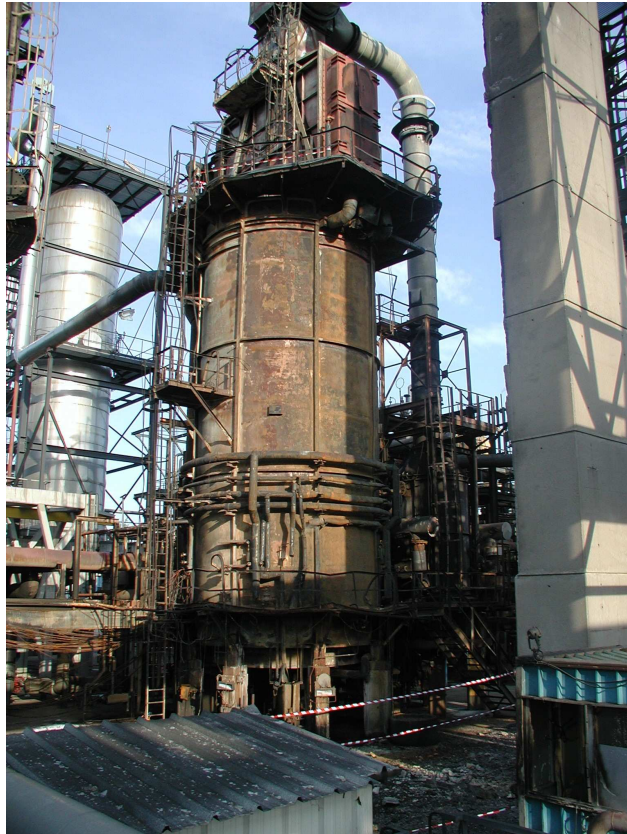
View of furnace 42F201 (after the fire)

✓ Considering the extent of the damage to the furnace, the decision was made to completely rebuild it, including the associated civil works structures (concrete support posts, first section of the flue). The furnace was rebuilt nearly identically, although the following improvements were made:

- ✗ 6 burners were installed instead of 4 for better distribution of the heat flux,
- ✗ installation of a remote burning ignition device,
- ✗ installation of temperature sensors on the skin of tubes on two heights in the radiation part, as well as on the lower layer of the convection part, in order to monitor any abnormal increase in temperature that may be due to coke deposits accumulating inside,
- ✗ the installation of additional inspection ports.

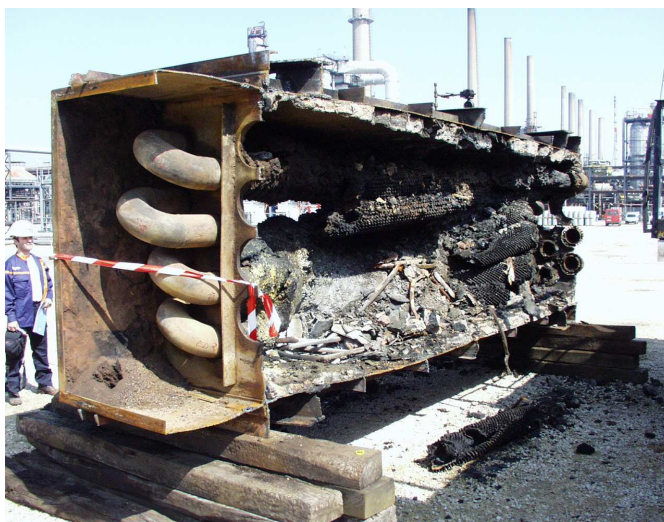
Partial view of furnace 42F201 after the fire and dismantling for inspection

✓ Furnace 42F201 underwent the most extensive damage:

- ✗ Total destruction of the convection array (fusion of the upper levels of the convection, only the lower layer had tubes that were not melted, including a burst tube) (see photo below),
- ✗ Fusion and vitrification of the refractory material on the convection part (see photo below),
- ✗ Overheating of the radiation array,
- ✗ Damage or deformation of convection and radiation wall and structural elements,
- ✗ Degradation of support columns,
- ✗ Deformation of the first section of the flue.

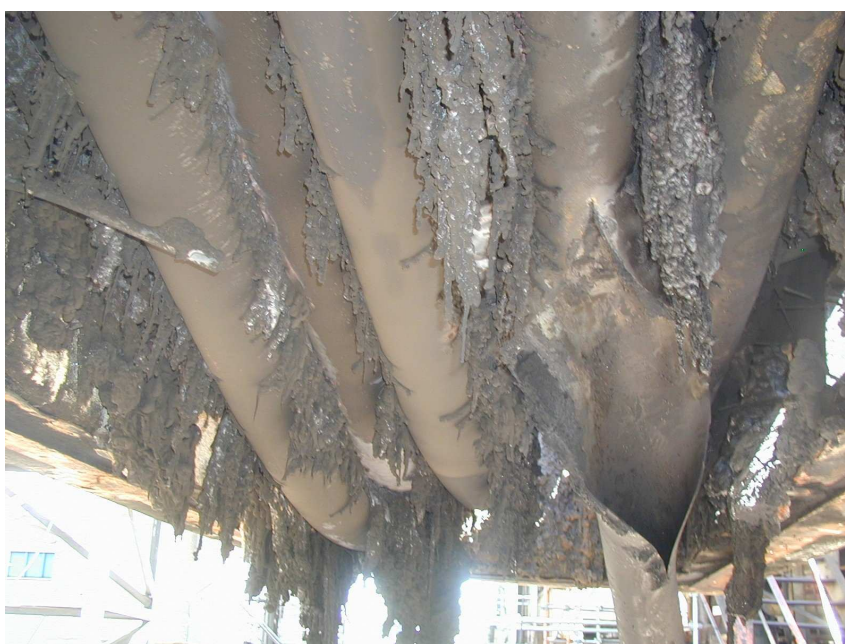
View of the lower convection layer (after the fire)

It appears that the tubes which make up the lower convection layer were not melted due to the fact that they were being supplied all the way to the end by the load and thus "cooled".

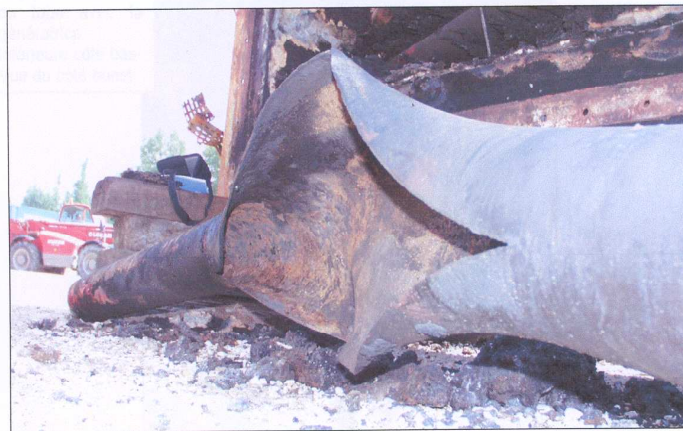
Among them, a tube that was found ruptured (a clean rupture 500 mm in length), was then determined to be the cause of the fire (see photo below).

Views of the ruptured tube

It appears that the rupture was the result of four types of damage which combined their effects and reduced the thickness of the tube to the point where it could no longer resist the operating pressure.

✓ **presumed corrosion from polythionic acids:** these acids form when the load's sulphur compounds come in contact with oxygen. This situation cannot occur during normal operation, as the load does not contain oxygen. It is encountered during shutdown periods and hydraulic testing operations. To avoid this phenomenon, a passivation operation is performed during the shutdown period (the procedure was formalised in 1985). It appears that the attack may have happened some time ago as the passivation operation has been performed since 1980. It appears to be the result of localised formation of ruts on the inside of the furnace tubes.

✓ **decreased thickness by oxidation/sulfuration:** in the ruts formed by the polythionic acid corrosion, the material (austenitic stainless steel) lost its corrosion-resisting properties, resulting in reduced thickness through corrosion.

✓ **presence of sigma phase** (intermetallic compound causing highly marked brittleness of the metal) in small proportion which may have facilitated the development and penetration of the intergranular corrosion.

✓ **intergranular cleavage leading to slow creep** which eventually generates cracks on the outer skin of the tubes: this phenomenon could be explained by poor heat exchange due to a coke deposit inside the tube. This external tube damage was not visible with the naked eye.

The furnace inspection plan was reviewed in order to consider the first lessons learned from the expert assessment and includes additional inspections, made possible by a new design:

✓ On the convection part:

- ✗ replicas and X-ray inspection of convection tubes once per cycle,
- ✗ during the next major shutdown in 2007 (after 25,000 hours of operation): thickness measurements of lower level tubes and 20% of the peripheral tubes, geometric calibration of tubes (search for creep), X-ray inspection (search for internal corrosion and the presence of coke),
- ✗ continuous monitoring of tube skin temperature.

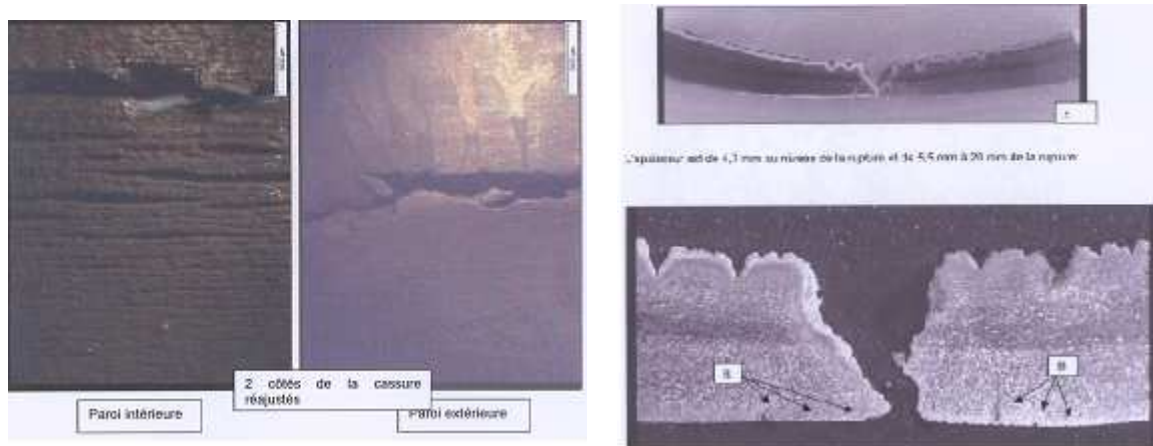
Microscopic view of the break and its two edges readjusted (burst tube)

Decrease in thickness through oxidation/sulfuration (internal skin), presence of sigma phase (internal skin), intergranular cleavage (internal skin) and cracking (external skin).
