Explosion of a fireworks fabrication and storage facility

June 01, 2004

Villeneuve sur Lot – [Lot et Garonne]
France

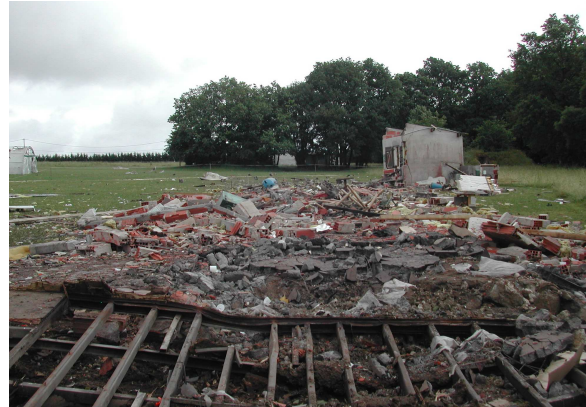
Building 9 was completely destroyed. All of the walls are blown down to floor level, including the 40 cm wall anchored into the ground which had separated the 2 rooms of building 9. In the shell storeroom (room 9A), there was a crater measuring 3 m x 1.5 m and more than 50 cm deep, near the outside wall.

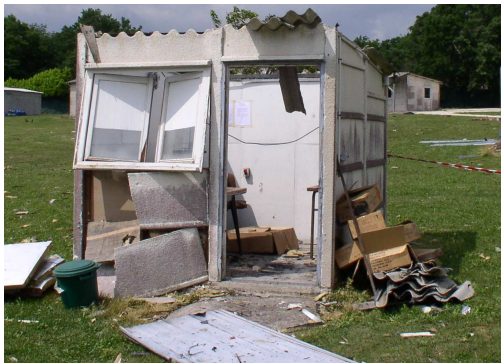
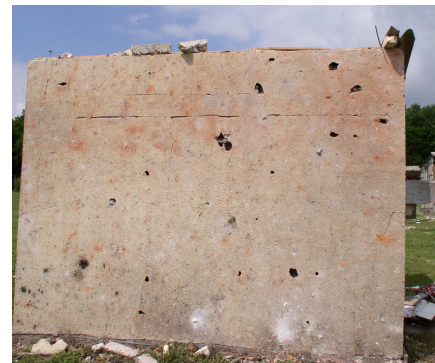
The explosion caused significant damage to the neighbouring buildings due to overpressure and projections. Fourteen buildings were partially or totally destroyed (structure and roof), the roofs of three additional buildings were damaged and the window and doors of six other buildings significantly damaged.

No domino effect was observed in the other shops or pyrotechnic stores. Only the plastic sheeting used to cover a greenhouse was partially burned owing to the stars that were launched onto it. This installation is located more than 70 m from building 9.

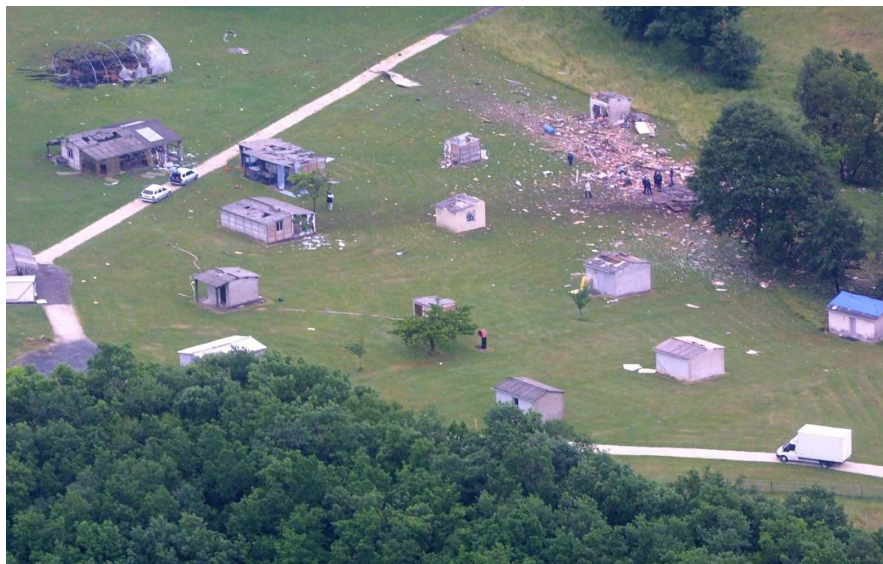
Debris was spread into four zones around building 9, in an elliptical shape. Each of the "pedals", which begin at the building's four walls, had an average length of 50 m. However, wall and roof debris was found up to 160 m away from the building.
