Toxic leak on factory piping

October 6, 2003
Saint Chély d'Apcher – [Lozère]
France

Metallurgy
Piping
Ammonia
Maintenance
Nut rupture
Intervention
procedure
Personnel training

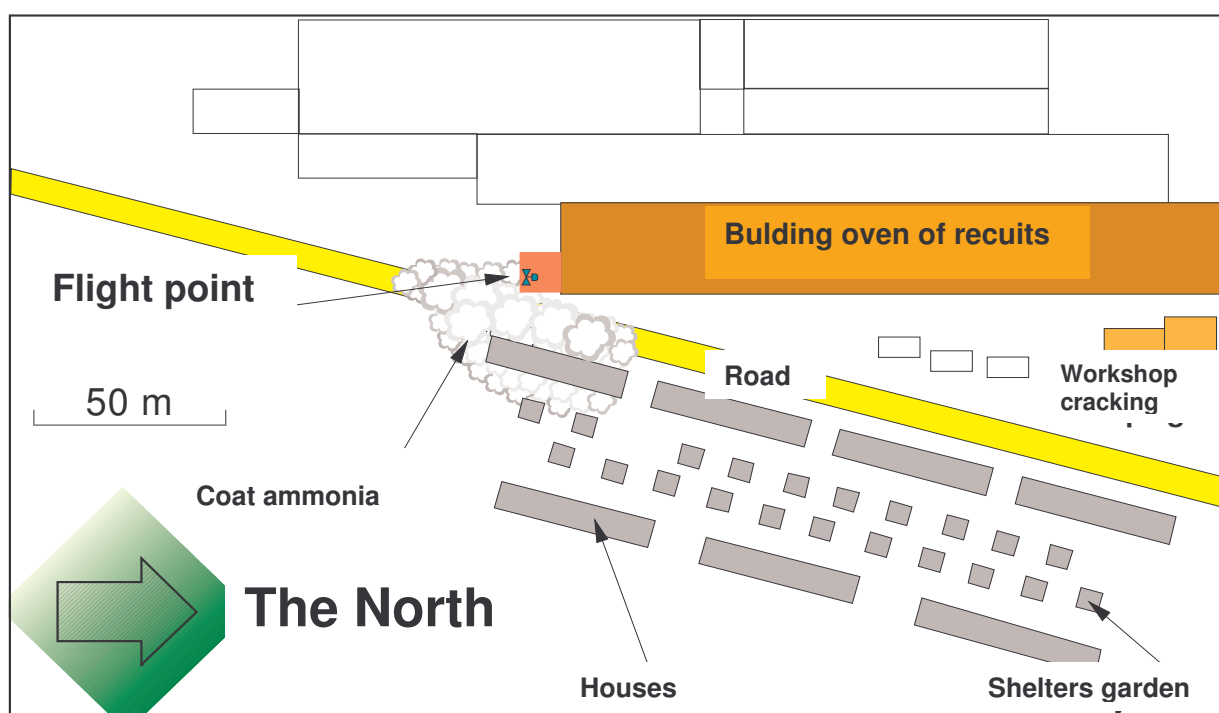
Fig. 3. Position of the leak in relation to its environment

Monday, October 6, 2003. The night-shift operators smelled an ammonia odor. A foreman reported a weak although visible leak, on the valve fitting on an ammonia transfer pipe. The 1 m/s vent was coming from the south. The temperature was 5°C.

Wearing a respirator, he installed a ladder and went up to tighten the fitting located at a height of 3 m. The leak was stopped. However, in order to orient the opening of the valve outlet upwards, he tightened the fitting a little more and it ruptured.

The leak lasted approximately 10 minutes (the time required for manual shutdown + drainage of the pipe section) in the middle of the 8 mm branch connection. The operator estimated that approximately 60 kg of ammonia had been released.

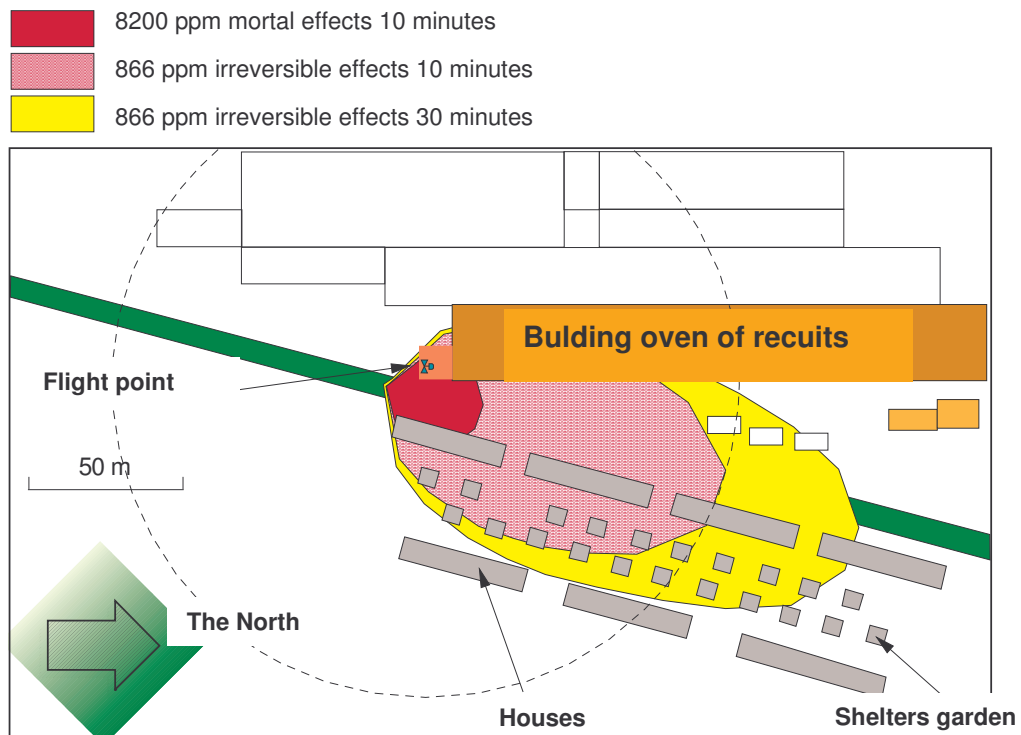
Fig. 4. Probable path of the toxic cloud

The visible whitish cloud that formed extended over approximately 50 m. The very dense part remained around the first block of the factory's 3 apartment buildings across the road.

Based on 15 kg per minute for 10 minutes, the toxic cloud is estimated to have travelled approximately 120 m for the limit of irreversible effects.

After the cloud had passed, the concentration inside a closed but unsealed dwelling of the first building may have become dangerous if it had not been evacuated.

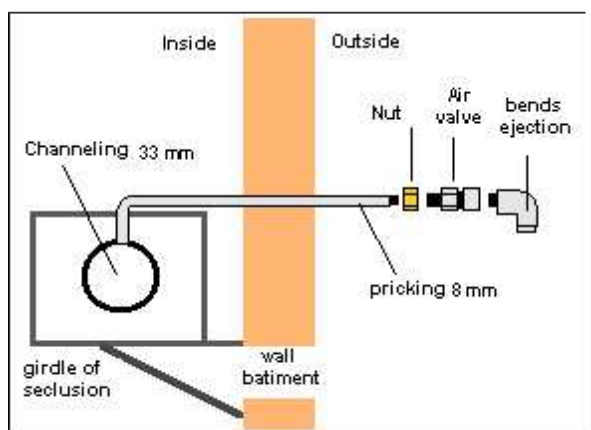
Fig. 6. cut pricking lid

On the morning of October 6, 2003, a slight ammonia odour led to an examination of the piping and a small leak was located on a valve fitting.

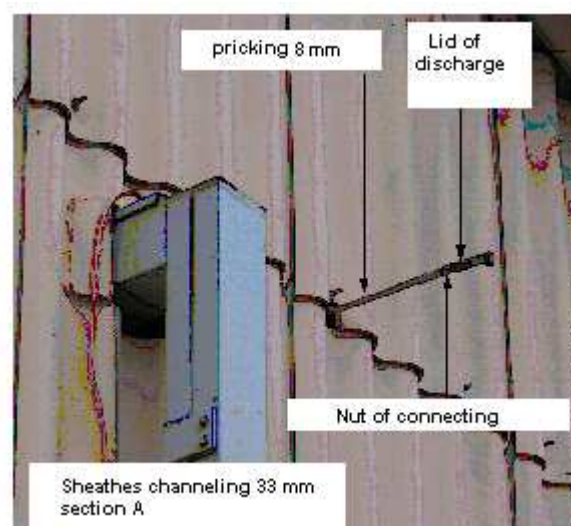
Fig. 7. Valve outlet on building facade

- a lifting device must be used to remove the leaking fitting which is located at a height of 3 m;
- production must be shut down and the pipes purged prior to the operation.

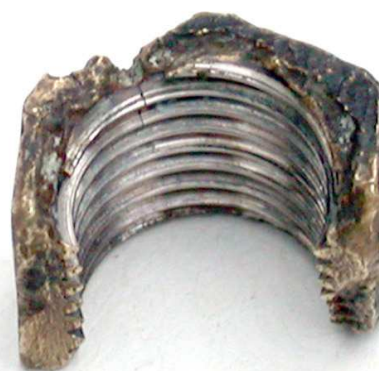
Fig. 8. Piece of the defective nut

The search for the immediate causes of the accident was carried out around the main "fitting nut failure", event, which was found in pieces.

Cause No. 1

The material did not withstand the operating stresses. The nut was apparently made of chromium-plated brass, which is not ammonia-resistant (it should have been made of stainless steel). The fitting shows signs of oxidation, most likely due to the leak and the weakening of mechanical performance characteristics.

The operator conducted an in-depth inspection of all ammonia-related installations. The fittings of the other branch connections were replaced on the two other sections of the pipe. It appears that one of them was also made of chromium-plated brass. The installation was then purged and put back into service upon approval of the Classified Installations Inspectorate.

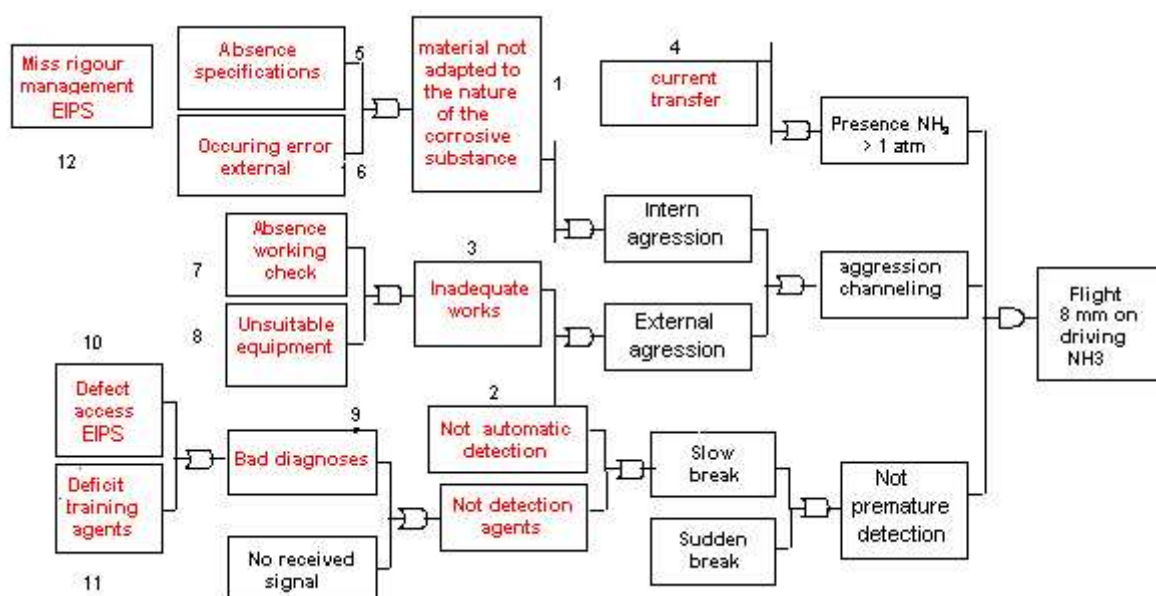
Fig. 9. Summary of faults that led to the branch connection rupture

Cause No. 4

Intervention on a pipe under load.

Cause No. 5

Lack of specifications relative to interventions on the ammonia system.

Cause No. 6

External contractor insufficiently informed of ammonia-related risks and hazards

Cause No. 7

Lack of thoroughness in the SMS (management of modifications and monitoring of safety-related equipment).

Causes Nos. 3, 7, 8

Inadequate operations, performed without a work order and with inappropriate equipment.

Causes Nos. 2, 9

Despite slow corrosion of the nut and the slight leak found, the morning shift then the night shift made an incorrect diagnosis.

The lack of creating proper access to the valve promoted diagnostic errors and made intervention operations clumsy. This circumstance is to be combined with the management of modifications. The operator has an anomaly management procedure, but the leak that was detected the morning of October 6 (an intermittent leak on the valve connection) was not considered to be an anomaly. No information was passed on to the personnel of the following shifts.

The incident was made possible through incomplete analysis of the modifications made to the pipe during the month of August to reduce the hazards (by dividing it up into 3 sections). The automatic safety feature did not function as a portion of pipe had been installed that was not monitored by an ammonia sensor.

The fact that the pipe was not considered "safety-related", and that it was not taken into account in the management of safety-related purchases, made it possible to procure and install a part made of a metal that was non-compatible with ammonia, and the subsequent leak.

Cause No. 11

The behaviour of the agents, particularly the tinkering on the pipe under load, and the lack of their "emergency stop" reflex reflects the agents' lack of training and practice.

- The operator established specifications for the ammonia piping modifications.
- The list of safety-related equipment was reviewed.
- A training procedure involving all personnel consisting of 4 levels and 3 types of "ammonia" certification is currently being developed.
- The automatic shut-off valve test procedure was improved.
- Visual inspections on the concrete trench were planned.
- Expansion of the ammonia detector network to cover the remaining valves.
- Access and protection arrangements of certain remaining safety-related equipment.
- The modification management procedure remains to be improved.
