# Implosion of a styrene storage tank during truck unloading operations

January 7, 2005

Tertre - Belgium

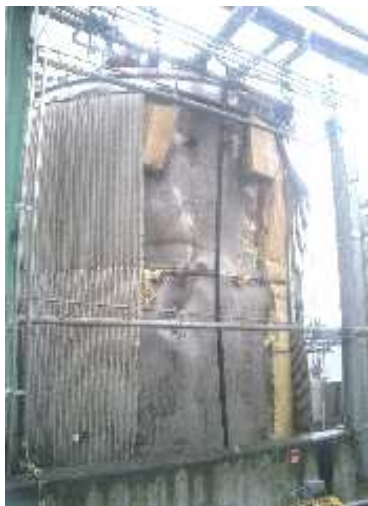
Shortly thereafter, a low level alarm on the tank's refrigeration unit (glycol solution) sounded in the control room. A slight increase in the styrene tank's level was also observed at the same time. Following an inspection on site, a styrene and glycol water leak was reported, as well as significant deformation of the storage tank.

Destruction of the storage tank (and the internal coil),

The accident is due to the incorrect alignment of the gas return line: the butterfly valve on the truck remained nearly completely closed throughout the entire unloading operation (forgotten by the driver).

The tanker began depressurising and, as it was "full vacuum" type, a partial vacuum was created. Upon completion of the unloading operation, the partial vacuum was estimated to be 0.6 bar. This would not have happened if the tank had been protected by a vacuum breaker, as stipulated in the operator's specifications.

At the same time, the storage tank developed a slight overpressure. The high level alarm was not managed correctly in the control room when it had sounded. As far as the very high level is concerned (causing the unloading pump to stop), it was never reached due to bubbles that were trapped in the barometric seal, which limits pressure increase inside the tank.

At the end of the unloading operation, when the driver opened the butterfly valve completely, the pressures in both the tanker truck and the storage tank were balanced out. The intake of air that followed was enough to cause the implosion and subsequent destruction of the storage tank.

The operator replaced the storage tank and undertook the action indicated in the following paragraph.

Installation of a system to prevent the depressurisation of the storage tanks at all time (even during truck unloading operations).

Slaving of the unloading pump to the correct connection of the lines (pressure measurement).
