Meeting – Bordeaux, June, the 11<sup>th</sup> and 12<sup>th</sup>, 2002

## LESSONS LEARNT FROM INDUSTRIAL ACCIDENTS

Classified installations / IMPEL inspectors

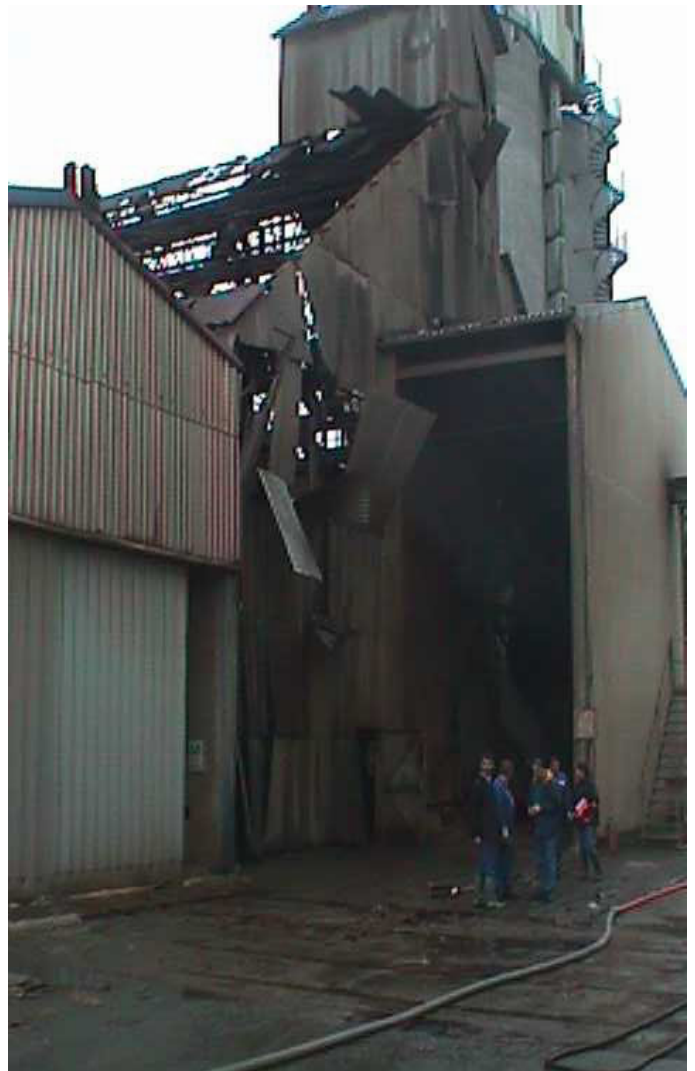
The hot gases and/or incandescent particles caused the combustion of dust deposits in the respiration system of the cylindrical silos located a few metres away, but at a height greater than that of the horizontal silos. The firemen, alerted by wisps of smoke, rapidly intervened and stopped the fire in these depots, thus preventing the fire from spreading to the vertical cylindrical cells.

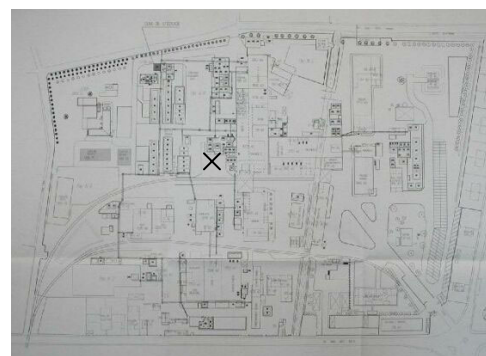
x : Location of tank C95 containing Benzoyl Chloride

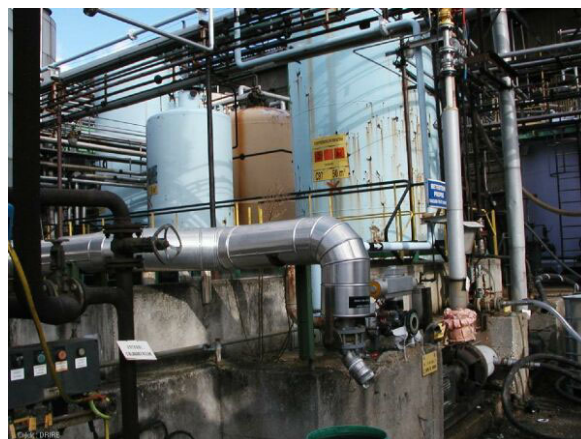
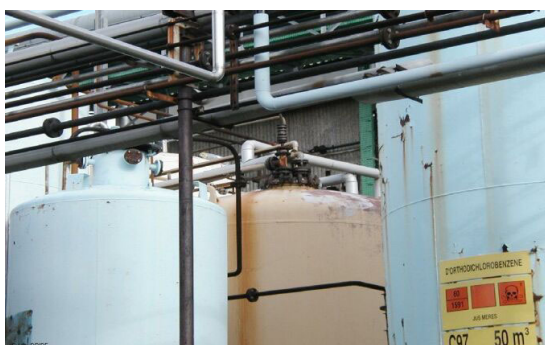
Having noted that the transfer pump was malfunctioning, the GLCF technician stopped the operation and began spraying down the tank with the sprinkler system. The personnel noted a small explosion, probably due to excess pressure in the tank, and a cloud of acid gas was released through the faulty flange seal on the upper dome of the tank.

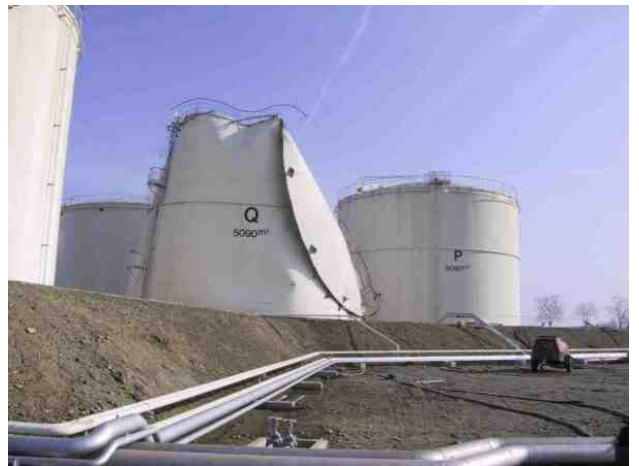
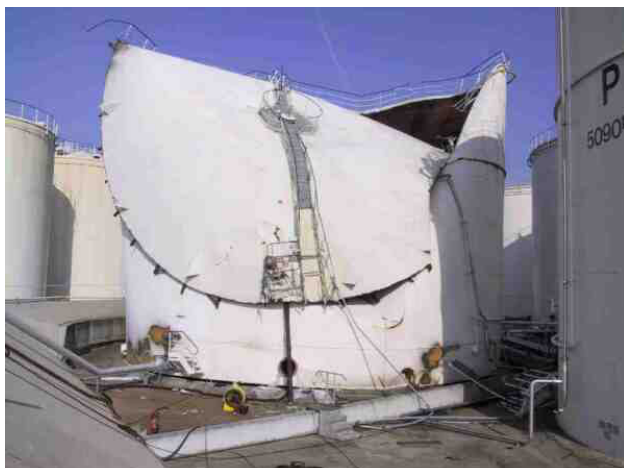
The tank was totally destroyed. Activity at the depot was stopped for approximately 2 months.

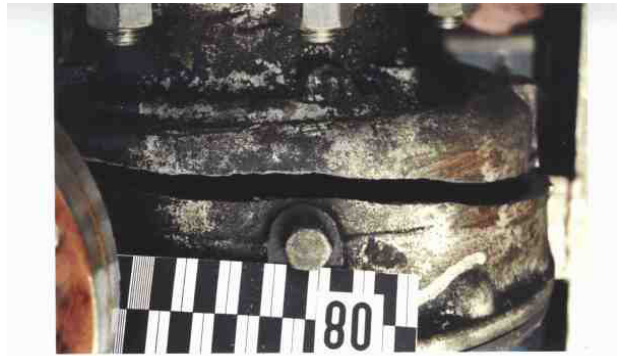
- ✘ incorrect supporting of the lines and line accessories
- ✘ incorrect attachment of the lines to the pump

The phenomena was aggravated by the nature of the pump's casing (cast iron).

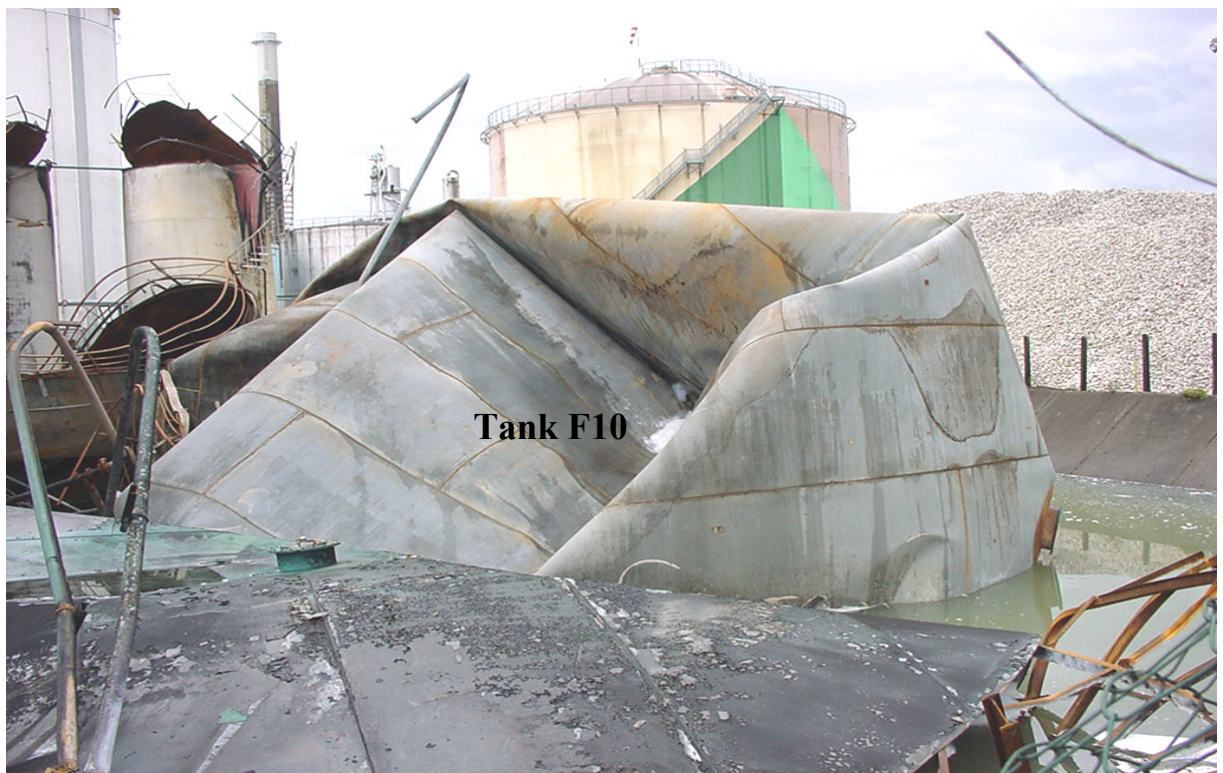
**Roof of tank F10**

**At 4.42 pm (t = 0)**, tank F10 exploded projecting its roof more than 10 m into the air. The roof fell onto the roof of tank F8. Catchpit B and tank F10 caught fire.

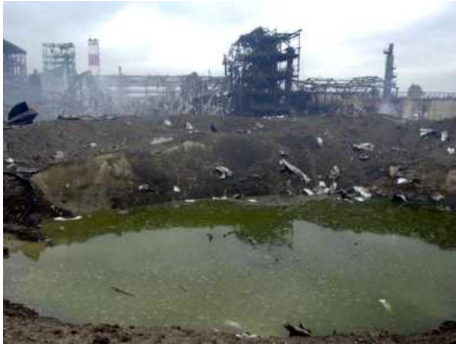
**Crator made by the explosion  
(ground zero)**

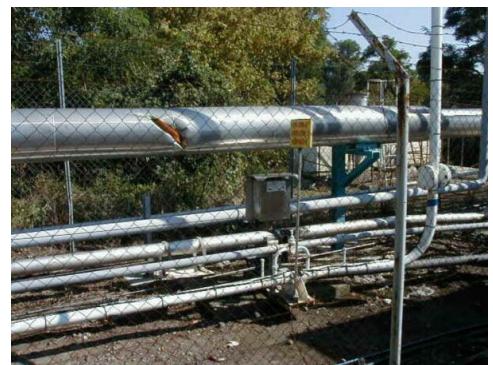
**Impact made by flying debris  
on a water pipe**

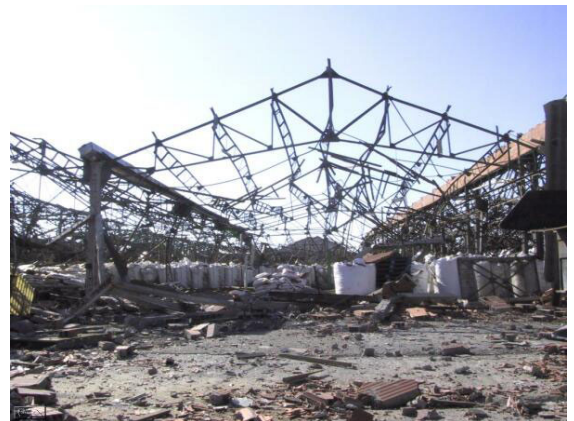
**Warehouse destroyed by the explosion**

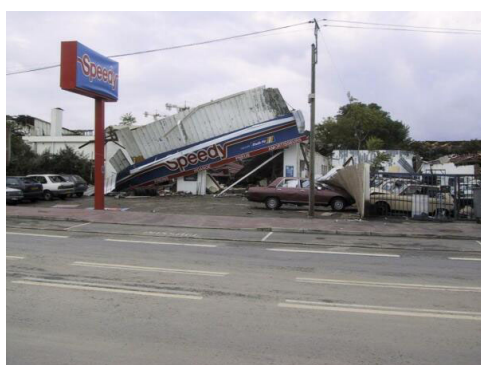
**Vehicle maintenance company destroyed**

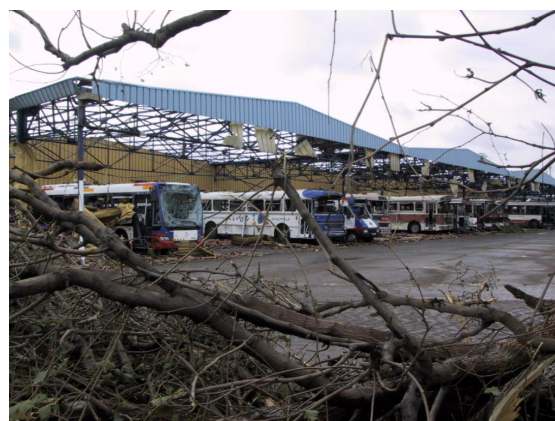
**Bus depot destroyed**
