**« LESSONS LEARNT FROM INDUSTRIAL ACCIDENTS »**

**Registered installations French Inspectorate / IMPEL**

**Seminar – DIJON, November 2003, 4<sup>th</sup> and 5<sup>th</sup>**

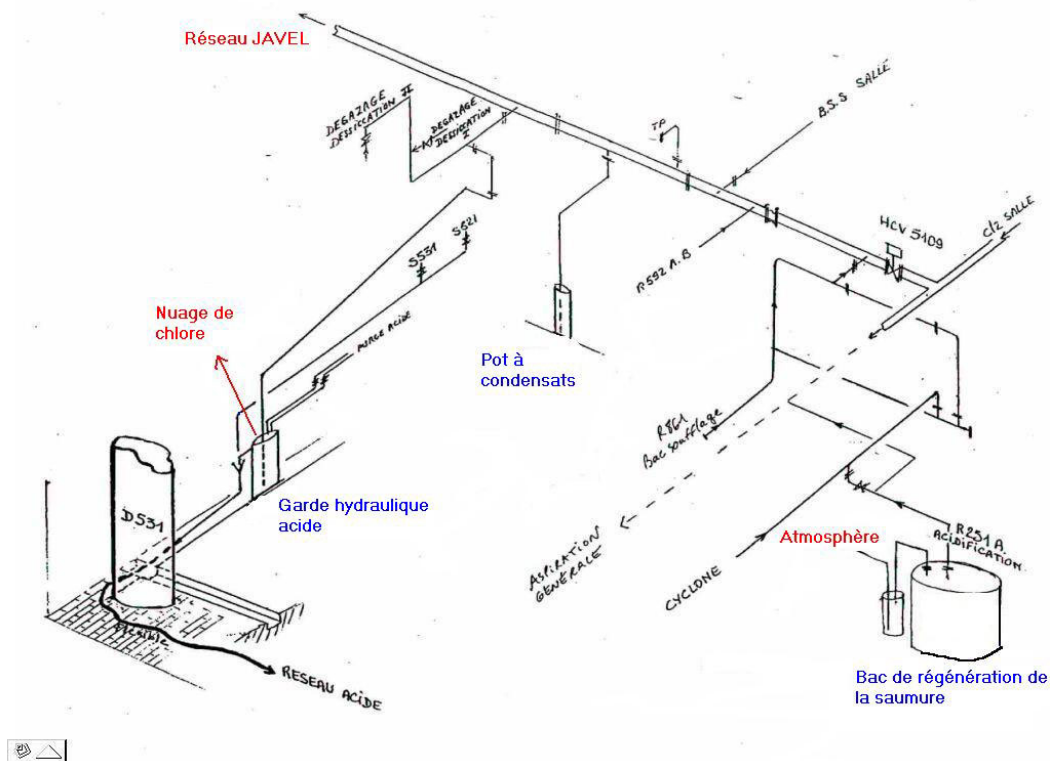
The accident was caused by an unexpected influx of air into the tank used to regenerate the brine coming from the mercury electrolysis cells. This influx of air, resulting from an insufficient water level in the liquid seal protecting the tank, lead to pressure fluctuations in the installation and triggered a high pressure alarm in the tank. The excess pressure lead to the regeneration unit being secured and particularly the automatic connection of the tank valve on the javel water network collecting all of the residual chlorinated gaseous effluents (see diagram below).

The malfunction of the liquid seal, protecting the brine regeneration tank, was repaired only a month later after the incident happened again, although this time without consequence. The operator will now ensure that it is supplied on a permanent basis.

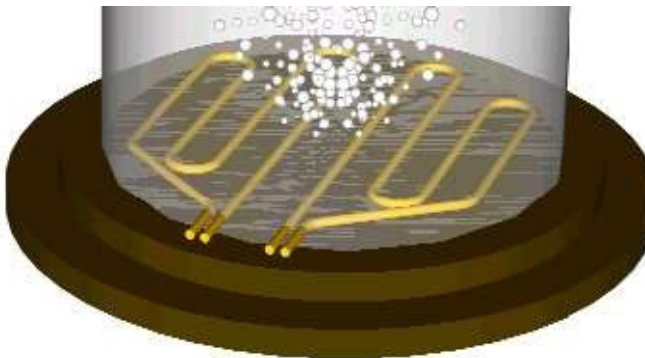
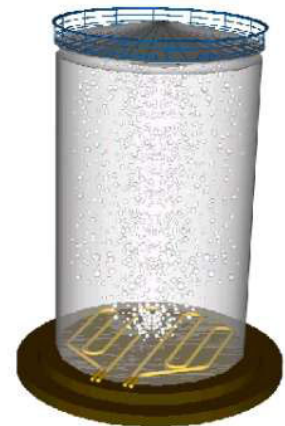
- × First, failure of steam coil in the tank due to :
  - ✓ Different material thickness over 10 cm-length (remind: total length is 119 m)
  - ✓ Corrosion of the steam coil but visually noticeable
  - ✓ Inspections recently carried out : In 2001, a pressure test and ultrasonic measurements had been done.

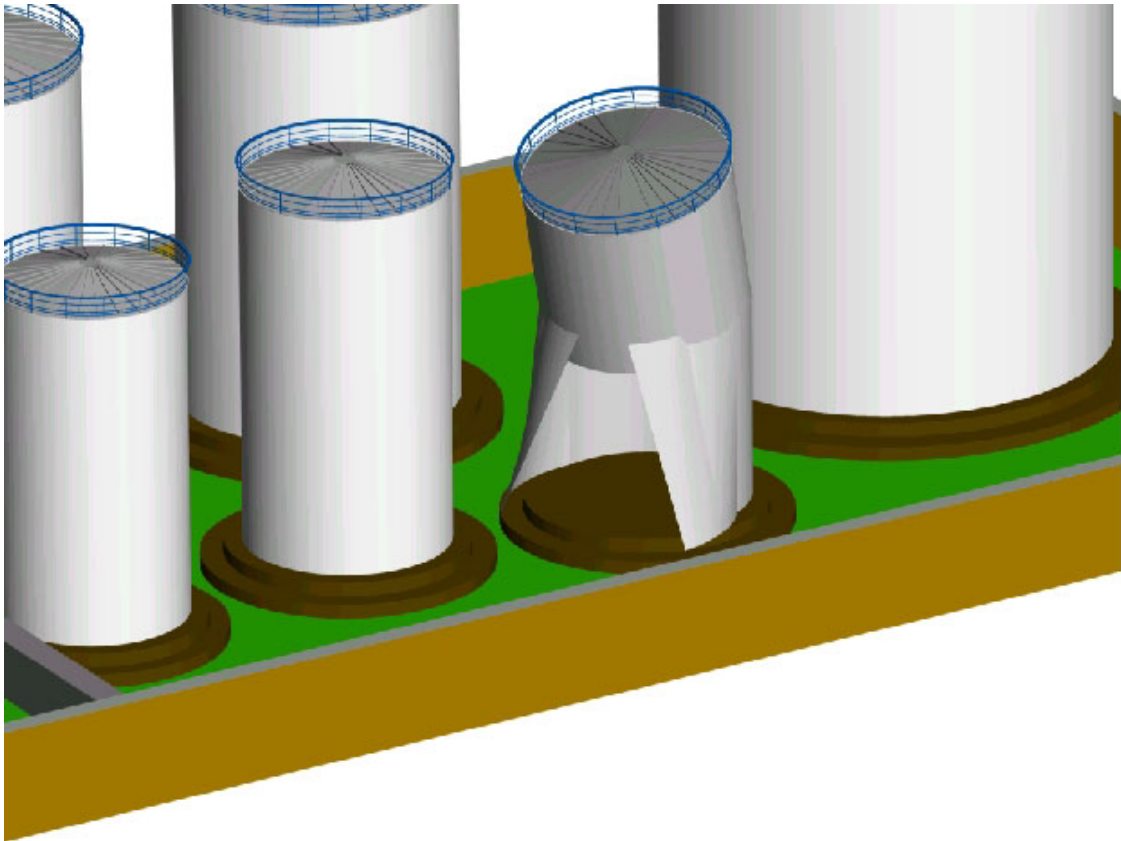
- × Due to weakest spot in the hoop, the tank failed because of an inferior quality of one of the welds. In fact, the tank was able to withstand the extra pressure caused by expansion of vapour but not the pressure waves.
- × The tank fails in a few seconds and the product flows through the tankpit.

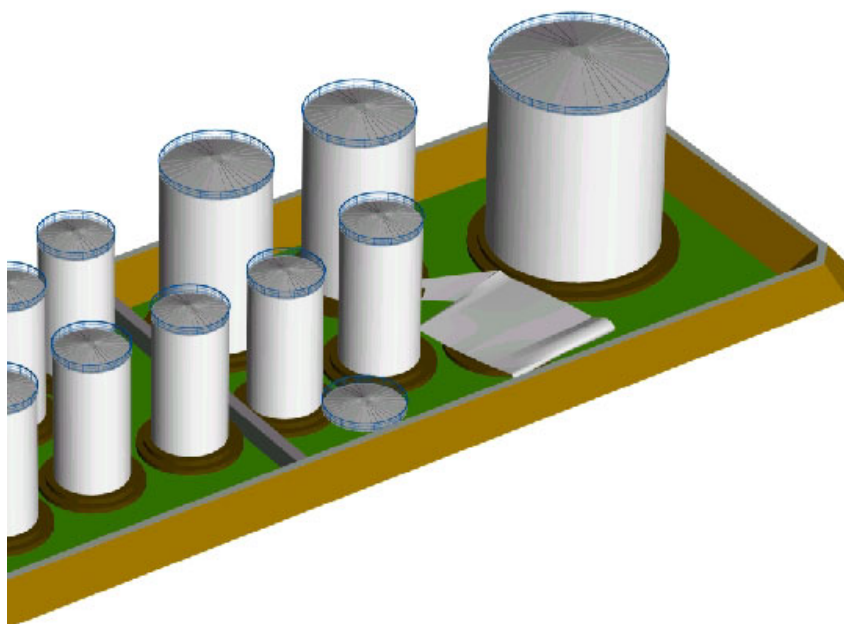
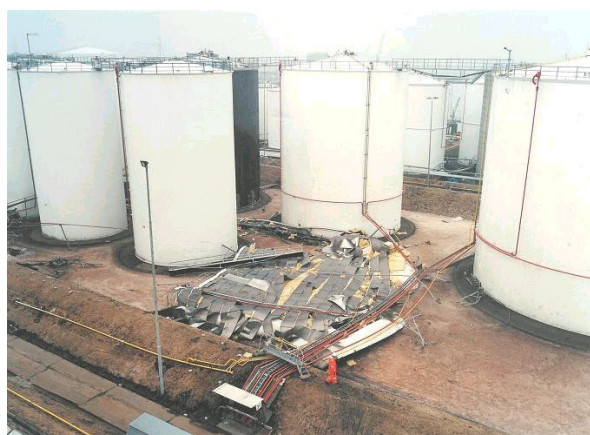
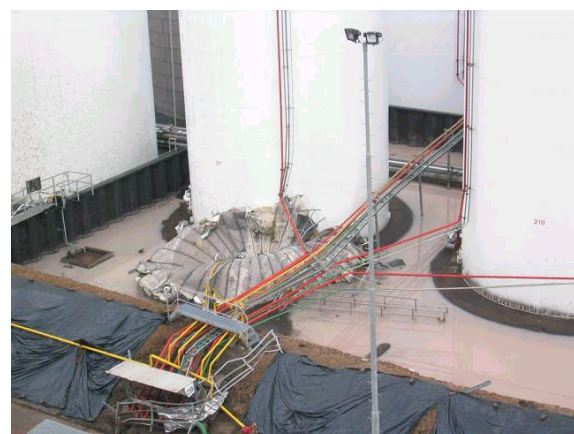
The tank turns on its side and the roof ripped off and moved. Ortho cresol spread over 3 ha.

- × Direct operational activities are excluded as cause. It is clear that the accident is due to the failure of the steam-coil. Indeed, 10 cm piece of coil is from thinner material and is internally corroded.
- × Tank could take the overpressure caused by the expansion of steam but it collapsed due to dynamic pressure.
- × Furthermore a weak weld was found in third ring of the hoop.

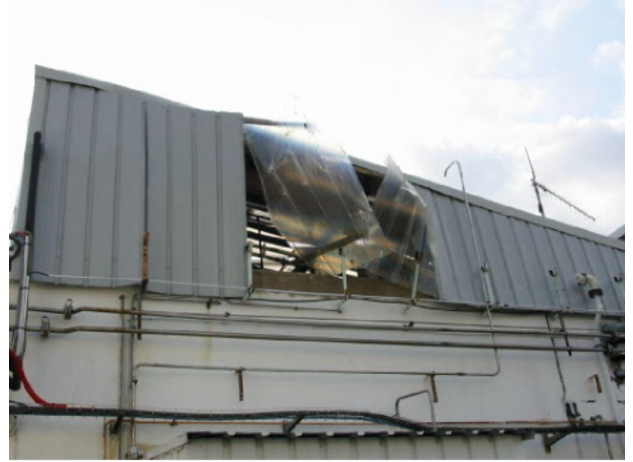
- ✓ Twenty square meters of the ceiling were blown out, mainly on the span of clear sheeting (the sheeting was folded although it remained in place),
- ✓ The siding on the upper part of the building, to the west and to the north, was blown out over 5 m with partial tearing away of the sheeting,
- ✓ Traces of product projection was visible on the northern part of the wall, up to heights of 2 m,
- ✓ Impact holes (possibly due to pieces of PVDF) were observed on the clear siding.

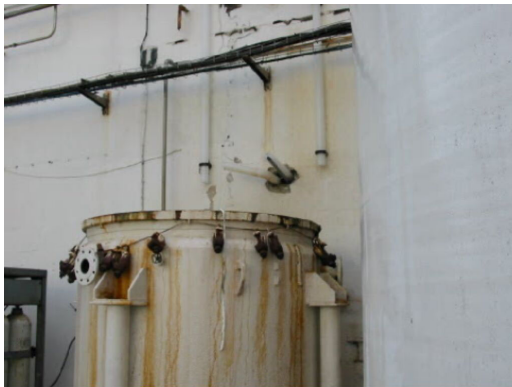
At the level of the crash tank zone, located outside the building:

- ✓ The crash tank's plastic cover was completely ripped away, as well as all of the connecting pipework,
- ✓ 30 cm of liquid is present in the tank,
- ✓ A piece of broken plastic was projected through a window in the administrative office.

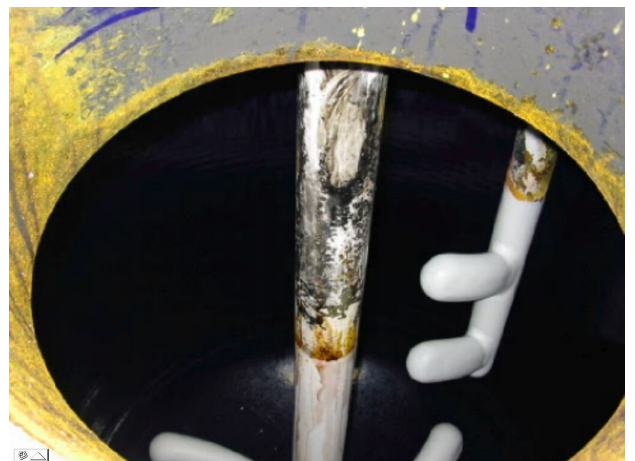
- ✓ Several gaskets exited their seats (manhole, cover and vent outlet), and their metal reinforcements were partially torn,
- ✓ Yellow traces indicate that product exited by the cover gaskets and manhole,
- ✓ A change in appearance of the PVDF piping and the valve was noted,
- ✓ Numerous enamel fragments were present on the reactor and in its immediate proximity
- ✓ The lower part of the metallic protection of the mixing shaft is caved in.

The self-detonation of an oxygen (O<sub>2</sub>) / hydrogen (H<sub>2</sub>) mixture, the hydrogen being produced by the acid corrosion of an unprotected metal surface. A corrosion spot was observed at the top of the mixing shaft. This defect on the coating of the enamelled surface of the reactor’s mixing shaft happened when the mixer was being installed after inspection, an impact to which the operators did not pay any attention. As such, a gaseous mixture of dichloromethane and oxygen, sufficiently enriched with hydrogen in order to be self-detonating, may have formed in a recess of the reactor, created by the tube. The results of the tests, the extent of the damage associated with the blast and the observation of an enamel corrosion spot, backs the hypothesis of hydrogen being present in the environment.

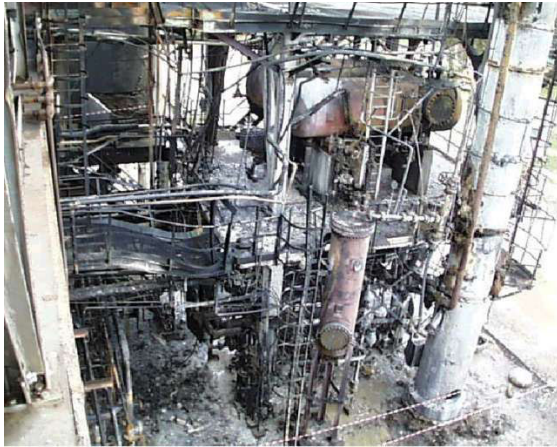
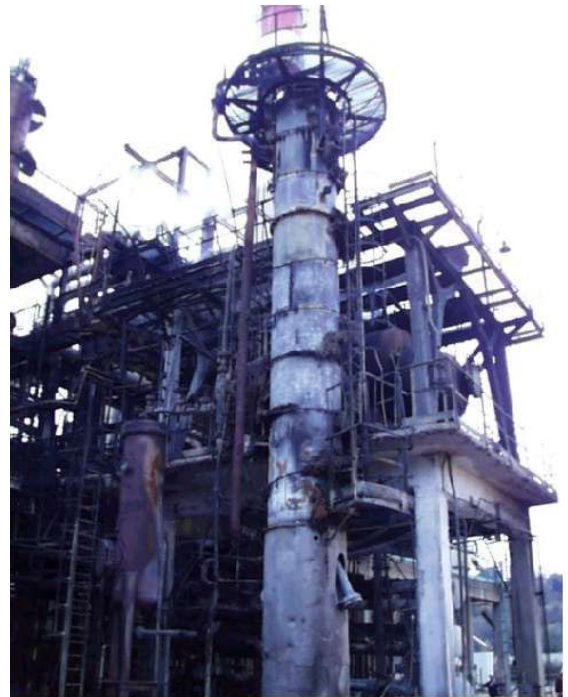
**Bensat unit**

✓ Most of the structures invested by the jetfire were protected by a fire-proofing layer; they were damaged but didn't have mechanical failure. Pipe connections and process units lost their sealing and released some gasoline and hydrogen that contributed to the extension of the fire and the destruction of the unit.

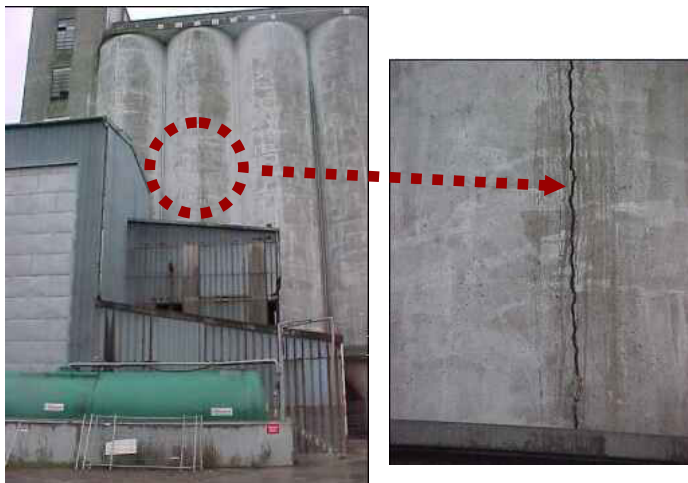
**Jussy accident: (ARIA No. 23368)**

During a security round on October 20, 2002 around 10 am, the silo manager was alerted by the sound of material falling onto the drier roof. He noted a crack along the entire height of a 25 m tall cell. Roughly a ton of corn had spilled out, damaging a wall allowing access to the control installations located at ground level, under the outflow cones forming the base of the cells.

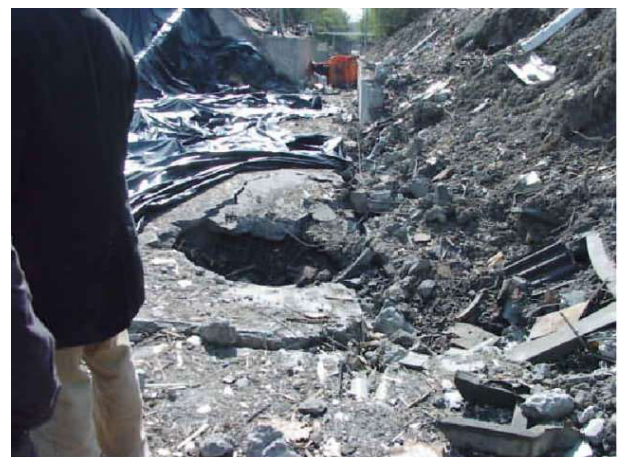
*Crater at the location of the machine – Photo DRIRE NPC*
