Meeting IMPEL / ICPE Inspectors  
on industrial accidents

Lyon, April 1999, 27<sup>th</sup> and 28<sup>th</sup>

## Summary

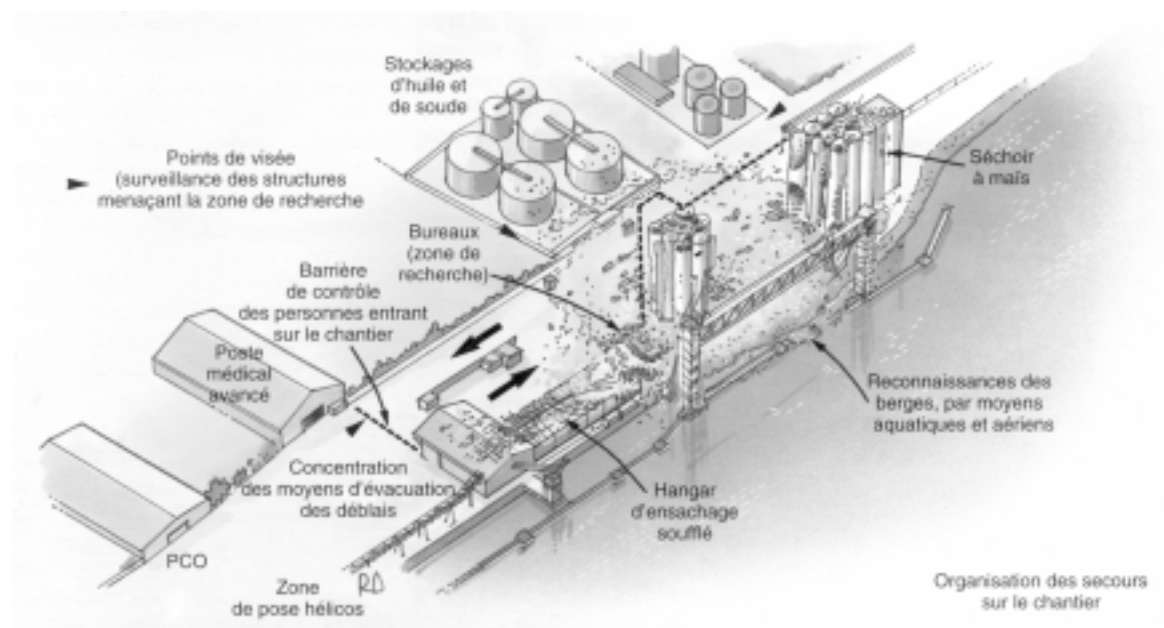
The vertical silo central and northern sections collapsed. The northern section buried the offices. Only 16 of the 44 cells seemed to be still in place after the accident. A characteristic of this accident is the fact that two sets of cells collapsed: a set situated to the north and adjacent the handling tower, and another set in the silo's central section (see photo).

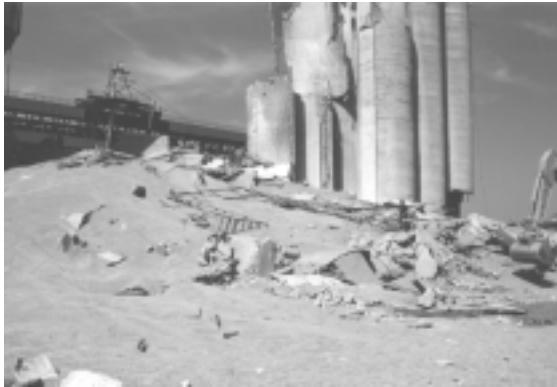
The northern handling tower, as well as the cells immediately next to it, were nearly totally destroyed. On approximately half of its initial height, only part of this tower's curved half-shear wall, the side sections of which forming the walls of the adjacent intermediate stacks were pushed backward, onto the pit of a neighbouring cell. The fact gives evidence to an explosion in the handling tower, which would have occurred after any explosions in the neighbouring storage units.

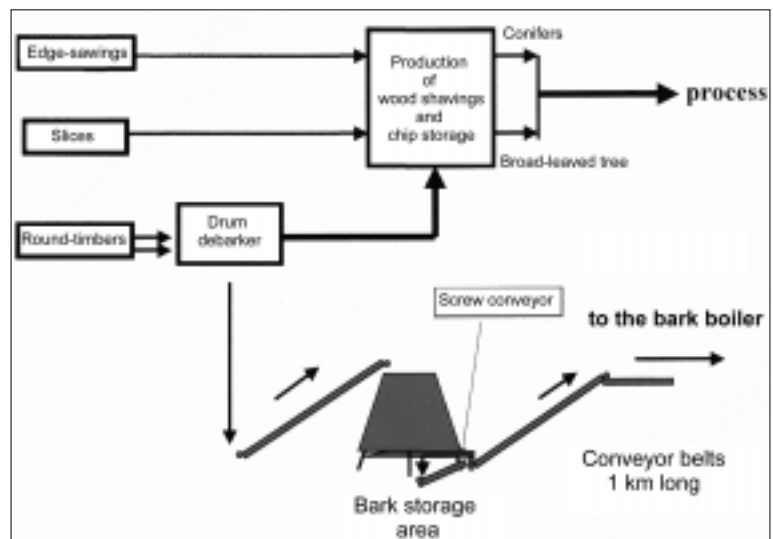
The paper mill's wood zone generally includes the raw material storage zones, the transfer to the drum debarker and the grinder for the transformation into wood shavings, the chip storage area, and the bark storage area (see diagram below).
