Meeting - LYON, June 2000 , 6th and 7th

« LESSONS LEARNT FROM INDUSTRIAL ACCIDENTS »

ICPE / IMPEL Inspectors

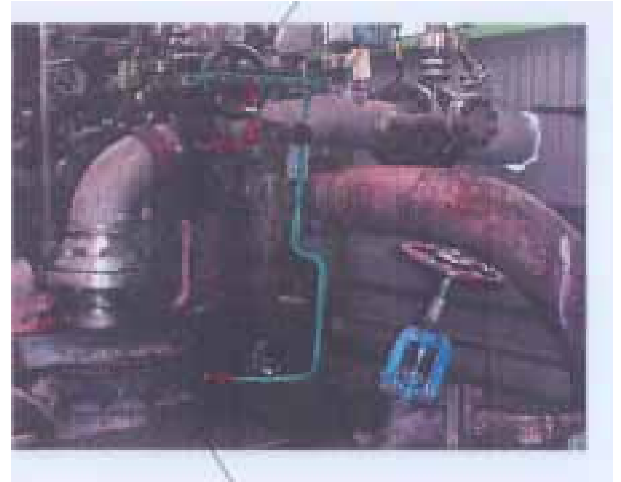
Considering its importance in the train of events, further information is provided about the autoclave's closure mechanism (see photo opposite).

It consists of a pivoting system comprised of the manhole cover and an adjoining elbow-shaped tube section enabling the autoclave to be connected to the overpressure protection system consisting of a rupture disk and a valve mounted in series. A seal is required at 2 levels: one seal is located at the cover/manhole junction, and the other is located at the junction between the elbow tube and the stationary overpressure protection pipe. Two jaws, one at each level and actuated by a lever, ensure the overall tightness of the device.

- The launch of the operation was prepared normally and the operator began the habitual procedures, particularly the closure of the autoclave.
- The operator believes to have closed the autoclave but in fact forgot to tighten the jaws of the previously described mechanism.
- The launch of the vacuum operations, the loading of the product and the following phases were carried out: polymerisation began.
- The leak did not occur immediately: only when the pressure was sufficiently high, that is to say at the end of the heating phase, the leak occurred suddenly at the "quick" junction. The mechanism remained in place although the seal slipped out of its housing causing the leak.
- The VCM spread through the workshop ...
- Then it spread to the exterior via the facility's mechanical ventilation system.

In response to the reported human failure, a mechanical device was installed by the operator. It now detects where the not the jaws are actually tightened during the autoclave vacuum operation.

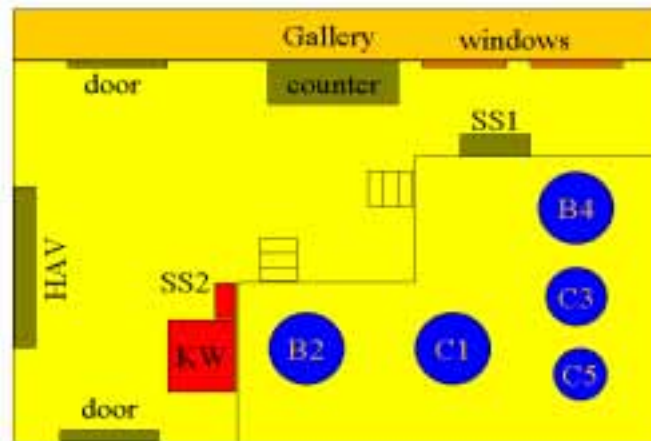
C ₁ , C ₃ , C ₅ :	hydrogenation reactors
B ₂ , B ₄ :	vessels
SS1,2 :	switch cupboards
KW :	catalyst washing plant
HAY:	main shut-off valve

In the following picture you can have a look to the room the fire occurred.

κ Above the source of fire there was a hydrogen pipeline. Due to the heat of the fire a soldering point of the pipeline fails. Hydrogen is released and an explosion happens.

λ At the broken part of the pipeline a big flame appears destroying the windows in the wall near the gallery. So the manual shut-off valve located in the gallery cannot be reached. Furthermore the hydrogen flame fires with high energy a wall with several shut-off valves. This can be concluded due to burned out valves and leaky flanged.

μ A switch cupboard located in the area of fire influence gets on fire. A short circuit and a fire of the electric installation happens. The pump for phenyl acetyl carbinol misunderstands the signal and starts pumping phenyl acetyl carbinol through a leaky flanged joint into the source of fire. It needs 15 minutes till this is recognised and the pump is tuned out.

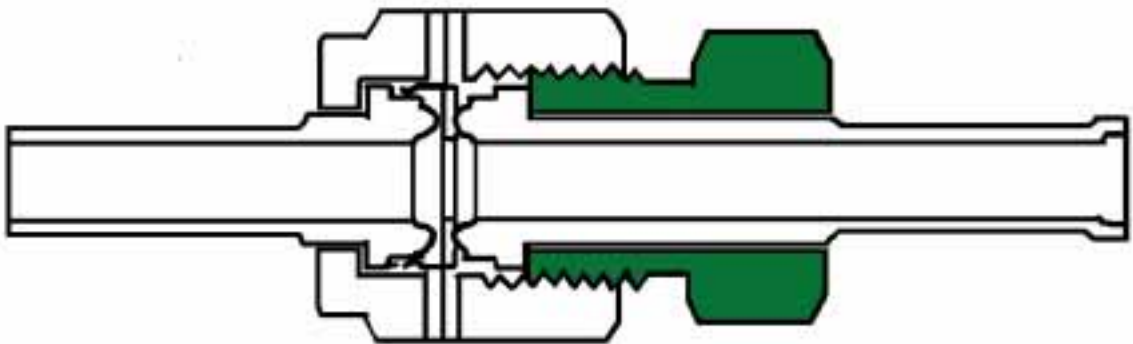
Représentation schématique d'un raccord VCR.

The origin of the accident was due to a defect in the design of the VCR connectors between the gooseneck and the valve on the cylinders. These components consist of parts supplied by different suppliers which lead to guide length differences of the fitting nuts. In some cases, this could lead to a cross threading which may be gas-tight at the time of leak testing but are rather precarious. In certain cases (hammering or humming transmitted by the gooseneck, shocks, vibrations...), the connection may shift slightly and develop a leak.

The cylinders were filled from a bank consisting of two independent half-banks: while the pressure in the system was stabilized at 17 bar, the operator switched from one half-bank to another and set the pressure of the system at the latter's pressure, or 60 bar. The overpressure probably caused the seal on the VCR connector to suddenly burst.

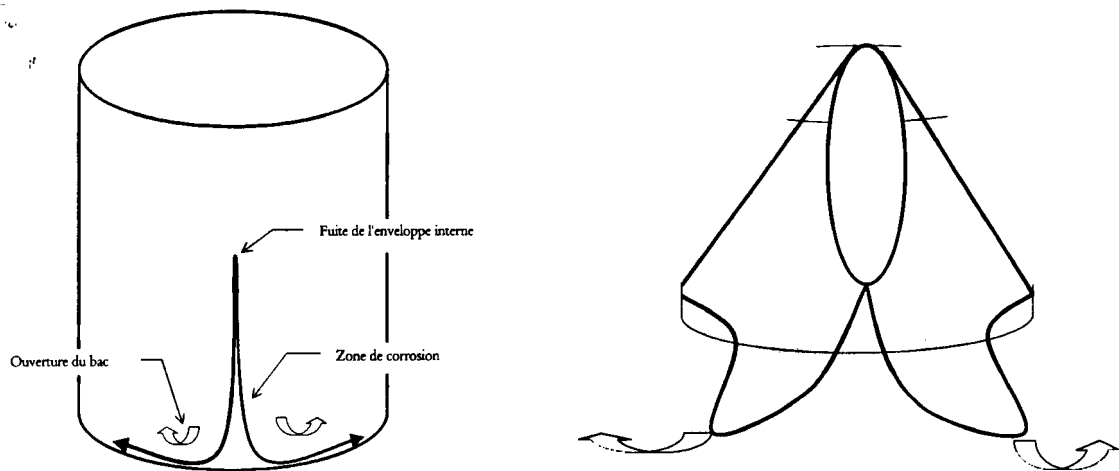
The tank in question was made of a steel casing lined with lead sheeting to ensure a hermetic seal in relation to the structural casing. This tank, measuring 9 meters high by 8 meters in diameter, was correctly dimensioned to contain phosphoric acid at atmospheric pressure. The retaining basin consisted of a slab (thickness: 15cm) and retaining walls (thickness: 15cm at the base, 10cm at the top). The entire structure was made of reinforced concrete. The mechanical resistance at the slab-wall intersection was ensured by two metal brackets made of 10mm steel round stock placed every 20 centimetres. This dimensioning should have resisted the hydrostatic pressure exerted by the tank.

Furthermore, the pressure exerted by the acid is greater than that exerted by the water during the resistance test ($1,640 \text{ kg/m}^3$ for phosphoric acid). The rupture occurred suddenly and the wave effect created pressure on the retaining walls must greater than the hydrostatic pressure. In addition, defects were discovered in the concrete reinforcement: the reinforcement bars were not correctly attached.

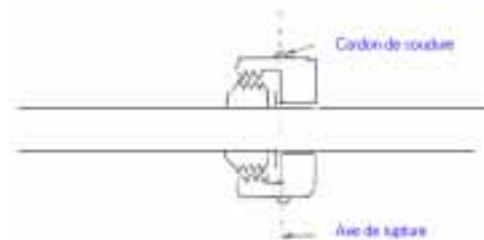
The leaks were caused by the rupture of a 3-piece connector. The latter was broken during previous operations and had been rewelded by the plastics technician. The weld was insufficient and the repair was not reported to the operator.

On the day of the accident, the electrician had modified the installation in order to slave the start-up of the pump to the opening of the solenoid valves which feed the two hydrochloric acid tanks. The pump started although the solenoid valves remained closed. The pressure thus began to rise until the 3-piece connection burst.

The pump was over-dimensioned, on the one hand, and the ventilation valve of the device was located too far from the pump (on the storage tank's high level), on the other hand. The pipework support elements were insufficient; there was only one single stop button located near the pump and thus difficult to access.
