Meeting – REIMS, June 2001, 12<sup>th</sup> and 13<sup>th</sup>

## « LESSONS LEARNT FROM INDUSTRIAL ACCIDENTS

ICPE / IMPEL inspectors

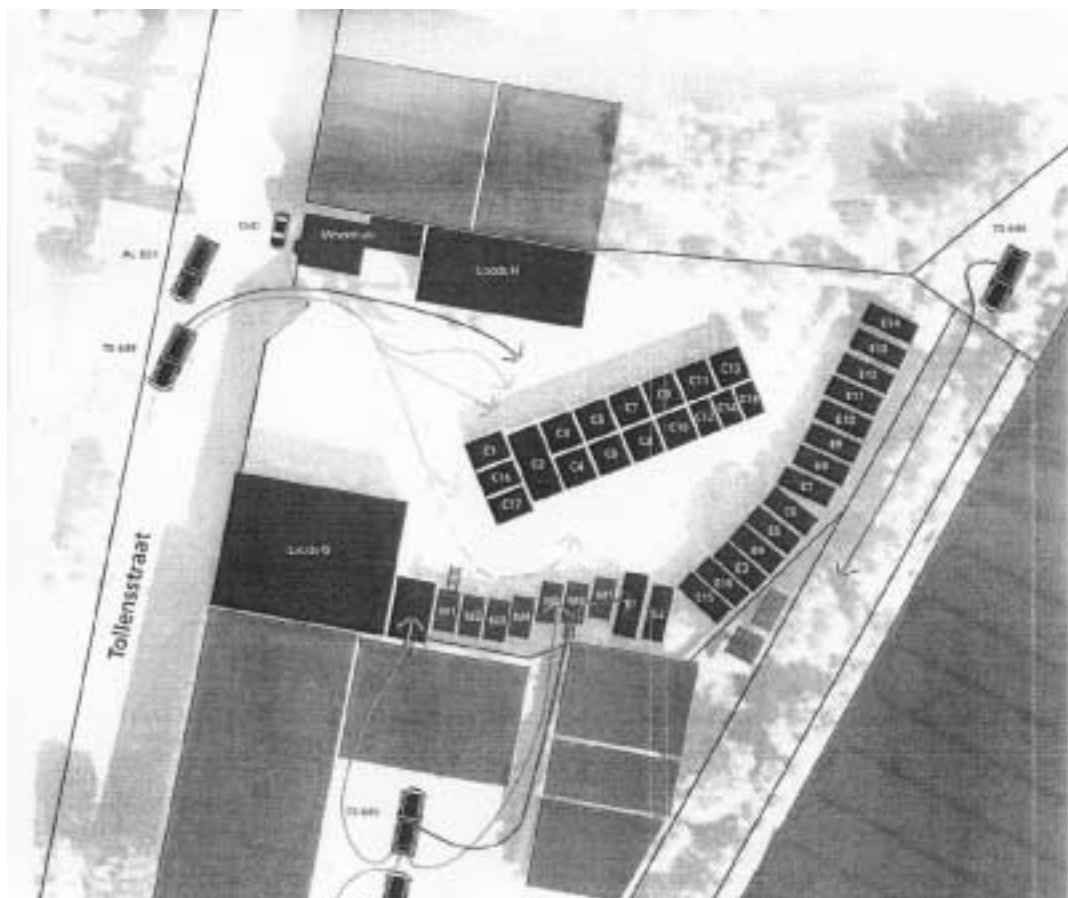
**M: MAVO box**

**C: central zone cells**

🚒 At 3.08 p.m., the fire brigade arrived on the scene, determined that the site was a pyrotechnic storage facility and called for reinforcements. Operations to fight the fire were organised: several fires had already broken out on the site. The fire brigade took up the positions as indicated in the diagram above.

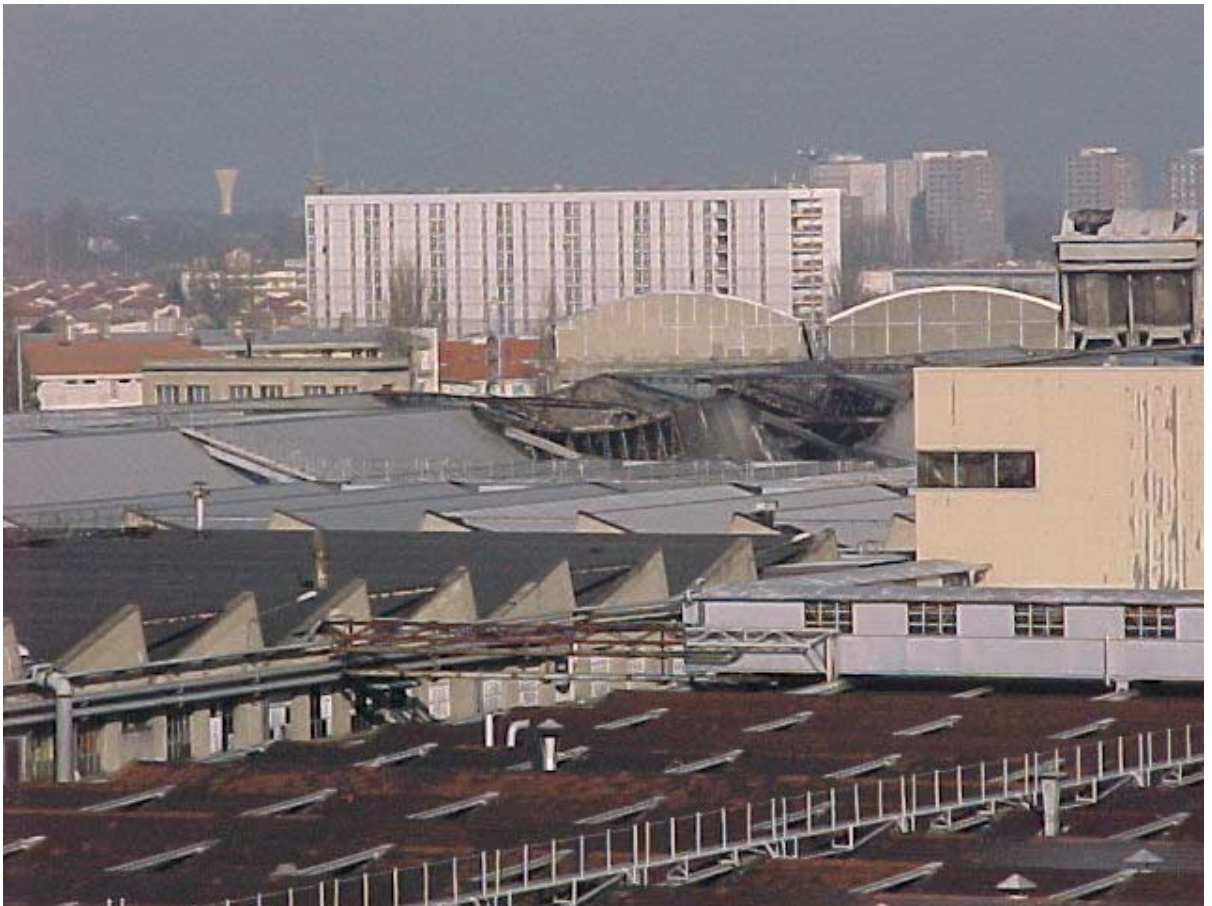
Photo DRIRE Auvergne

The fire took place in a building measuring 16,000m<sup>2</sup> at ground level. Largely unused, although undergoing reassignment, the building was used essentially for the basement storage of raw synthetic gums. A machine, referred to as MAC BU, was located in the west part of the building, used for preparing mixtures for gum.

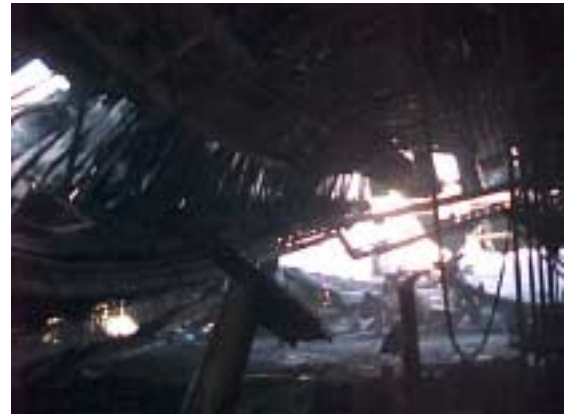
Photo DRIRE Auvergne

An outside company, in possession of a fire permit, was performing maintenance operations, installation-removal of metal elements, using torch cutting and welding operations. The hypothesis is that a cinder of molten metal initiated the slow combustion of the gum present on pallets for an undetermined duration before the fire broke out.

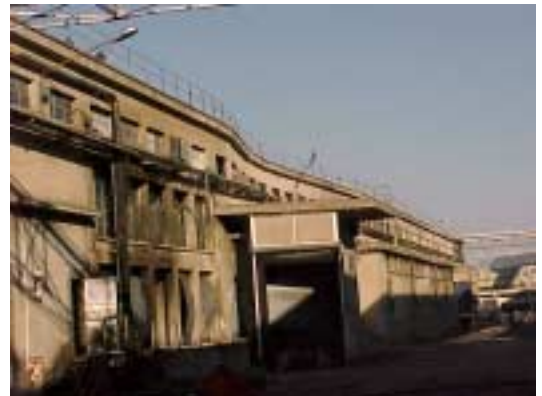
Photo DRIRE Auvergne

On the other hand, knowing the difficulty in putting out a widespread gum fire, it appeared a posteriori that the fire could have been much better contained then extinguished if the firefighting means, which were limited, had been implemented faster.

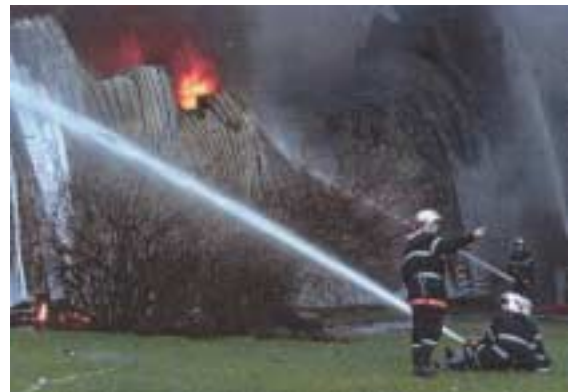
Photo Media

The fire broke out around 10 o'clock, while an employee was engaged in pumping a sealant from a 1,000-litre container to a 25-litre drum by means of an explosion-proof pump and an antistatic rubber hose in an area that was protected by halon explosion suppressant. The employee saw sparks jump out, followed by flashover. Despite the rapid intervention of the personnel, the fire quickly spread to the central workshop, as the fire door between the workshop and the solvent area had been left open, and then spread to the finished products storage area. These two areas were insulated by a fire door, but the fire spread through the roof (melting of the sky-dome type light fixture).

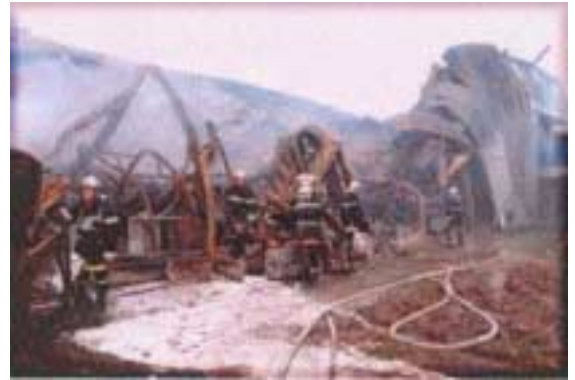
Photo media

The material damage, in the order of 70 million French francs, was considerable: plastic materials, mostly PVC, solvents (toluene et xylene) and finished products (polyurethane sealants and prepacked glue) formed the largest part of the materials affected by the fire. The MDI storage area and the drums being produced, which were protected by the fire walls, were not affected.

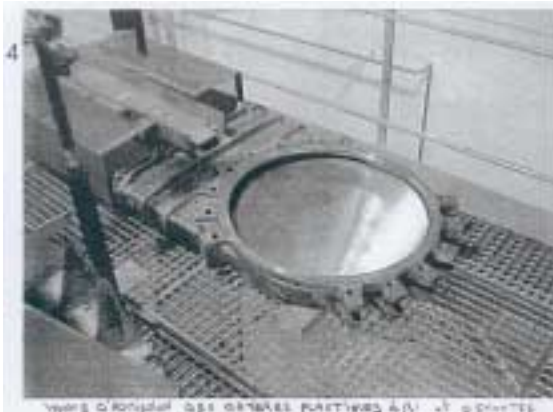
The inlet valve being open, the catalyst was inserted through the branch connection installed on the reactor. Following insertion of the catalyst and before initialisation of the insertion of the bottles, a fire started in the inlet duct. It immediately spread to the duct's acoustic liner. The liner, which was combustible, spread the fire, and "deflagrated", producing blazing droplets. Two dry chemical extinguishers were immediately used to put out the fire, which proved difficult to reach. The guillotine valve was locked and the N-flux in the reactor was sharply increased.

The damages caused by the fire itself are as follows:

- 🚒 Destruction of the supply duct,
- 🚒 Destruction of the separator and damage to all sensors and electrovalves,
- 🚒 Partial destruction of the guillotine valve,
- 🚒 Destruction of the thermal insulation and all electrical, computer and pneumatic cabling on the upper zone of reactor R1,
- 🚒 Structural damage to the building, mainly to the roofing and the structure situated near the fire.

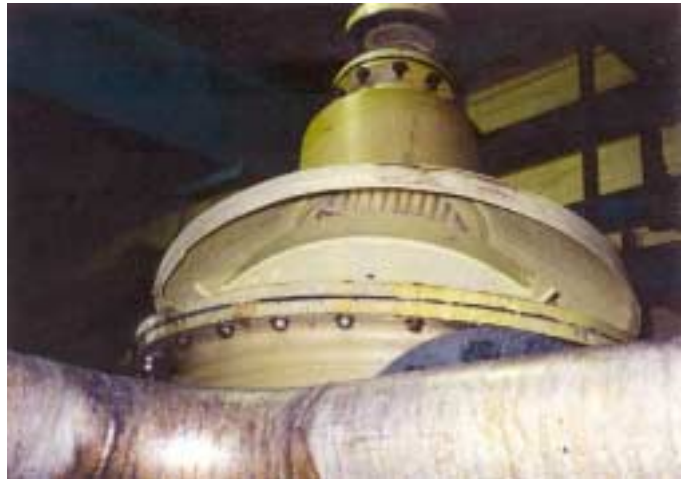
On the material level, the top of the scrubber column is ruptured, together with other materials in connection with it.

- 🚧 Engineering re-installation of the process,
- 🚧 Lost materials (cf. photos).
- 🚧 Response teams operation costs,
- 🚧 Clean up of the installations,
- 🚧 Post-accident investigations : both for internal and external investigation inquiries.

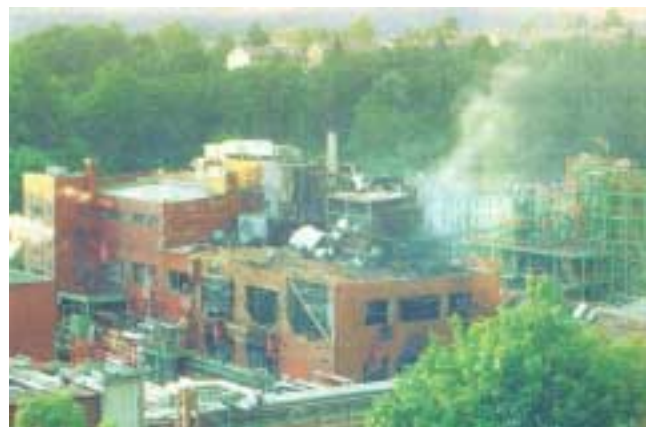
At the same moment the reactor exploded. The pressure wave grasped the two employees who were injured considerably. In the following of the explosion a fire occurred.

A lot of dwelling houses suffered partly considerable damages especially because a lot of windows were smashed by the blast. The establishment was devastated in a circuit of 200 m around the place of explosion. A contact line of the railway was pulled down.

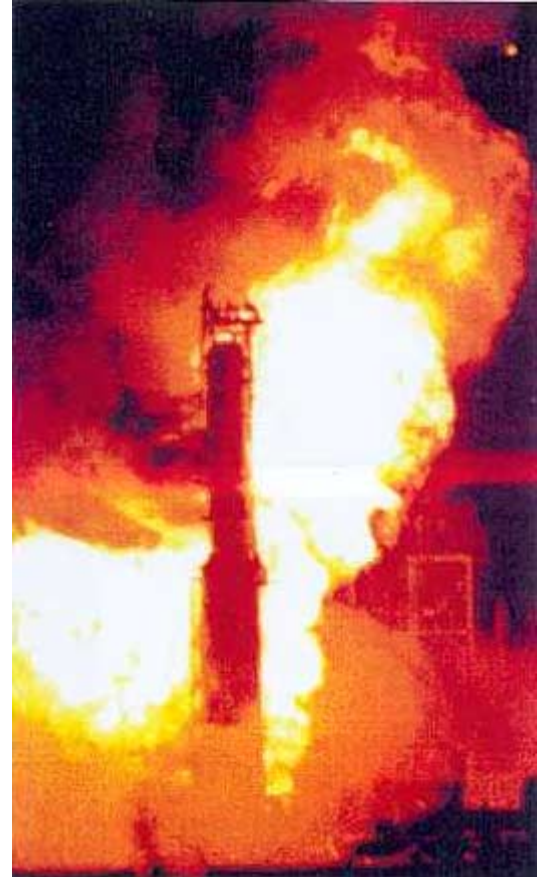
- through a domino effect, rupture of the header (8 inch diameter) of tube V3, and flash-up of the leak,
- through a domino effect, rupture of the valve manifold of tube V3, which is connected to the site's flare-stack network, and flash-up of the gas leak. This led to a partial venting of the flare-stack network.

From 10 p.m. onwards: the burning leaks continued to burn until the rest of the unit was consumed and the flare-stack network could be isolated without danger, which was on September 4<sup>th</sup>, around 3 12 p.m.

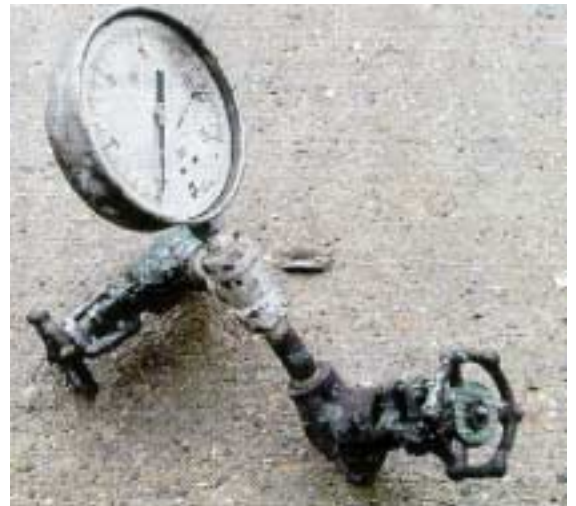
On 6 October 2000 at 00:27, an employee of the plant tried to replace a manometer on the outlet side of the pump that pumps propylene out of a holder into the depropanizer tower and into a separation tower. The pump is located at the edge of the production unit and is adjacent to an open space. The working pressure of this pump is 20 bar. The employee tried to unscrew the manometer by means of a pipe wrench. During this manoeuvre the pipe nipple broke off on the screw thread at the first shut-off valve. The shut-off valve on the press of the pump was closed. The shut-off valve which makes that there is no pressure in the manometer set-up was opened.

Propylene was released in the direction of the employee and away from the production unit. A cloud of gas was formed in the open space next to the production unit, which got ignited very fast. The ignition was accompanied by a muffled bang followed by a fireball with a diameter of about twenty metres.

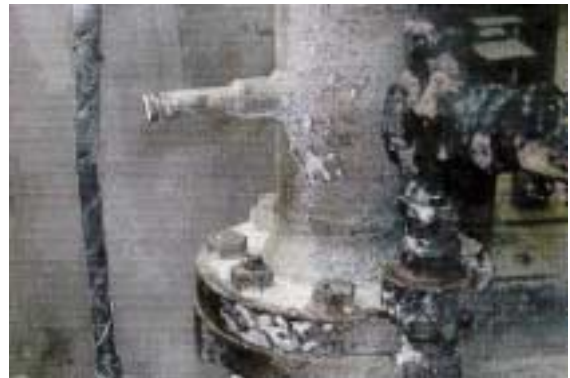
🔗 The set-up concerned is a 1/2" connection to a 4" pipe. The specification indicates that for such a set-up a "schedule 80" pipe must be used. This implies a **wall thickness** of 3.734 mm.

🔗 It appears from the wall thickness (2.5 to 2.7 mm) measured that a pipe with specification "schedule 40" was used; the specification indicates a wall thickness of 2.769 mm for this.

🔗 According to the specification, the coupling between the valve and the pipe must be a welded joint (type "Socket Weld"). On the concerned part the connection was made by means of a screw thread.

🔗 Calculations have shown that the built set-up has a moment of fracture which is five times smaller than a set-up that would be built in accordance with the specifications and that a fracture in a manipulation under these circumstances is not unusual. Therefore, the direct cause of the accident is the realisation of a non-conformal set-up.

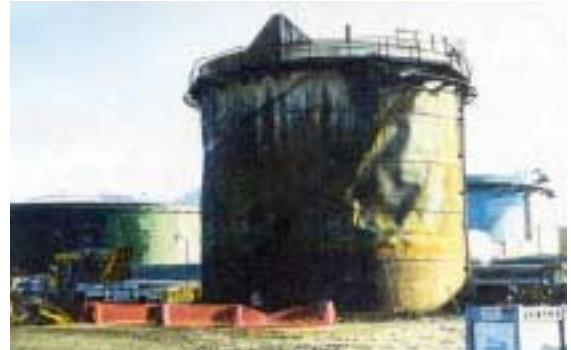
About 20 m<sup>3</sup> of hydrocarbons were released by the safety vent of the drain water tank on the floating roof and, from here, flowed through the roof draining pipe to the ground. A pool of hydrocarbons was formed near the tank. A vapour cloud was formed by the hydrocarbons evaporating from the pools on the tank roof and on the ground, reaching the neighbouring road, located about 60 m away.

Live steam entered in the tank, due to a failure of the coil, probably caused by corrosion. The inner temperature of the tank raised up to 60°C at least, causing the quick evaporation of light end of hydrocarbons to start. The internal overpressure caused the opening of the safety vent on the floating roof with an outflow of the upper hydrocarbon layer.

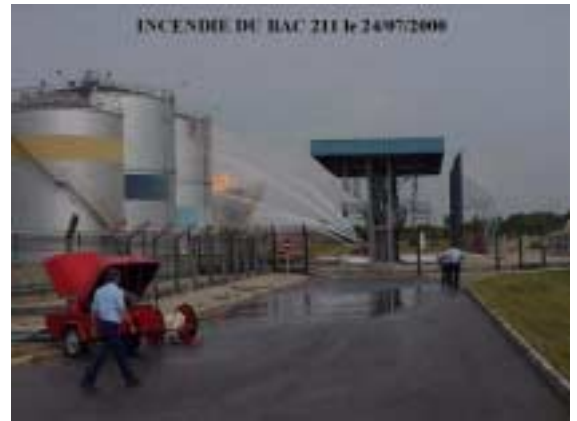
- 🚒 checking of the soundness of the tanks (as the 3 tanks of 2,500 m<sup>3</sup> capacity that were next to the damaged tank had been subjected to a high amount of thermal radiation, it was therefore necessary to check that the soundness of the tanks, (hermetic seal, strength) had not been affected)

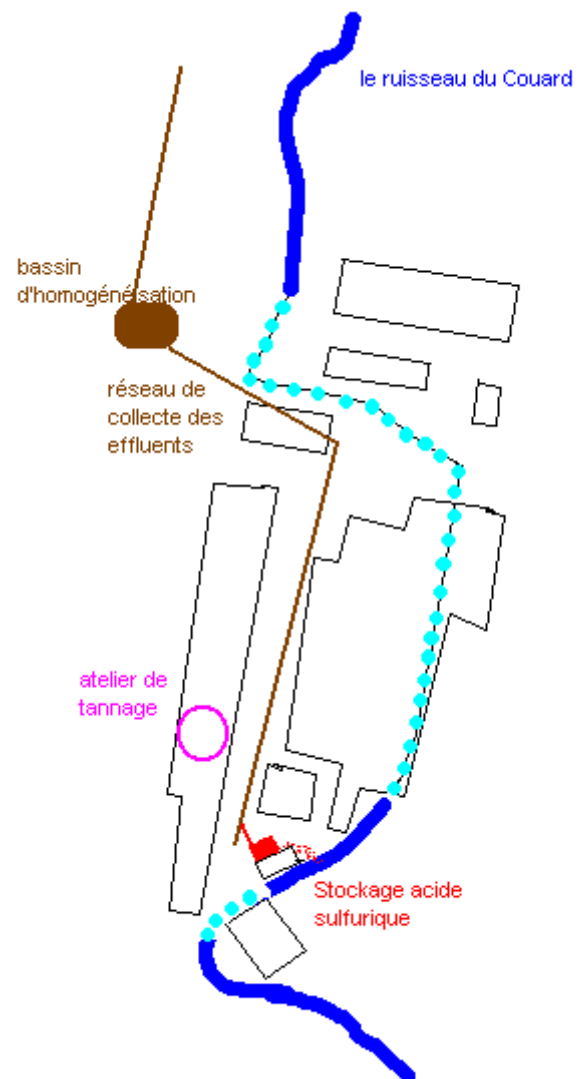
The location of the leak on the elbow of the interior drainage line which was always in contact with the acid and under pressure, attests to the faulty design of this storage container, which does not respect the provisions of standard order 31 "bis" concerning sulphuric acid storage facilities.

The faulty maintenance, inspection and design of the storage installations were the cause of this accident. The pressurisation of the gas in the tank is an extraction method which aggravates the consequences in the case of a leak.

Prior to return to operation, the order required that the tank be subjected to an internal and external inspection, the backfitting of the drainage device, and the installation of a leakproof containment device or the refurbishing of the catchpit.

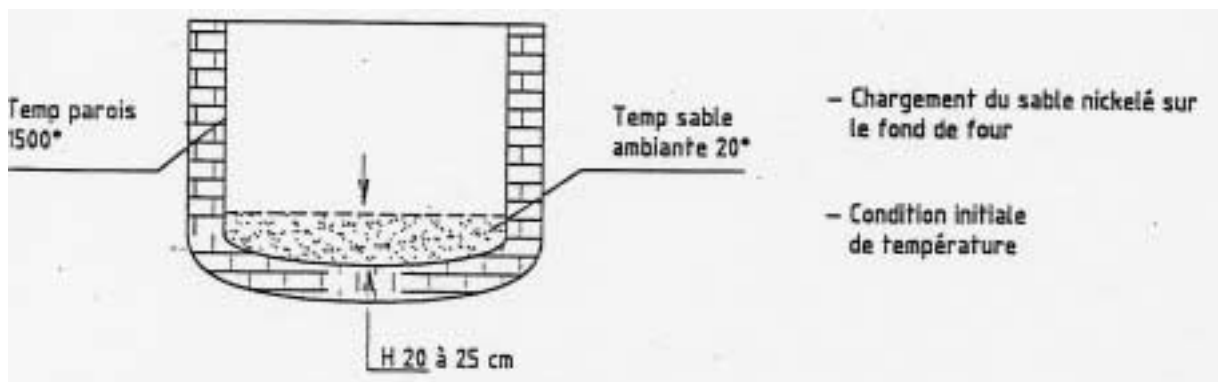
Start of the operations : t=0

🔗 The analysis of the causes concludes that the loading method (nickeled sand in the bottom of the furnace) which was the origin of the accident.

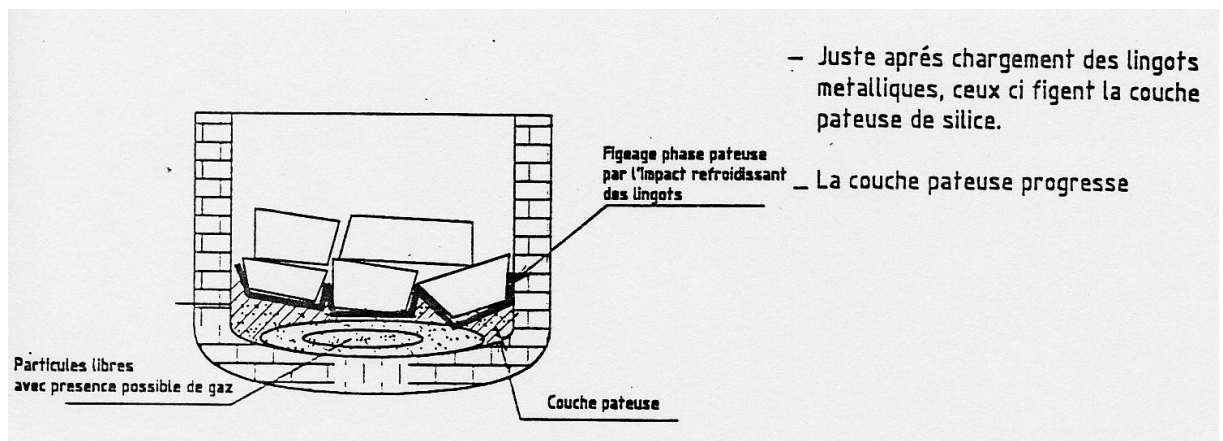
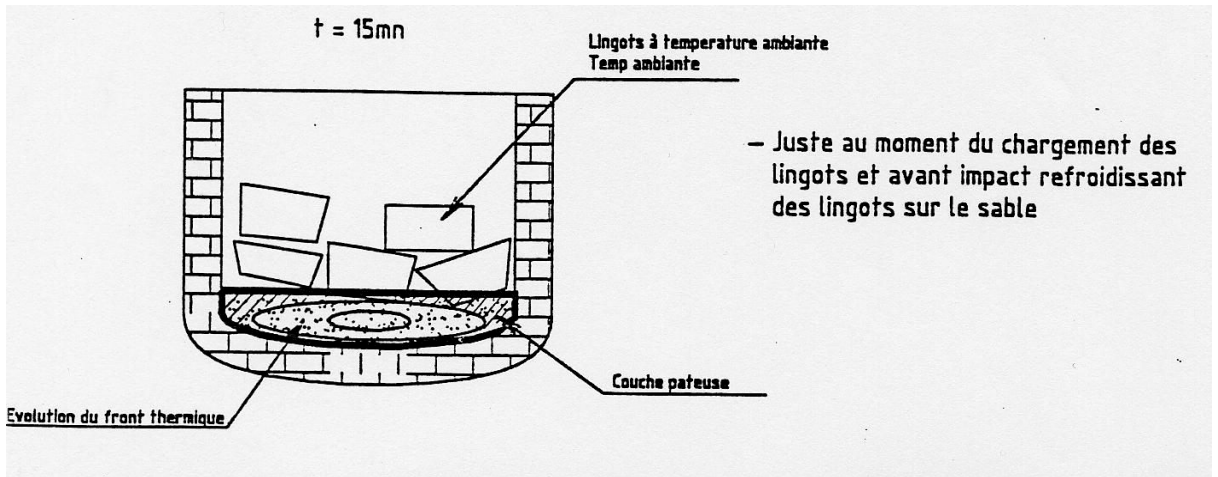
Loading of the ingots moment t

Thermal impact of the loading of the metal ingots

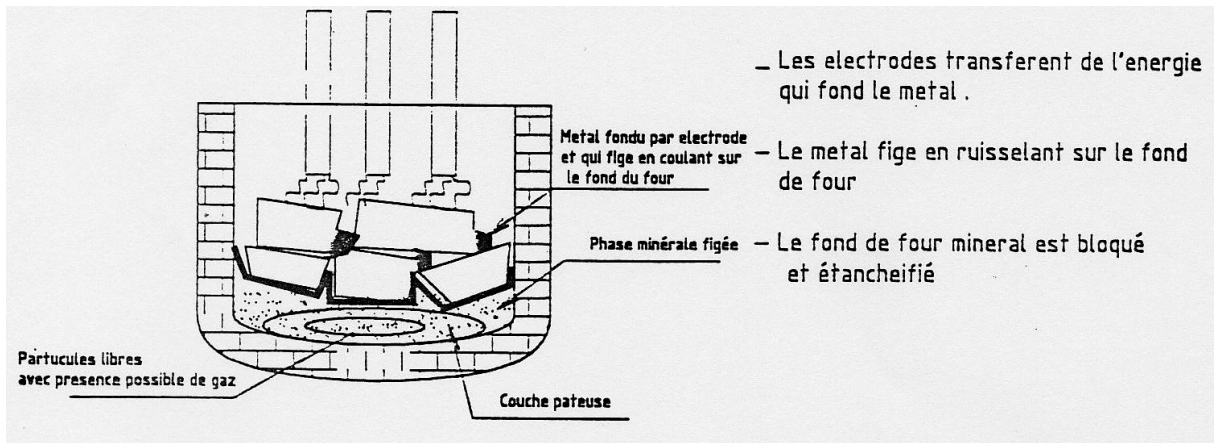
Fusion start of the metal ingots  $t=15min+x$

🔗 While the load remaining in the furnace was melting after the accident, melting difficulties and rapid temperature increases to 1,700° C followed by abrupt drops to 1,550° C were noted. The temperature rise/drop phenomenon was noted 2 to 3 times. This phenomenon is interpreted by the dissolution of unmelted products in the bottom of the furnace and their rise to the top.

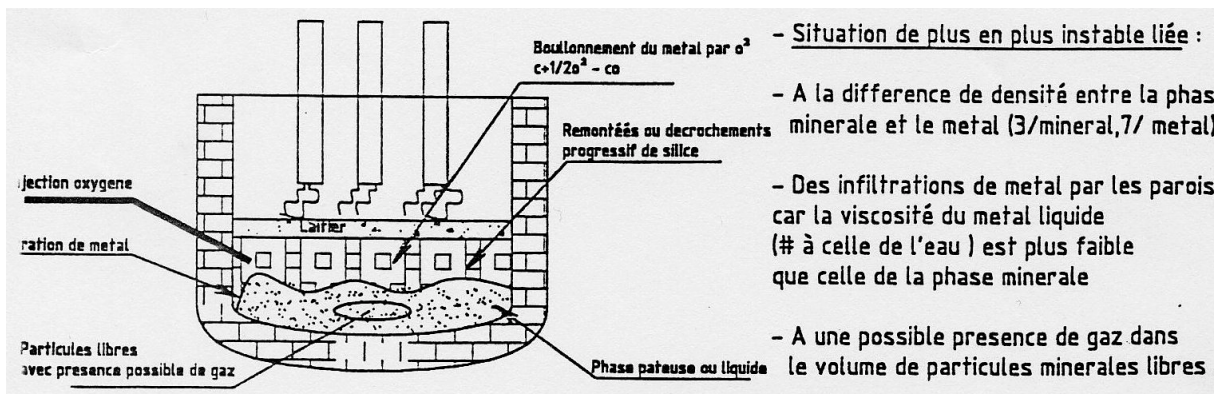
Furnace situation, melted metal ( $t+15min +40min$  : injection d'oxygène et  $t+15min+45min$  : metal fusion)
