# Welcome address

# **Opening address**

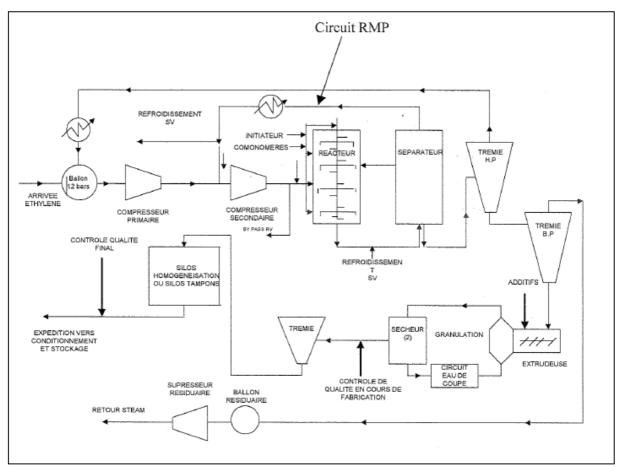
Figure 1: Simplified diagram of the process

A simplified description of the reaction is as follows (see figure 1): the ethylene undergoes polymerisation in a reactor pressurised between 1,000 and 2,200 bar and at temperatures ranging from 150 to 300 °C. The pressure is controlled by a valve located at the outlet of the reactor; this valve also is used to extract the reagent / polyethylene mixture. The mixture is then directed to the separator of the Medium Pressure Return line where it is separated into two phases (approximately 20% polymers and 80% ethylene as the conversion rate of the reaction is in the order of 20%). The polyethylene drawn from the lower part is then conveyed to the high then low pressure hopper. The ethylene is also conveyed with the polymer phase.

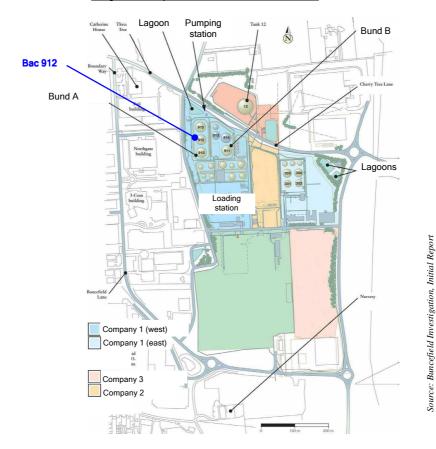
Diagram 1: Layout of the Buncefield Terminal

The Buncefield oil storage depot, Great Britain's fifth largest storage site, is located 40 km north of London near the town of Hemel Hempstead, in Hertfordshire County. It typically stores 150,000 tons of fuel (gasoline, fuel oil, kerosene) for a total capacity of 273,000 m³. This depot has the distinction of supplying kerosene via a pipeline to London's Luton and Heathrow Airports, the latter being Europe's biggest and busiest. These two sites have also implemented backup supply channels.

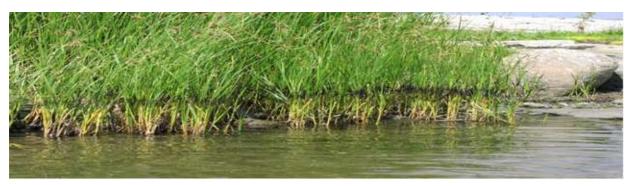
Environmental consequences of the spill of heavy fuel oil in the oil harbour.

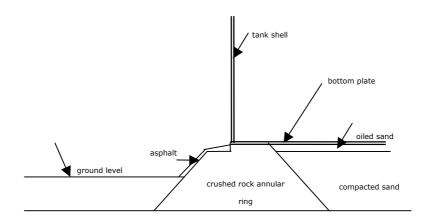
Figure 2: Schematic view of the tank foundation

The foundation of storage tank D2 consisted of a crushed rock annular ring. The rocks had a diameter between 50 mm and 150 mm. The crushed rock annular ring had a height of approximately 120 cm of which a part was below the ground level. The crushed rock ring had a width of approximately 340 cm at the bottom and 100 cm at the top. The shell was situated in the middle of the width of the crushed rock ring. The inner part of the annular ring was filled with compacted sand. Above this sand there was a layer of 5 cm consisting of oiled sand, to avoid external bottom corrosion. Figure 2 provides a schematic view of the foundation of storage tank D2.
