# **Lessons learnt from industrial accidents**

Seminar in Paris - France

3-4 June 2009

**Final Project Report**

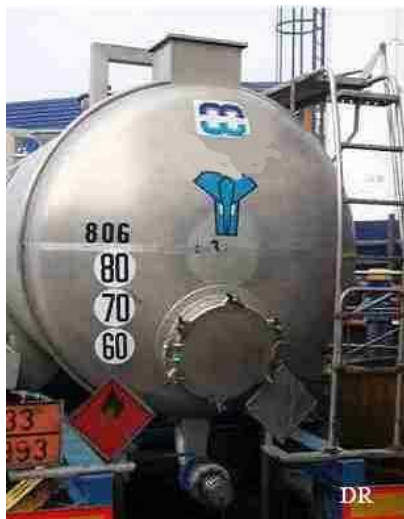
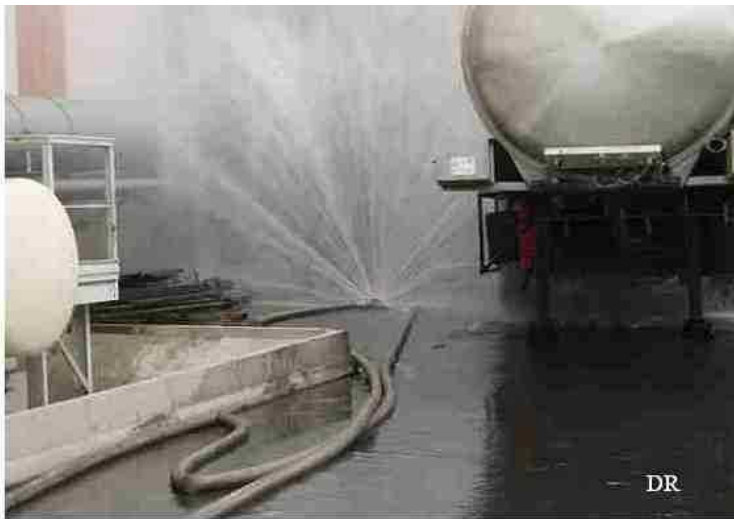
At the same time, 2:30 pm, the internal tanker truck pressure rose and the manhole located on the back face of the truck broke open. The truck degassed all at once; then, both the truck and tractor were propelled some fifteen metres due to the effect of this pressure burst and came to rest when reaching the edge of the track.

**Photographs of the tanker truck and the various spraying set-ups (reconstitution – Source: site operator)**

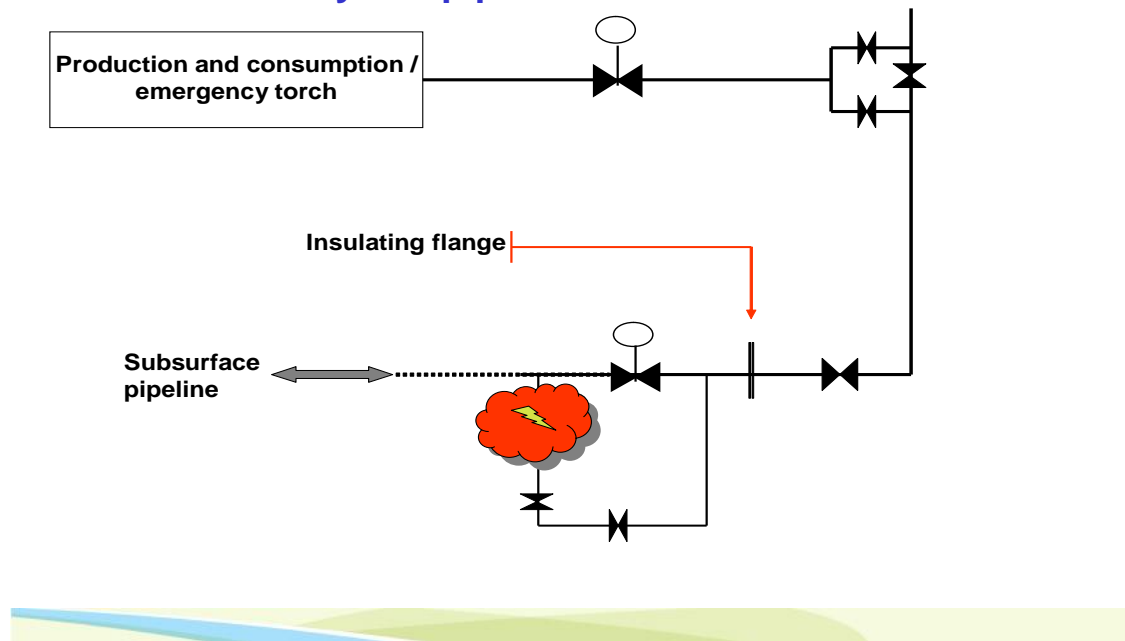
Figure 1: Scheme of the ARG ethylene pipeline at the site.

The accident happened at the blocking station of the international ethylene pipeline owned by a company which is a joint venture of six international chemical companies including the company of the plant. The blocking station is situated at the transition from subsurface to surface course of the pipeline. It is equipped with a remote controlled hydraulic gate valve, an insulating flange and a bypass with manual gate valves (Figure 1). The diameter of the pipeline is 250 mm and of the bypass 80 mm. Ethylene is produced by the company from LDF - light distillate feedstock (light petroleum) - and used for the production of polyethylene. At the time of the accident about 27t/h of ethylene were injected into the pipeline under a pressure of 83 bars. The pipeline is assigned to the German pipeline regulation, the so called "Gashochdrucksleitungsverordnung". Pipelines are excluded from the Seveso directive.

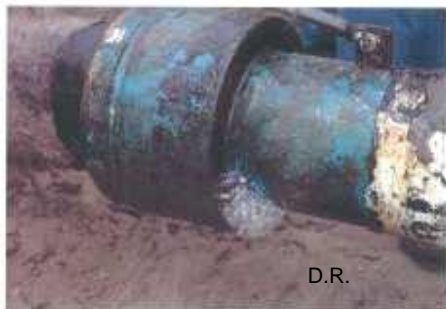
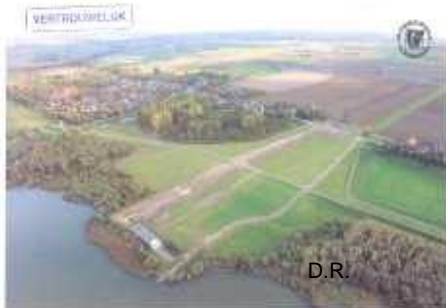
The investigation, as carried out by the Inspectorate of the Ministry for the Environment, has provided evidence that an underground pipeline, in which hydrogen gas is transported, developed a leak resulting in an escape of hydrogen gas. The leakage lasted for at least several hours but it can not be excluded that the leakage started weeks or even months prior to the discovery of the leak.

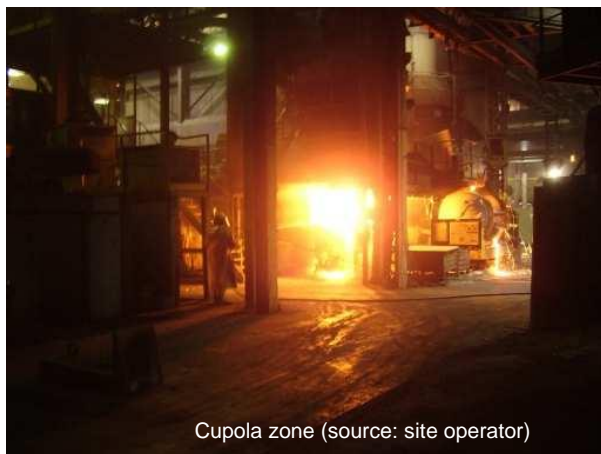
The explosion took place at the time the molten residue was being dropped into the skip.

Cupola zone (source: site operator)

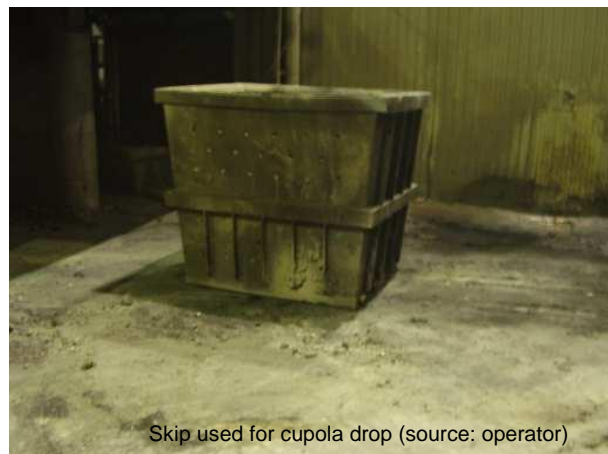
Skip used for cupola drop (source: operator)

→ the technical measures were primarily focused on removing humidity in the metal skip, for the purpose of eliminating the risk of explosion due to contact between residue after melting (cast iron residue) and water, i.e.:

- ✓ acquisition of three skips so as to better manage equipment utilisation and ensure sufficient drying time for the refractory cement (36 hrs). Skip labelling was also introduced;
- ✓ storage of this containment capacity at a site protected from water;
- ✓ drying of the skip intended for daily cupola drop using a gas burner;
- ✓ placement of a bed of black foundry sand at the bottom of the skip to both eliminate all eventual traces of residual humidity and provide additional protection at the skip bottom.

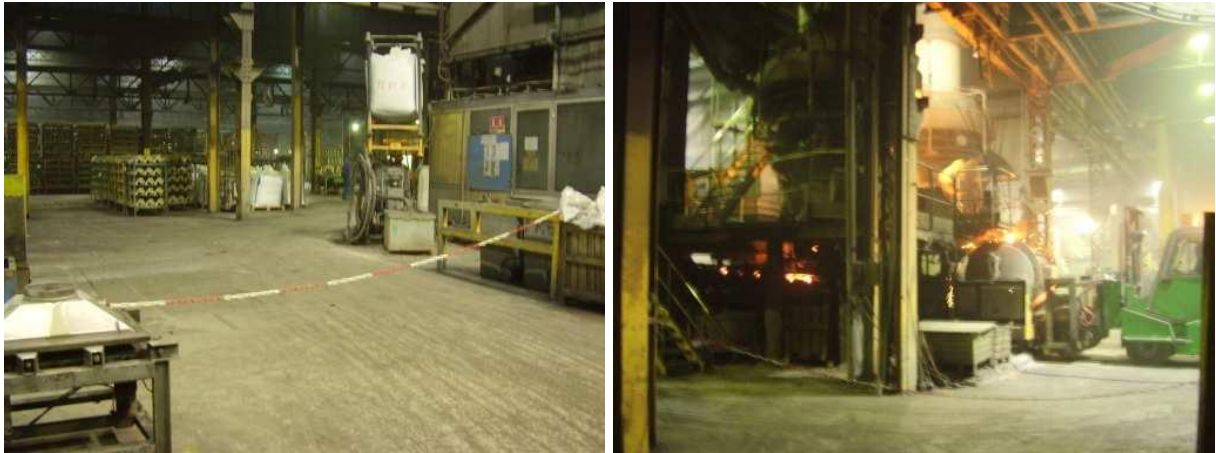
Delimitation of the protection zone (source: operator)

- ✓ clearly identifying the protection zone by demarcating a boundary around the cupola furnace;
- ✓ installing a sound alarm designed to notify personnel during the cupola drop period;
- ✓ designating a cupola drop supervisor with the responsibility to trip the alarm and ensure that the protection zone is always free of any unprotected or unauthorised individuals;
- ✓ revising operating guidelines and appointing a Head of Operations, who among other things is to verify that the refractory cement lining the skip is well dried;
- ✓ updating, in conjunction with employees, the list of individual protective gear (by occupation or by workstation) to be worn: helmet with a face shield, safety jacket and aluminised gloves, and appropriate pants;

- ✓ scheduling of evacuation drills to allow personnel to become acquainted with the alarm system and other onsite safety features.

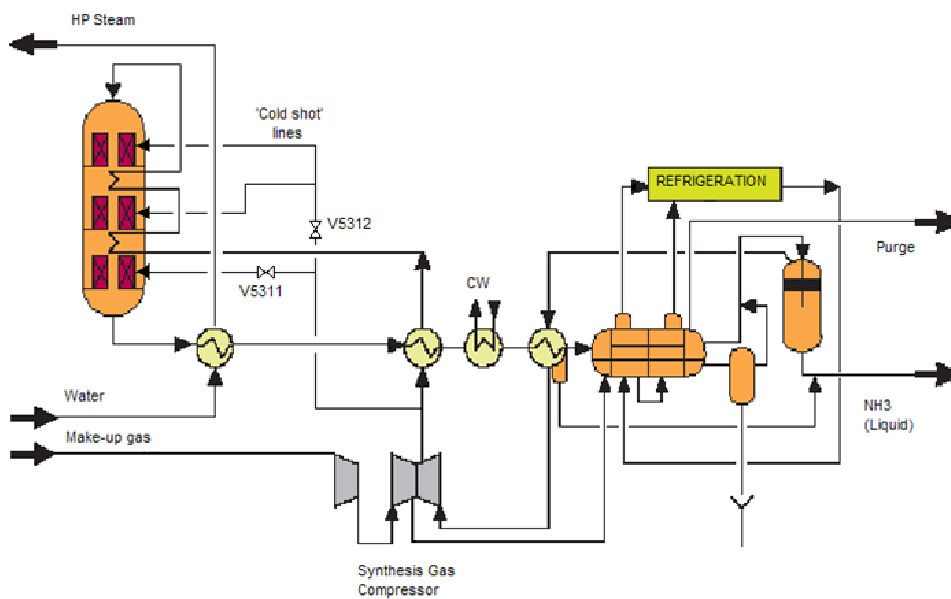
Figure 1 - Ammonia Synthesis

The unit involved in this accident was the ammonia synthesis column.

Around midnight on the night of Wednesday June 1<sup>st</sup>, 2008, an extremely flammable leak of a so-called "synthesis gas", containing primarily hydrogen, occurred on valve V5312 within the ammonia synthesis column. The gas, released at a pressure of 220 bar and a temperature of 120°C, ignited spontaneously, forming two flame cones directed along the pipe connected to the valve. The pipe could not resist the heat from these flames; and under such internal pressure, it burst in freeing its contents, which in turn exploded. The quantity of gas released during the accident was estimated at 1.45 tonnes. The gas continued to burn for more than two hours, given the quantities found at the site when the fire broke out.

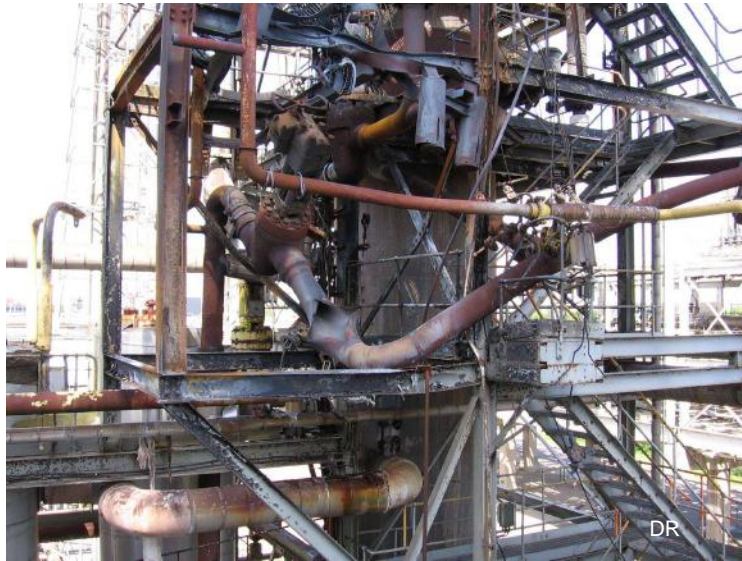
The consequences of this accident however remained confined to the zone adjacent to the valve.

The accident happened during a period of limited activity, with just one team of four technicians and a supervisor present in the unit. When the fire was detected, two technicians left the control room to isolate the valve. The pipe actually burst while they were still performing this operation. The pressure surge generated by the explosion was strong enough to knock one of them to the ground and send debris flying, a piece of which struck and slightly injured the other technician.

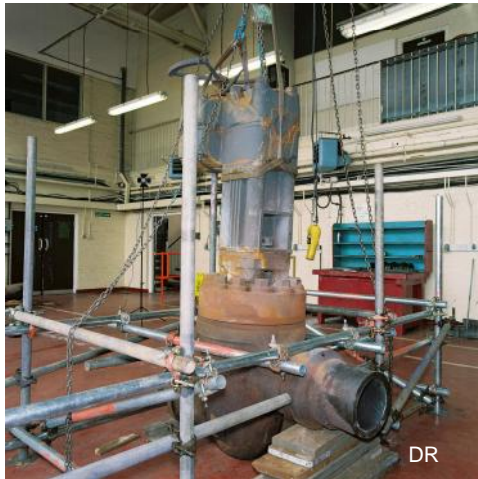
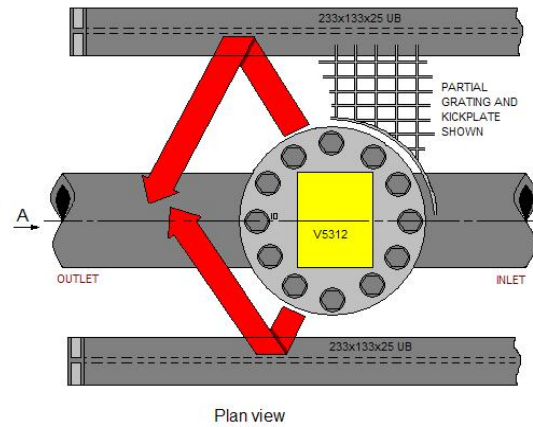
This accident was caused by a gas leak on the joint between the body and cap of a shut-off valve [V5312] on a pipe transporting synthesis gas. The valve, in the open position, was operating at full flow. The seal between the two parts, held together by 12 bolts, was applied to a metal-on-metal contact. Inspection of the valve indicated that gas had leaked in two spots prior to ignition, meaning that two distinct flames were produced.

Given the layout of the structure's metal frame, one of the flames actually "ricocheted" off the side and reached the pipe on the outflow side of the valve, causing it to heat for some ten to fifteen minutes, before bursting open over a full metre and releasing gas at a pressure of 150 bar.

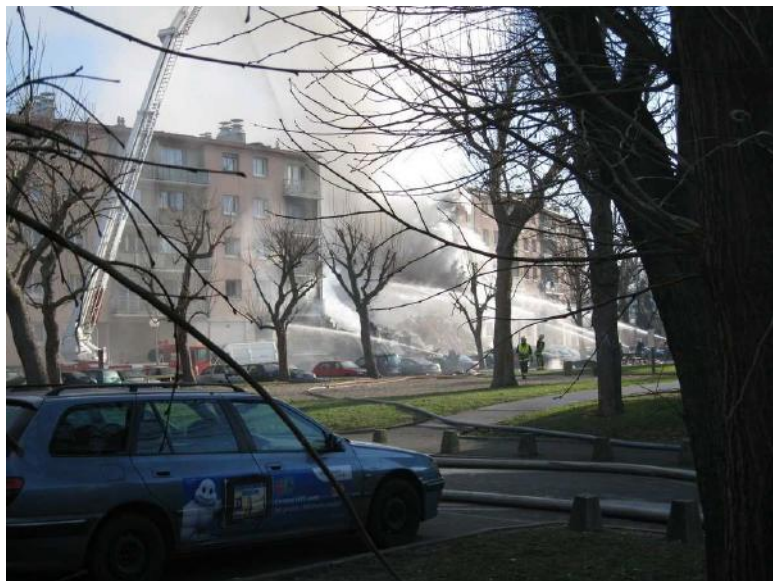
Fire-fighters were heavily challenged to extinguish the fire that broke out following the two explosions. Of the entire housing block, both the central and right parts were totally levelled and burned. All building residents had to be relocated to alternative housing.

The window panes of buildings lying just opposite as well as those of a neighbouring school (empty at the time) were shattered.

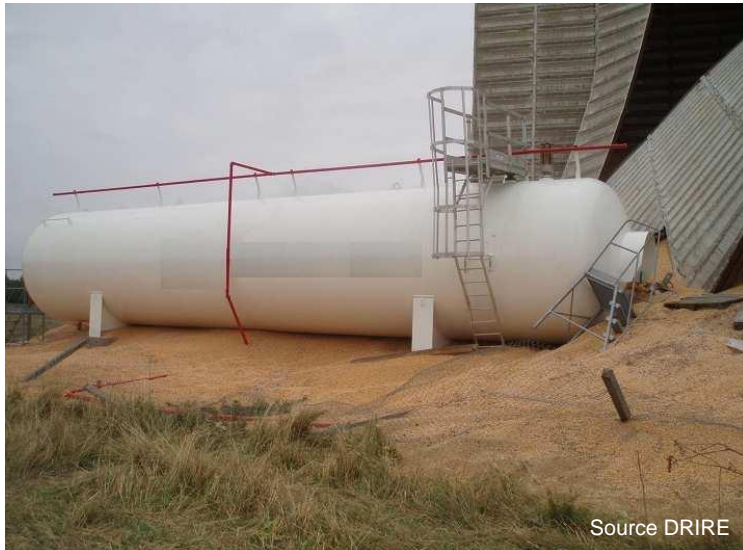
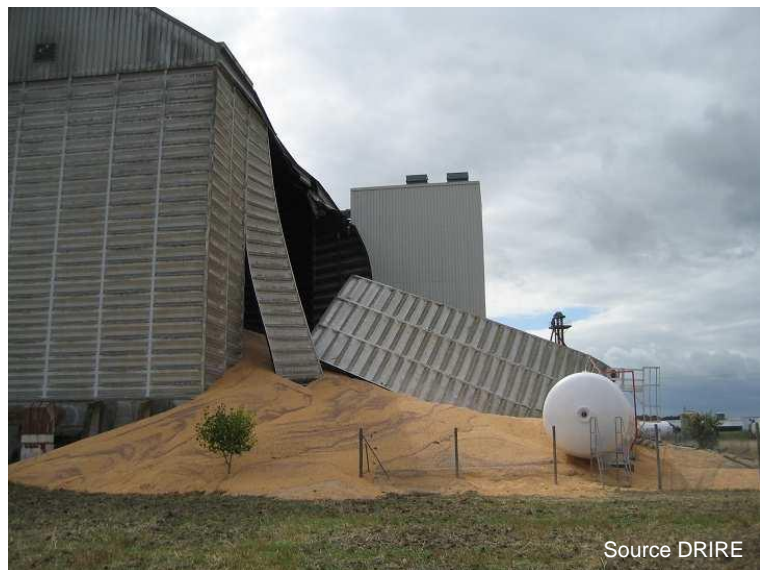
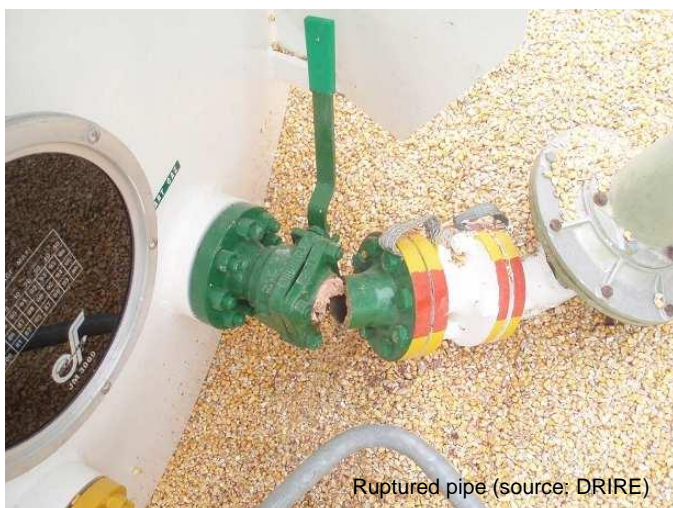
Only property damage was declared; no impact on the personnel, third parties or the environment was observed.

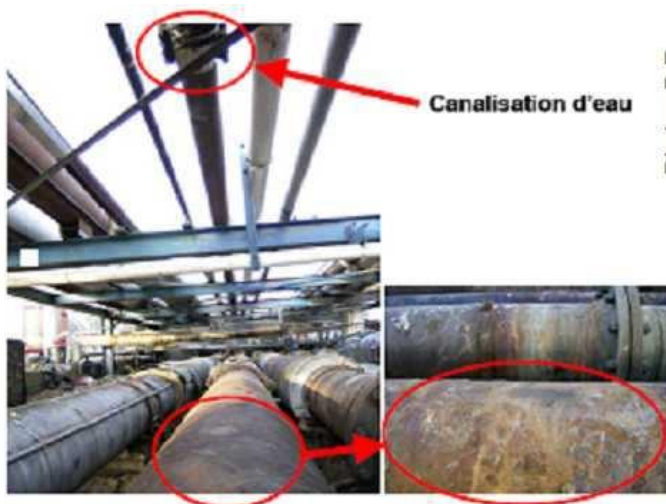
The defective pipe, 12 inches in diameter and lined with thermal insulation, was included in a group of facilities composed of some 20 pipes on two levels. An examination of the defective pipe section revealed the presence of a longitudinal crack approximately 16 cm long by 1 cm wide adjacent to observed local corrosion underneath the thermal insulator lining. Water flowing from a perforated pipe, positioned vertically with respect to the fuel oil pipeline, infiltrated under the leaky thermal insulation, first causing the steel to corrode and then perforating the pipe.

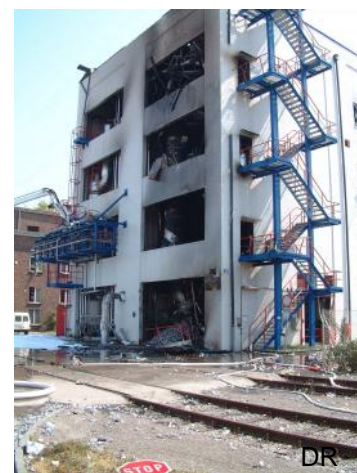
The upper part of the columns are blasted, one column is ripped on 2/3<sup>rd</sup> of its height. The 2 tanks are completely destroyed and their filling (mainly methanol) caught fire. A fireball with a diameter of 80 m is formed over the installations.

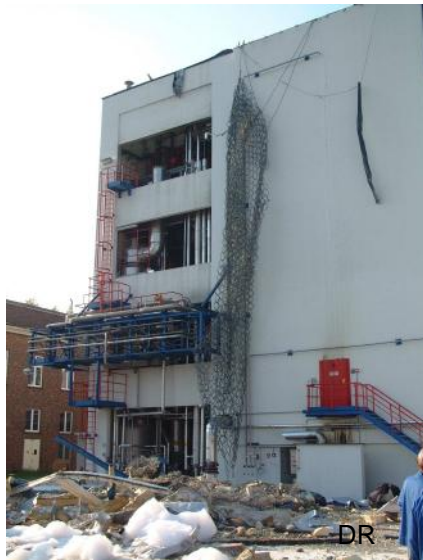
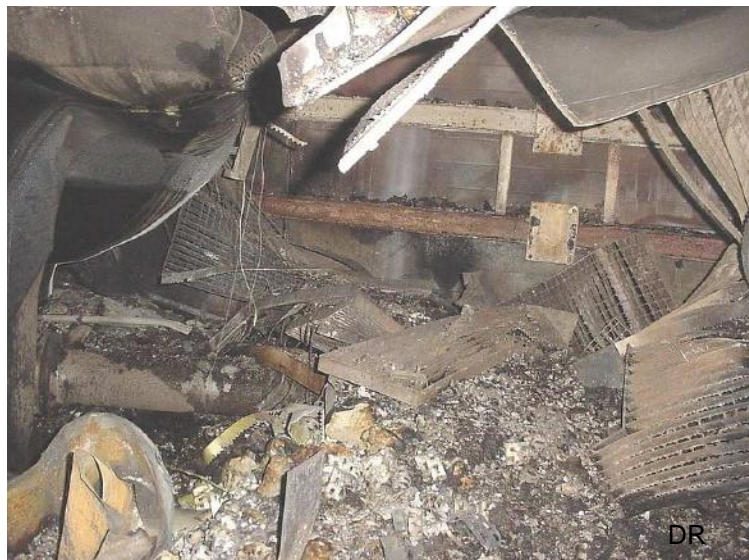
The explosions destroyed the devices in the cold box entirely. There was a big crack in the wall. No one got injured and no building got damaged, but a few broken glasses in the surroundings.

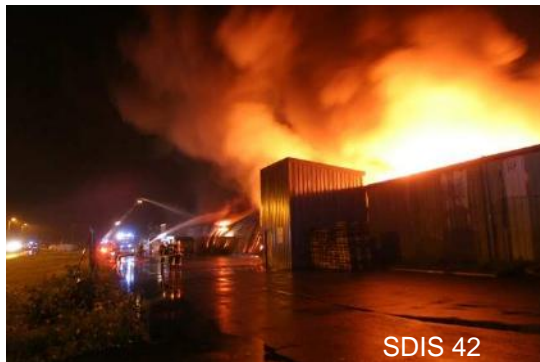
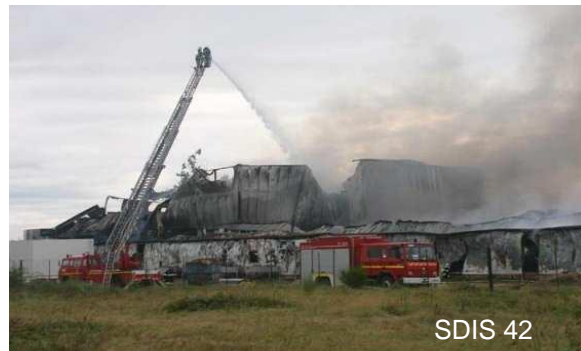
9,000 of the 10,000 m<sup>2</sup> occupied by the facility were destroyed; the loss was particularly heavy due to the considerable presence of combustibles (sugar, flour, cardboard, etc.). The refrigeration installations charged with R404a refrigerant (an azeotropic mix of fluoroethanes, whose thermal decomposition releases highly toxic and corrosive vapours: hydrogen fluoride) were damaged. The two storage silos filled with 60 m<sup>3</sup> of sugar and flour however were completely spared. The accident resulted in no victims, but 120 staff members had to be made redundant. The entire installation would be rebuilt at a cost of € 15 million.

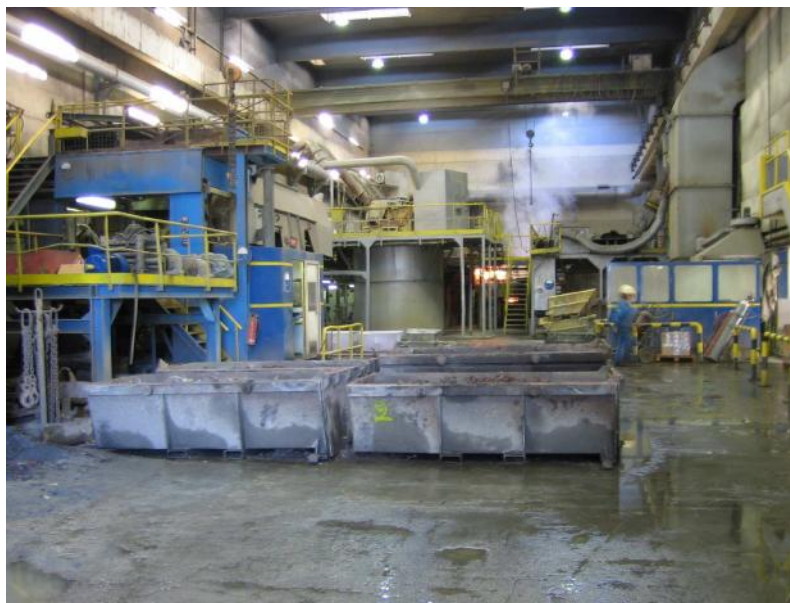
Hot processing (photo IBGE)

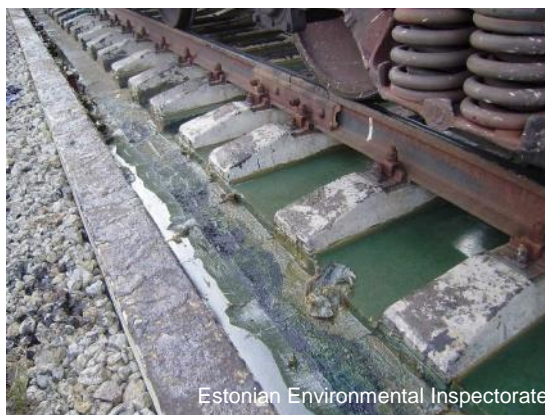
As the inspection on September 12<sup>th</sup> showed there had been recently a leakage of vacuum gas oil during the loading from the railway tank wagons. The railway is built on a reinforced concrete pool that is filled with crushed stone and the rainwater is discharged through a drainage system equipped with oil separators. The pumped rainwater is discharged into the sewage system of the nearby heating station and should reach the Baltic Sea. The system has valves and a well, which collects the oil products that have leaked. These should be pumped out from the well.

Actually for a long period the leaked oil products had not been pumped out from the pool under the railway. Thus, not only the recently leaked vacuum gas oil, but also significant amount of previously loaded shale oil reached the ditch running towards the sea.

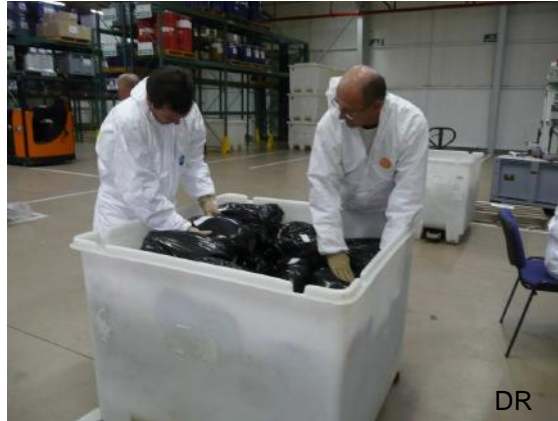
*Preparation of wet documents in plastic bags for cryogenic treatment*

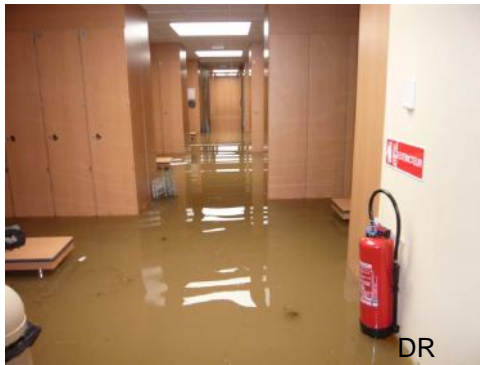
*Changing rooms during flood*

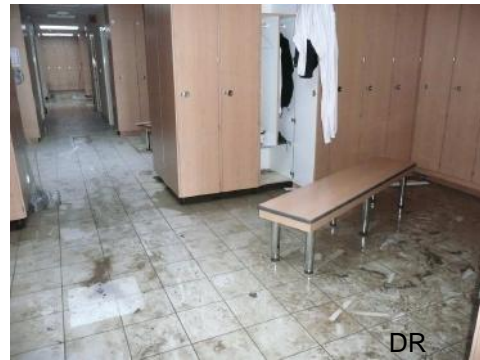
*Changing rooms after flood*

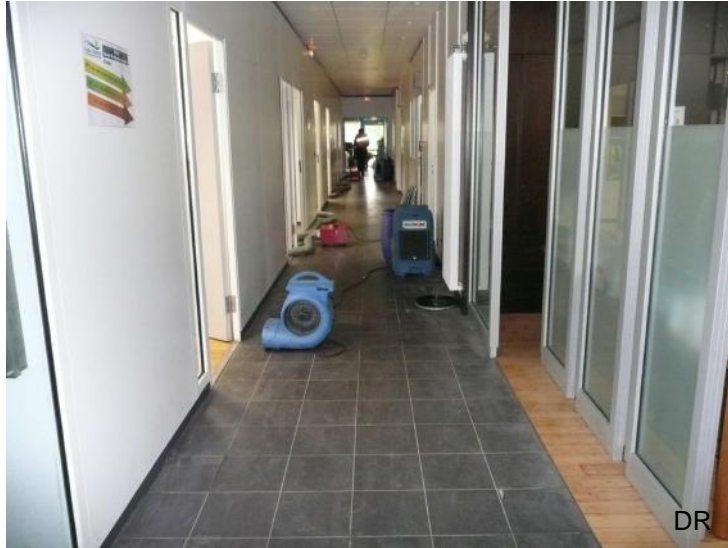
*Drying and dehumidification of premises after cleaning and disinfection*

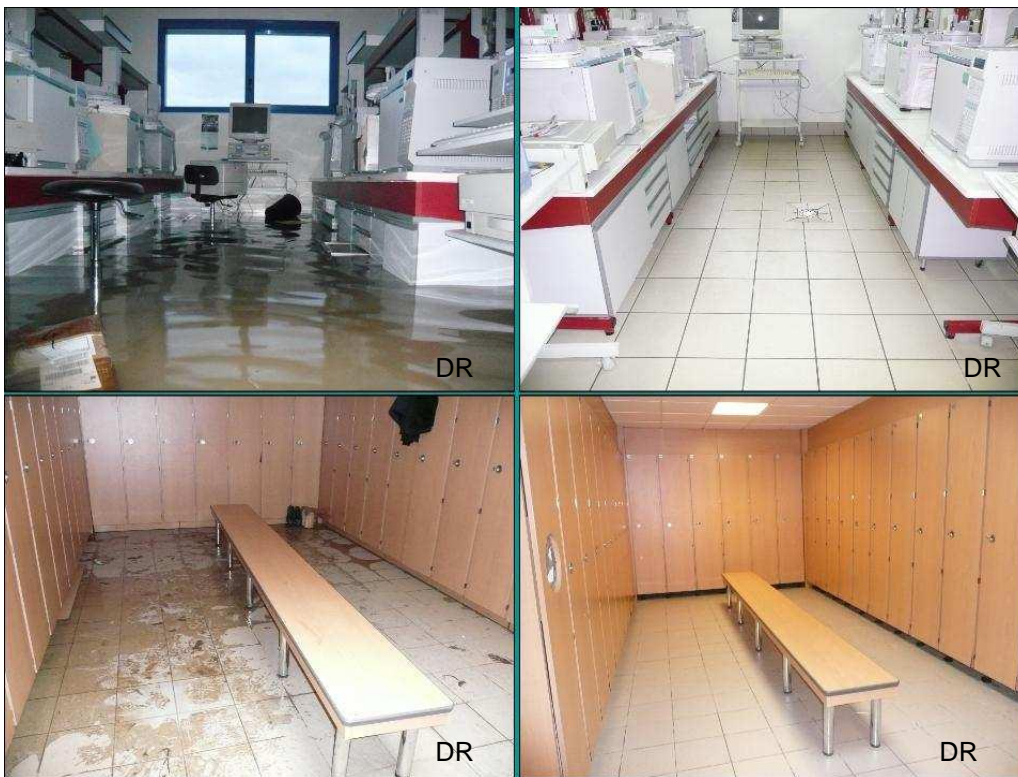
***Quick overhaul of facilities (drainage of water, cleaning, drying, tidying up)***

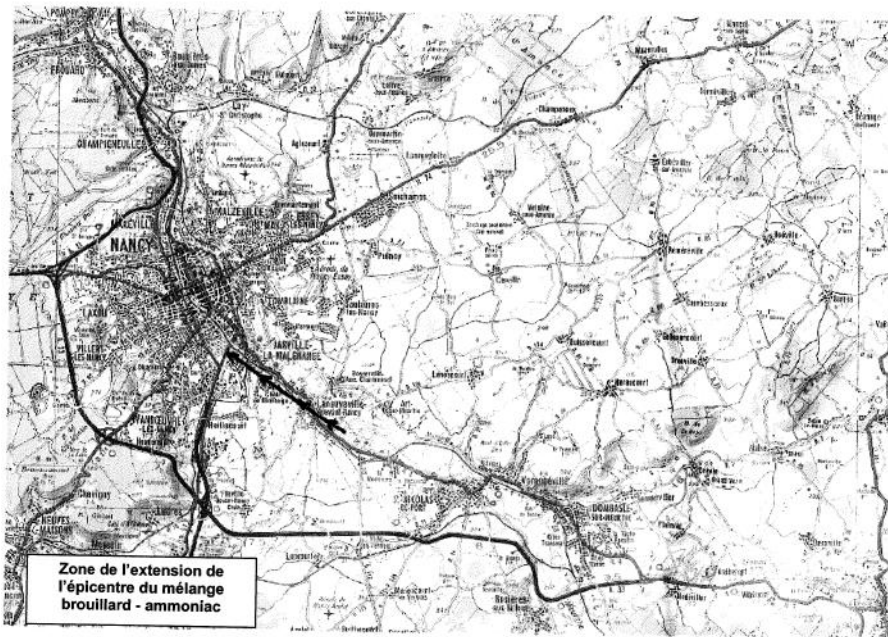
Once the gypsum clog had been removed at 6:50 pm, the effluent discharge pump was placed back into service. Insufficiently-distilled ammonia water kept being channelled to the settling basins for some 15 minutes before this anomaly was detected, sometime around 7:05 pm. Since the transit time for this volume of ammonia water (45 m<sup>3</sup> at a concentration of 22 g/l) through the plant's collector pipes heading to the basins equalled roughly 30 minutes, the polluted water overflowed at the level of the settling basin between 7:20 and 7:35 pm. The hot water from the column spread across the basin's 23-ha surface, above which the ammonia vaporised.

Given the meteorological conditions at the time (no wind, below-zero temperatures, high humidity) along with the inversion phenomenon caused by nightfall, the vaporised ammonia was entrapped by a thick fog layer several tens of metres high. The measurements taken by fire-fighters indicated that the air mass then shifted in a north-westerly direction, between 7:20 and 10:00 pm, with concentrations at the cloud centre dropping from 30 to 12 ppm. These concentrations were maintained throughout the cloud; moreover, during the entire incident, concentration levels remained less than the irritation threshold and considerably below the irreversible effect threshold.

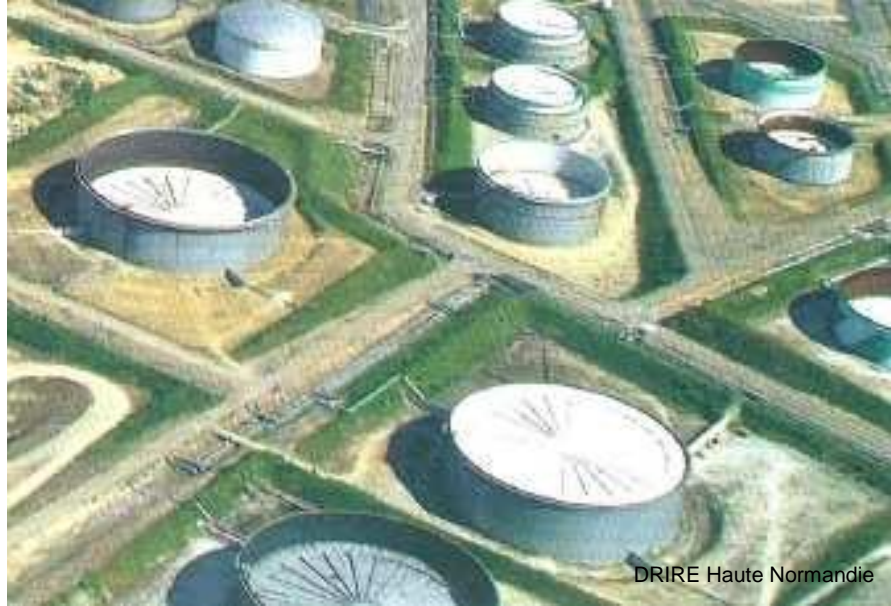
## Floating roof

### ① Accidental discharge of gaseous hydrocarbons

While awaiting the final results of investigations performed at the time the roof was disassembled, the initial findings released by the operator tend to support the hypothesis of a loss of flotation capacity due to overload caused by both the accidental filling with crude of a leaky caisson and the accumulation of rainwater on the roof. The foot valve on the rainwater discharge trough had been closed, subsequent to the detection a few months prior of hydrocarbon leaks inside the discharge drain.

Renewed use of the tank following repairs has been scheduled for the end of August 2009.

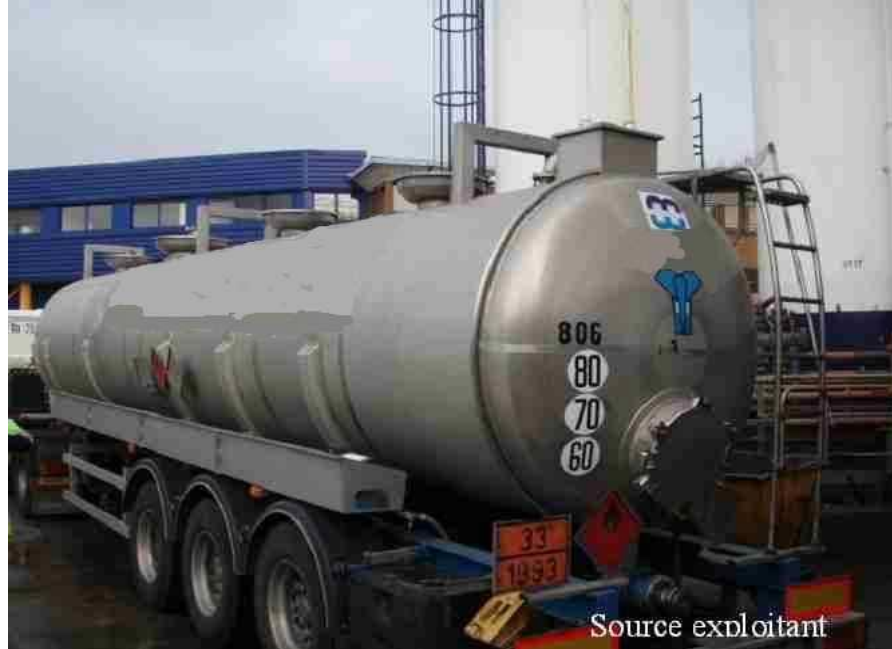
## Transport of waste in tank trucks

### ② Accident involving a tank truck transporting waste

In an industrial waste treatment centre, the cover of a manhole on the back face of a tank truck ruptured due to overpressure resulting from the decomposition of the waste contained in the truck. The tank degassed abruptly. The truck moved 15m forward and the cover was projected onto the siding of a hydraulic plant. The tank truck and the waste dispersed in the surrounding area were sprayed with water for 30 min to bring their temperatures down. The operating staff was evacuated from the accident zone and the administrative staff required to stay indoors. The water used to cool the tank and the waste was collected. An employee of the site sustained partial burns on his foot.

The waste responsible for the accident was a mixture of 30% hydrogen peroxide and 5% resin acids. The accident resulted from a transfer error that occurred on 29 May 2007 in a paper mill where the waste was produced. The waste was received in the treatment centre on the day before the accident for incineration. The operator faced problems in extracting the waste from the tank and observed a rise in the external temperature and internal pressure in the tank. The tank was sprayed with water from 8.30 am. Water curtains were used around 12.30 pm and finally fire nozzles at around 1.30 pm. The abrupt degassing occurred around 2.30 pm.

The analysis of the accident shows several failures: shortcomings in the waste acceptance process, transformation of the waste between the time of transmission of sample by the customer and reception of waste in the centre, no checks on temperature for manholes and vents on reception of the tank truck, etc.

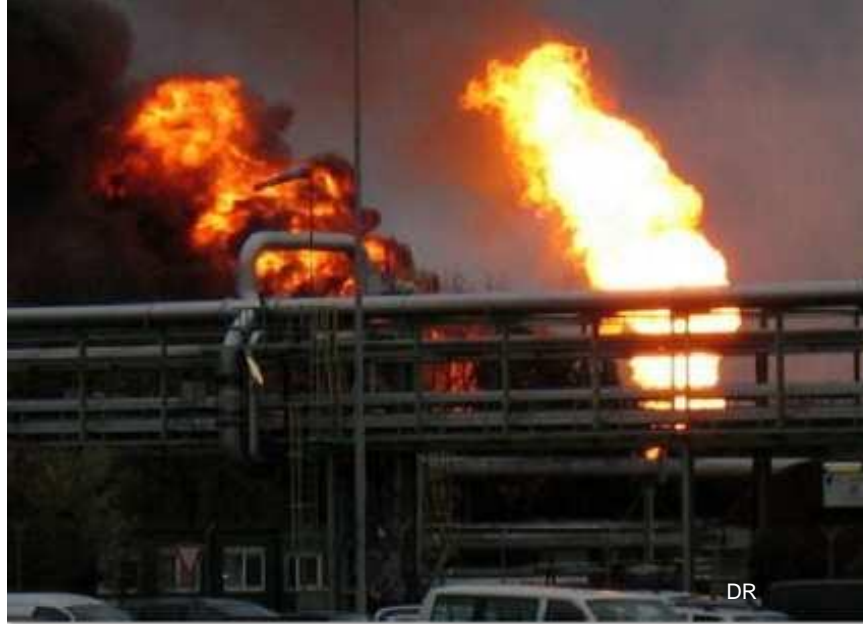
## Domino effects

### ③ Ignition of an ethylene leak on a pipeline

Ethylene contained in this 11 km section of the pipeline was at 80 atmospheres. A massive 30 m high flame was observed. The intense heat flow effected an aluminium tank containing acrylonitrile that was 10 m away. Even though the container was protected by a concrete wall, the acrylonitrile boiled and evaporated. Given the temperature, the container itself was “burning” and risked collapse. The fire-fighting operations became complicated but the blaze was brought under control in the end. However, half of the container was burnt. Material damage was significant but no casualties were reported.

Further to this accident, two expertises put forward several recommendations on improving the safety of pipeline tie-ins, as well as on the minimum distance to be maintained between inflammable gas pipelines and tanks containing inflammable liquids. The local authorities implemented an inspection schedule for transport pipelines of similar configuration implanted near SEVESO sites. The possible application of these recommendations may lead to new inspections, updating of safety reports and adaptations to meet new requirements.

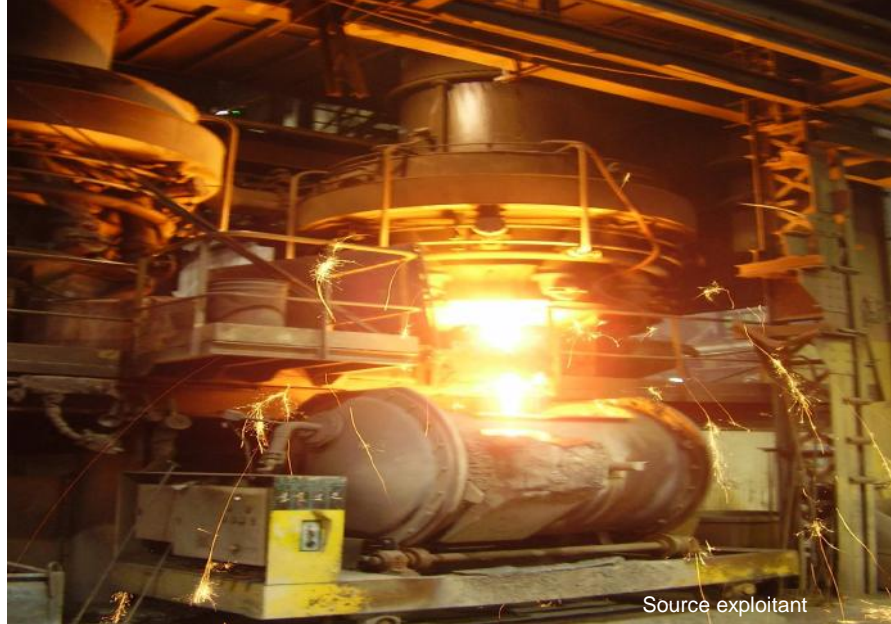
## Explosions involving water and molten metal

### ⑤ Explosion in a cast iron foundry

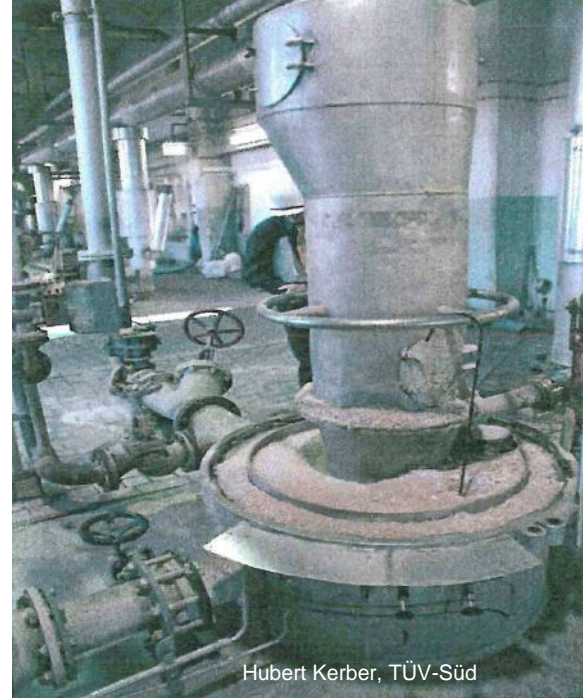
## Disturbance in power supply

### @ Accidental release of toxic emissions following a power cut

The consequences of the accident were reduced by the fact that a sufficient pressure level was attained to maintain the sealing device in place and a technician had the reflex of switching over the facilities to the "self-sealing" phase. The investigations that ensued after the accident revealed a lack of awareness on the vulnerability of electrical facilities especially with regard to the ripple effect of failure.

The remedial action taken by the operator included modifications in the reactor sealing system by replacing water with nitrogen to maintain the pressure, modification in the SO<sub>2</sub> alarm system. The site's safety management system was modified to take into account the lessons learnt from this incident.

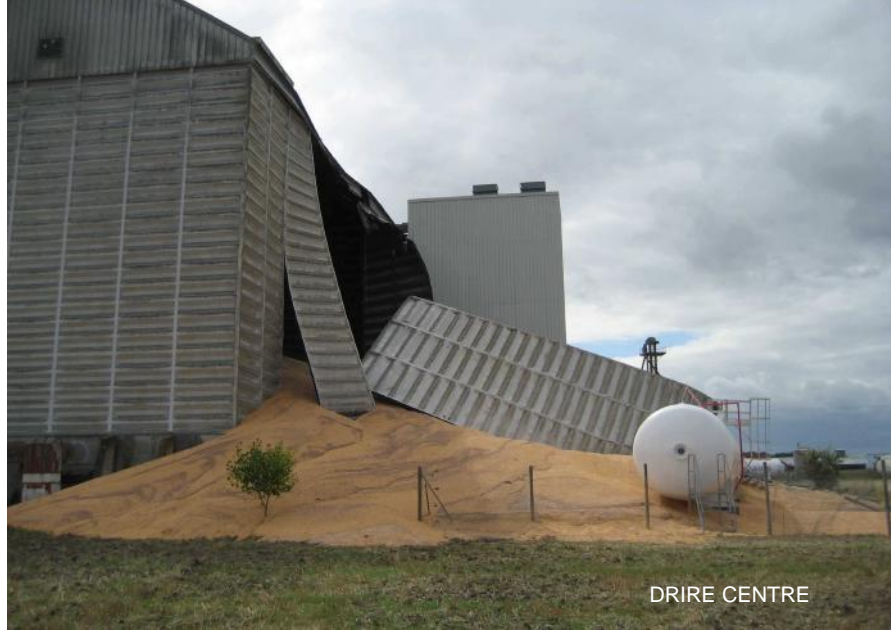
## The effects of time on industrial facilities

### ⑩ Rupture of a silo causing a release on a propane tank

2,100 tonnes of wheat and 1,000 tonnes of maize spilled over to the ground at around 1.30 following the rupture of the walls of a 14,900 m<sup>3</sup> "sheeting pile" silo built in 1989 and comprising 6 square storage bins (4 x 3 000 m<sup>3</sup> + 2 x 1 400 m<sup>3</sup>) as well as two 66 m<sup>3</sup> grain loading hoppers. A 95 m<sup>3</sup> propane tank situated at about 15 m from the silo and supplying the grain dryer was partially buried due to the spilling of the grains causing a pipeline to break and LPG to leak. The emergency services set up a safety perimeter (150 x 300 m) and stopped the leak by closing the valve located just before the rupture area.

The owner of the tank secured the container by emptying it and burning the gas using the flare network. The operation started at 6.00 pm and ended the following day at 5.00 am. No casualties were reported. An emergency prefectural order recommended measures to secure the site and mainly stop all activity, shut down and monitor the premises, empty the cereal silo and inspect its condition. The re-commissioning of the silo was subject to a prefectural decision.

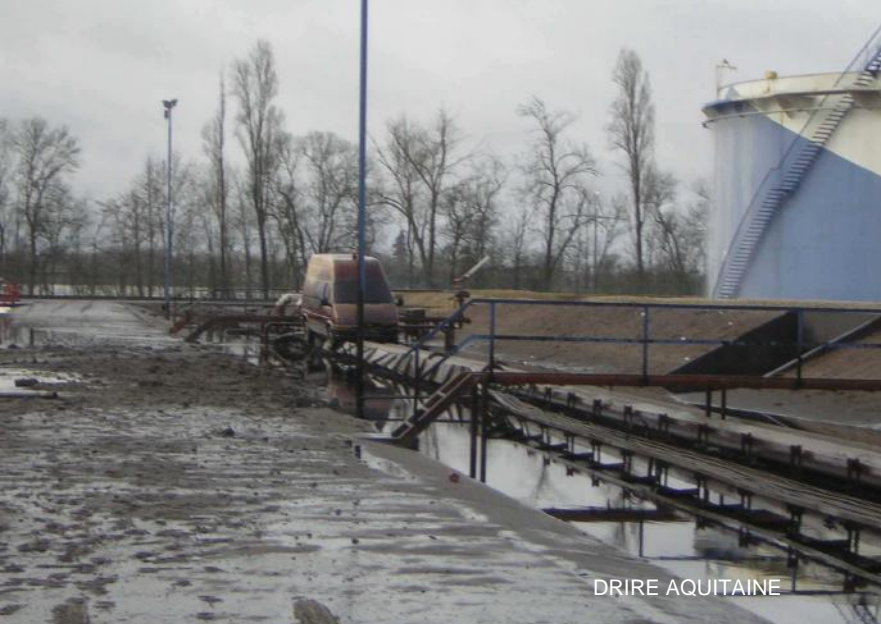
## 12 Rupture of a crude oil storage tank

The bottom of a 13,500 m<sup>3</sup> containing 12,000 m<sup>3</sup> of light crude oil tank ripped open at 8:00 am within an oil depot. The earthen dikes surrounding the retention basin withstood the wave effect; 2,000 m<sup>3</sup> of oil still overflowed however the dikes. For the most part, this volume remained onsite and in the gutters, although 50 m<sup>3</sup> reached the channels of the neighbouring swampland polluting 2 km of ditch network and reaching the superficial water table and 50 m<sup>3</sup> did flow into the GARONNE. The tidal action contributed to polluting up to 40 km of banks on the GIRONDE, DORDOGNE and GARONNE Rivers. The operator triggered the internal emergency plan and covered the retention basin with foam

in order to prevent against the risk of inflammation and limit hydrocarbon and hydrogen sulphide (H<sub>2</sub>S) vapour dispersion. The authorities evacuated all 12 employees of neighbouring companies, established a safety perimeter, halted river navigation and traffic on the road and railway in the area, informed local populations and the nearby power plant, and measured the air quality. The products spilled into the gutters and retention basin were channelled towards the facility's sedimentation basin and then transferred into empty reservoirs: in all, 6,000 m<sup>3</sup> had to be pumped out. The operator undertook pollution cleanup efforts (manual collection, dams, pumping, absorbent materials, use of dispersants, etc.) under the supervision of experts. Environmental associations and hunters don't notice significant impact on fauna. The products and wastes were disposed of in specific installations. Groundwater was also controlled. A total of 13,000 m<sup>3</sup> of fire protection water charged with emulsifier (COD: 2.7 g/l) was stored prior to undergoing an activated sludge type of treatment onsite by means of extended aeration. Operation loss is estimated at more than 50 M euros. A slight leak on the tank had been detected the previous day at 5:00 pm. The operator rescheduled at the following day in the morning the drainage into another tank due to the risks incurred by the operators and subcontracted personnel by having to block the tank's floating roof at night. Water was injected at the bottom of the tank for the night. A control of the tank bottom in 2006 (on 100% of the bottom and 10 % of welding) mentioned the presence of corrosion on the tank bottom as well as losses of thickness reaching 80%. As a consequence, repair work had been performed and then verified. Moreover, the inspection report noted that no procedure had been outlined for managing the type of emergency situation that appeared the day before the tank failed. This accident raises a number of questions about prevention means (conception: bottom, settlement; controls of the tank: frequency, modalities ...), measures to take when a leak is detected (emergency procedure, emergency storage, drainage ...) and protection devices against wave effects. A legal investigation was carried out.

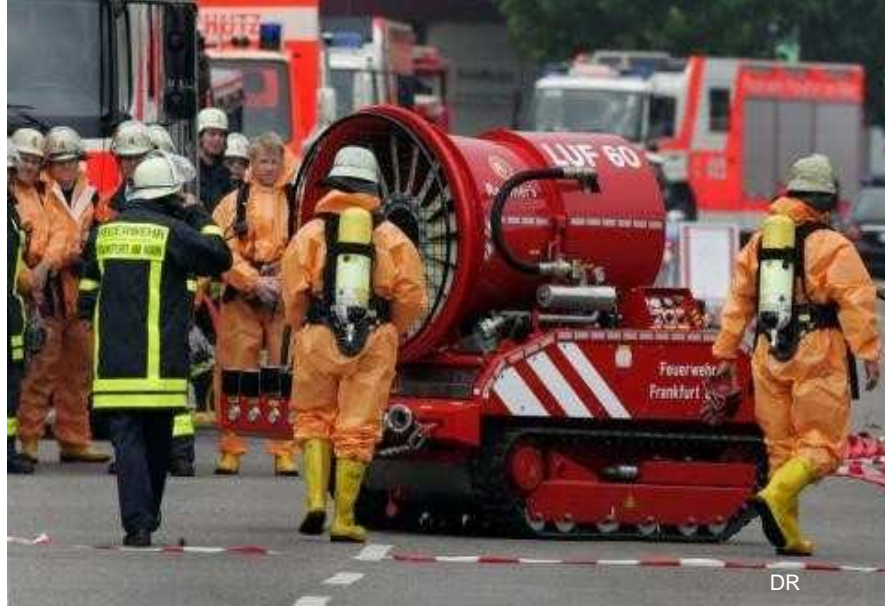
### 17 Accidental generation of chlorine in a company trading in chemicals

The accidental mixing may suddenly result in the production of significant quantities of toxic or inflammable gaseous reactants or corrosive projections and even lead to the damage or destruction of the container due to either a significant rise of temperature of the liquid or accelerated corrosion.

A tanker truck carrying 2 tonnes of aluminium chloride was emptied into a tank containing 11 tonnes of sodium hypochlorite. The driver came for delivery outside working hours and was misguided by the security guards. The mixture caused chlorine to be released. The emissions poisoned 46 employees, six residents and 58 employees of neighbouring facilities who were taken to 11 hospitals. 230 families were evacuated for 7 hours. The chlorine cloud impacted a surface of 4 km<sup>2</sup>.

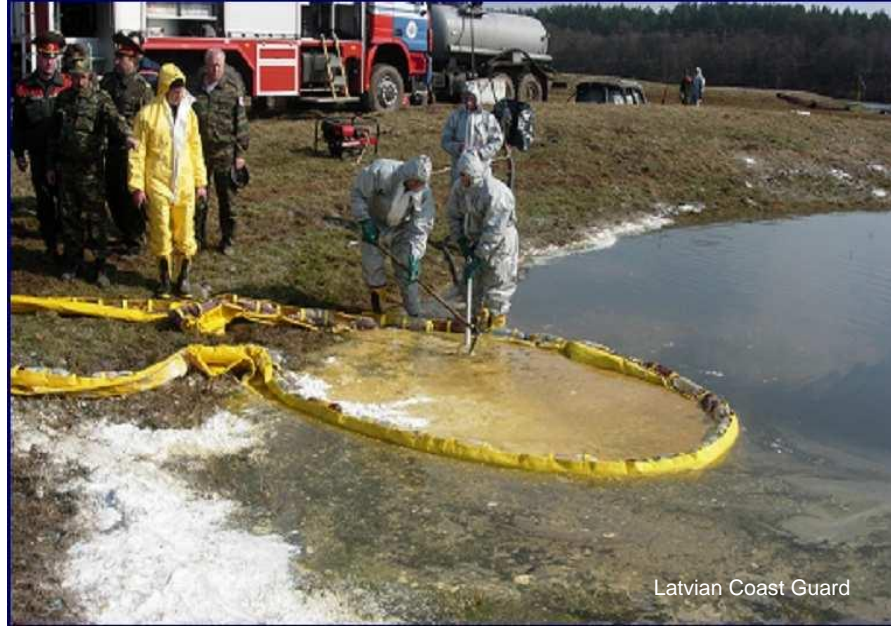
### 18 River pollution with transboundary effects

In Belarus, a leak was detected in a 377 mm diameter pipeline carrying gas oil causing 120 tonnes of hydrocarbons to be spilled in the DAUGAVA river for 5 hours. The emergency services contained the most of the gas oil at the source except 4 tonnes that managed to pollute the largest river of LATVIA, a tributary of DAUGAVA. The slick travelled at a speed of 2.5 km/h. The Latvian authorities were informed the following day and the pollution has already reached the country on 26/03.

The Latvian emergency services tried to install oil booms at the border but were unsuccessful due to the strong river current and the soil instability. The rescue work was further complicated by the need to seek special permission to carry out operations in the Belorussian soil. The rescue services installed oil booms over 1,800 m and absorbents over 3,000 m at 50 km from the border, as well as other lines of oil booms at 100 km from the border in a storage reservoir of a hydroelectric plant. These measures allowed the spilled gas oil to be recovered. The Latvian authorities alerted the masses on the pollution and the associated risks of using the river water. The Latvian environmental department regularly analysed the water to check pollution levels in the zone.

Environmental damage in the Latvian territory and the clean up operations were assessed at 170,000 euros.

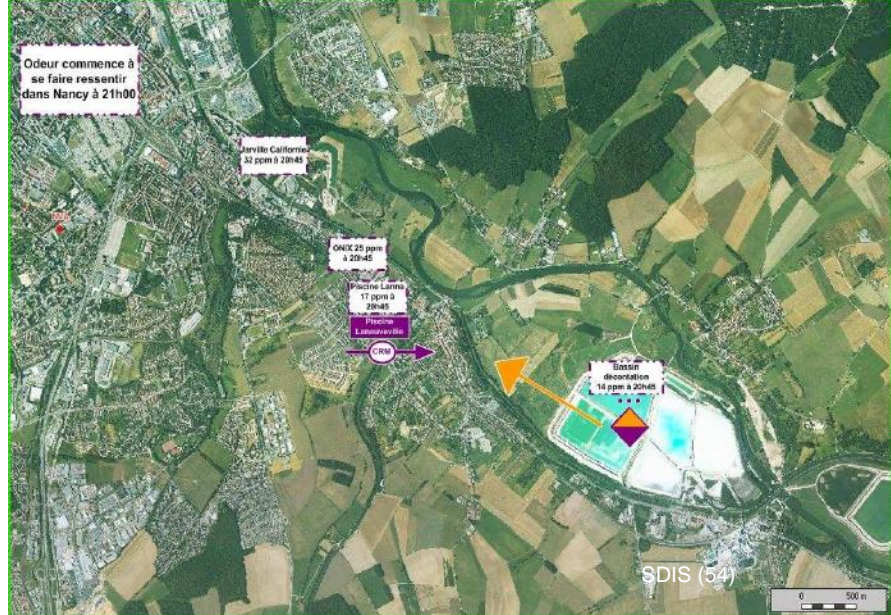
### 21 Ammonia odours in the city

ARIA 34027 – 20/12/2007 - 54 - LANEUVEVILLE-DEVANT-NANCY
