# Lessons learnt from industrial accidents

## 2021 Seminar

### 14th edition

*Report number: 2021/02*

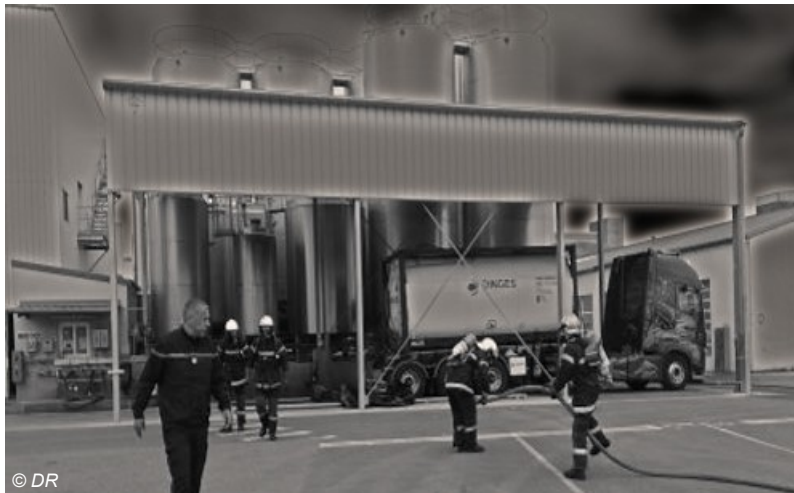
In this accident, the probability of a driver making two cumulative destination errors was extremely low and was not considered in the danger studies. However, the accident occurred because the site's organisation, particularly regarding product deliveries, did not enable this initial human error of external origin to be corrected. The dairy operator was focused on the fact that a delivery of nitric acid was expected, so was convinced that this truck contained the expected product. Therefore, he did not check the content of the delivery and its intended destination (cognitive tunnelling).

- padlocks were installed to prevent drivers from opening valves;
- systematic validation and verification of unloading operations by two operators;

- additional signs and indications near valves for product identification purposes;
- installation of a windsock;
- an audit of the procedures governing the delivery of chemical products and reminders to personnel of the safety rules, notably regarding chemical product deliveries.
