LESSONS LEARNT from INDUSTRIAL ACCIDENTS

12th SEMINAR

31 May and 1 June 2017 – Lyon

LESSONS LEARNT

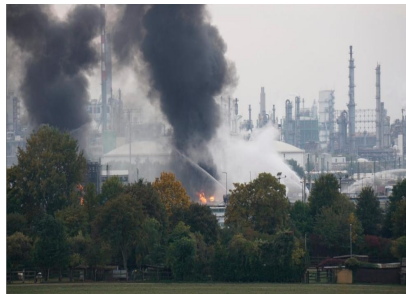
Extinction on a chemical platform, ARR

At 11:20 am in an upper-tier Seveso-rated chemical plant located in a port zone, fire broke out on a pipeline carrying a C4 cut of refinery product as maintenance works were ongoing. The subcontracted maintenance company's personnel exited the hazard zone. Safety staff attempted to snuff out the flame using extinguishers. The port's supervisory station notified the local fire department. At 11:30, just after the response had got underway, an adjacent ethylene pipe exploded. A 30-m long section of this pipe was ripped from its anchorage and ejected towards the dock where fire-fighters had established their position. The blaze spread to other flammable gas pipelines and a boat moored at the dock. Exposed to the thermal effect, several other pipes exploded in due course. The 160 fire-fighters on-site fought the blaze using foam. A controlled combustion of flammable gases was initiated. Both of the chemical plant's steam cracking units were shut down, as was a portion of the production units. All raw material deliveries to the site were cancelled. The local population was advised to remain indoors. Around the plant, air quality was being measured continuously. The platform operator announced the accident on its website as well as via social media. The fire was ultimately brought under control by 9:30 pm.

The human toll was extremely severe: 4 deaths (3 internal fire-fighters, plus a sailor on the boat moored at the port), 7 serious injuries, and 122 more minor injuries. Property damage was also tremendous.

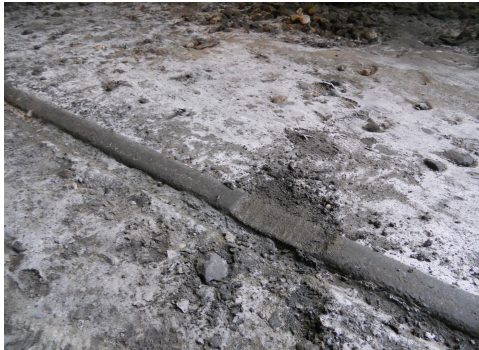
The emergency operations consisted in quickly cooling the surface of the spilled cast-iron with water cannons to prevent its horizontal expansion on the ground. The accelerated cooling generates a surface crust on the spilled cast-iron which mitigates the dust diffusion into the atmosphere. It was not possible to aspirate the emission of dust with the filtration systems on the casting floor because of the height and width of its diffusion.

In the post-emergency phase, the removal operations of the solidified cast-iron and the restoration of the former operating conditions were carried out.

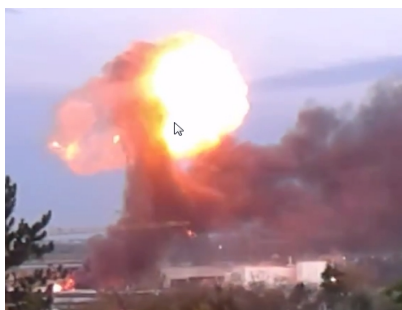
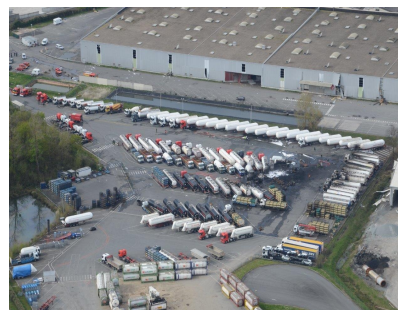
The accident occurred in the parking area of a road transportation firm. The substances being transported were mainly liquefied flammable gas (LFG) stored in tanks and bottles, along with hydrocarbons contained in tanks.

This site was used for parking lorries, especially at night and towards the end of the week (approx. 100 lorries).

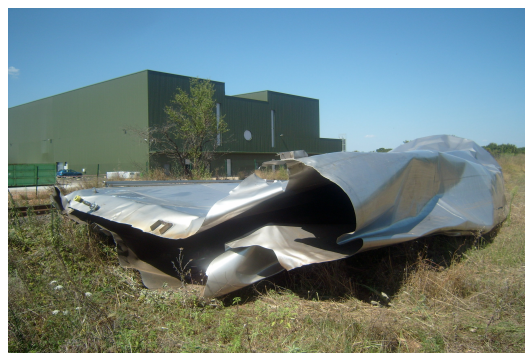
Inside a vinegar plant, a 150-m³ tank containing 38.5 m³ of an alcohol vinegar mixture exploded around 9:40 am. The 3,000-m² site had been in activity start-up mode, but engineering works were still underway. The tank bottom became detached from the shell. Its upper part, measuring 13 m high, 4 m in diameter and weighing some 3.5 tonnes, was projected upwards, by missile effect. It perforated the building roof and landed 80 m away on a rail line. Two subcontractors were injured, one sustaining serious burns. Both required hospitalisation.

Fire-fighters extinguished a fire outbreak in the company offices, most likely due to a compromised electrical installation. Nearby rail traffic was suspended. The vinegar spilled on the floor and was collected in the site's retention basin. The building adjacent to the tank was severely damaged and at risk of collapse. The neighbouring tanks, not fastened to the ground, were deformed either by the explosion blast or subsequent to striking one another. A 42-m² opening was visible in the siding near the tank. The projection through the roof left a 20-m² hole.

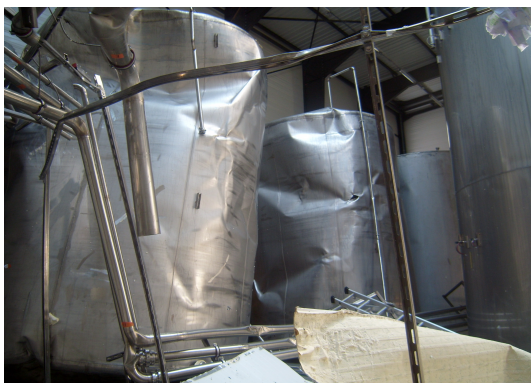
The tank involved had been installed on its base without being fastened. It had been filled 5 months before. The 38.5 m³ contents came from various mixes prepared at the former production site. This volume was composed of water, vinegar, alcohol and acid. The degree of alcohol in this liquid had been estimated at 9%. The planned operation consisted of welding 2 pipe brackets onto the shell. No prevention plan or hot work permit had been issued prior to initiating these works. The 1st weld was set 2.10 m above ground (i.e. 1 m below the liquid level), while the 2nd one was positioned at an elevation of 5.70 m (2.60 m above the liquid surface). The explosion occurred when readying for the 2nd weld. A pressure release noise could be heard by welders just a few seconds before the blast.

An expert appraisal was conducted by a specialist body in order to identify the causes of this accident. The first point appearing in the operator's post-accident assessment was that the mix contained in the tank had an effective degree of alcohol near 20%. At this concentration, the flash point of the mix is 36°C. The study indicated that the act of fastening the first bracket by welding, performed below the liquid level, caused local heating. The liquid temperature, initially estimated at 30°C in light of meteorological conditions, most likely rose to a temperature near that of its flash point. The heat created an explosive atmosphere within part of the tank's expansion space. The 2nd weld, which proceeded during the gaseous phase, provided enough energy to ignite the gaseous mix. According to the study, only 10% to 20% of the expansion space volume needed to be at the lower flammability limit concentration in order to trigger the observed effects.

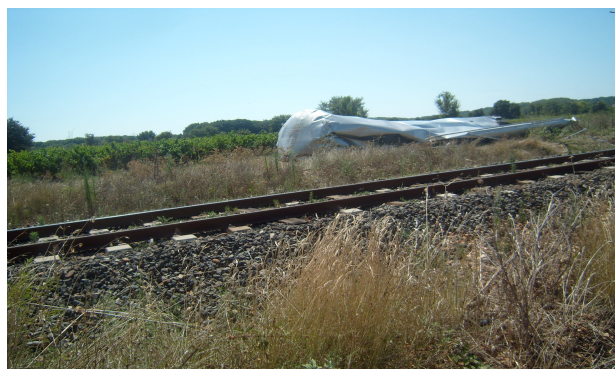
- absence of any analysis when initiating service at the plant. Start-up occurred without conducting any prior compliance review, as outlined in the Prefect's authorisation order ;

- installation design did not allow for a controlled dissipation of the energy generated by the explosion.

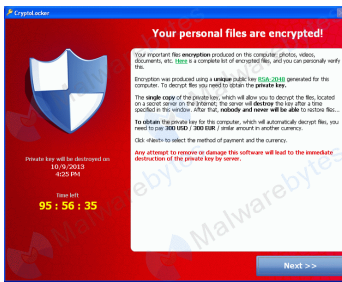
Compromised marine turbine

During the morning hours, a marine turbine operator noticed that he was no longer able to gain access to his communication interface systems. The installation had been hacked, with the hackers introducing ransomware, a programme that encrypts the data stored on a server, making it unusable until ransom money is paid. Output from the turbine was halted. The facility operator subdued this threat by shutting down the server and then thoroughly cleaning the information system. Operations resumed 2 weeks later. The electrical network had not been disrupted: this incident occurred just a few days after connecting the turbine to the grid.

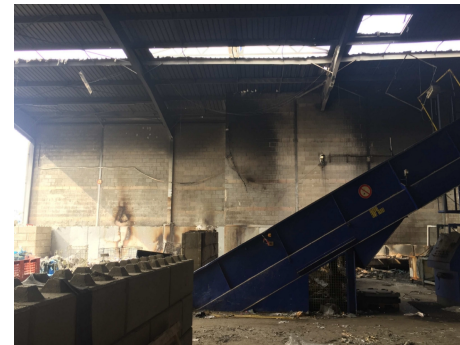
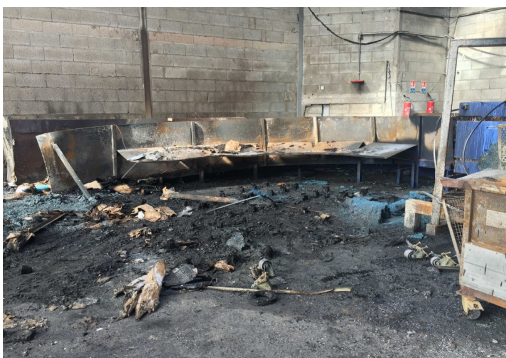
Around 8 pm, fire broke out in a 720-m² building at a waste recycling firm. The site was closed and the watchman momentarily away from his post. The blaze caused one of the power cables feeding the gate to melt, thereby preventing its opening. The watchman had to open the gate manually to enter the site along with first responders, who had been notified by someone outside the firm. A thick plume of black smoke was released. Fire-fighters connected to the hydrants on the lower part of the property. Emergency vehicle drivers were called in to back up the fire-fighting crew. The fire was brought under control around 10:15 pm, and rounds were organised to last all night long.

The roof on the burnt building was damaged, as well as many cabling connections, making it temporarily impossible to continue with sorting and packing activities. The sprinkler heads in place above the press were activated, which protected the press. The other buildings sustained no damage. The fire extinction water (700 m³) was collected in the 1,430-m³ underground retention basin. The 200 tonnes of waste affected by the fire (paper, cardboard, plastics, etc.) were discharged to certified treatment facilities.

The cause of this accident could not be identified. No activity (vehicle use) or hot spot works had been conducted in the building during the week before the fire. The bailing machine present inside the building had been idle and turned off for 3 months.

A malicious act was suspected. Around 7:25 pm that evening, the watchman had noticed intruders within the closed site enclosure. The four individuals had escaped by climbing the fence and then taking off in a car. The blaze ignited during the watchman's break at two distinct spots: one in the stockpile of panel pallets composed of plastic honeycomb polypropylene, the other in the recycled paper containers.
