Lessons learnt from industrial accidents
IMPEL 2015 Seminar
11th edition

Final report: 16 July 2015

IMPEL Seminar
Lille, 2 and 3 June 2015

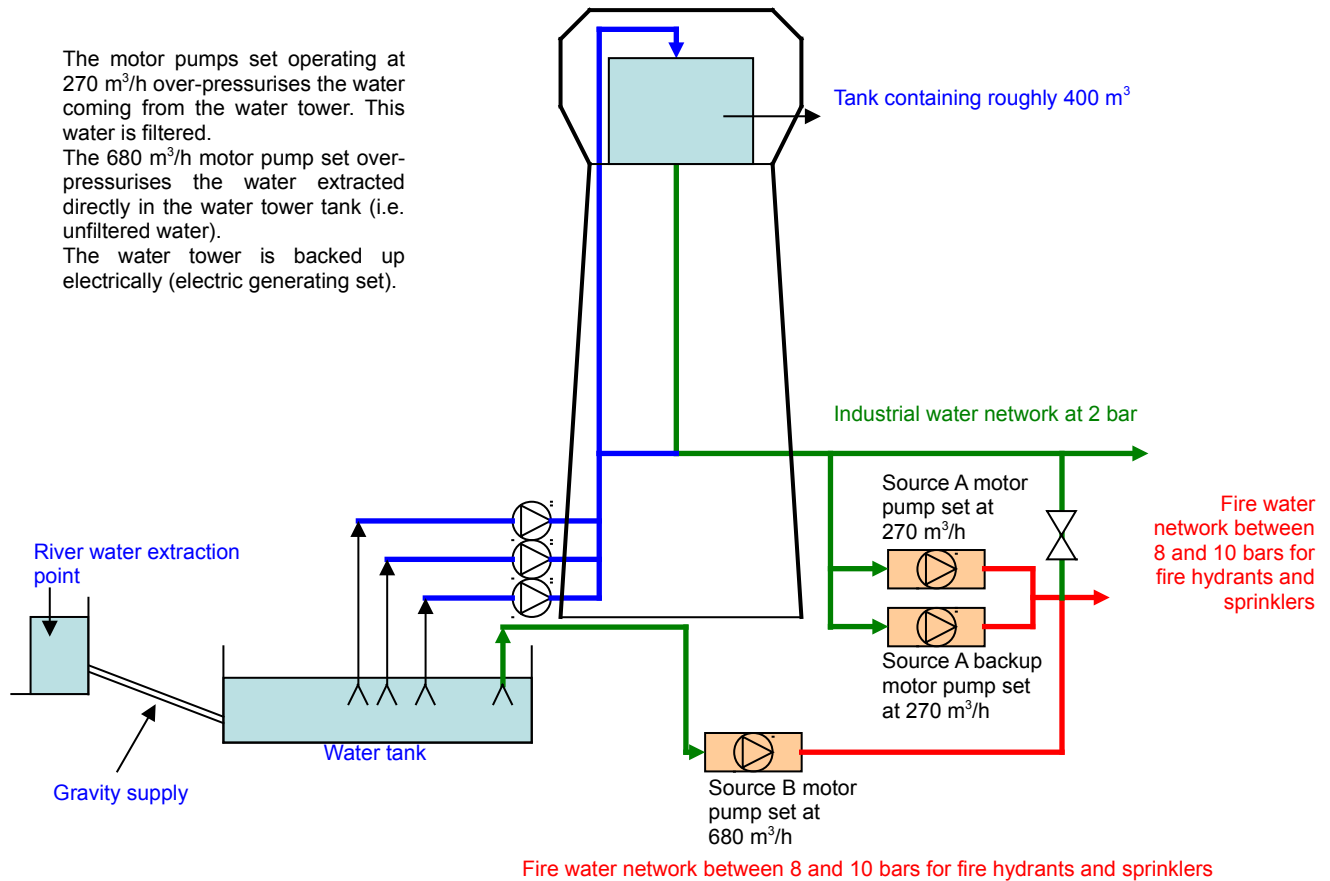
The 680 m³/hour motor pump set directly draws water into the reserve located below the water tower. The 2 motor pumps running at 270 m³/hour were fed via the water tower and industrial water network. The combination of these sets of pumps supplied the sprinkler protection system as well as the site's 23 fire hydrants and a portion of the fire hose cabinets.

On the day the fire broke out, both A motor pump sets at 270 m³/hour had been operational, while the B motor pump set (680 m³/hour) was down subsequent to a major malfunction that had occurred in July 2012 while treatment was underway.

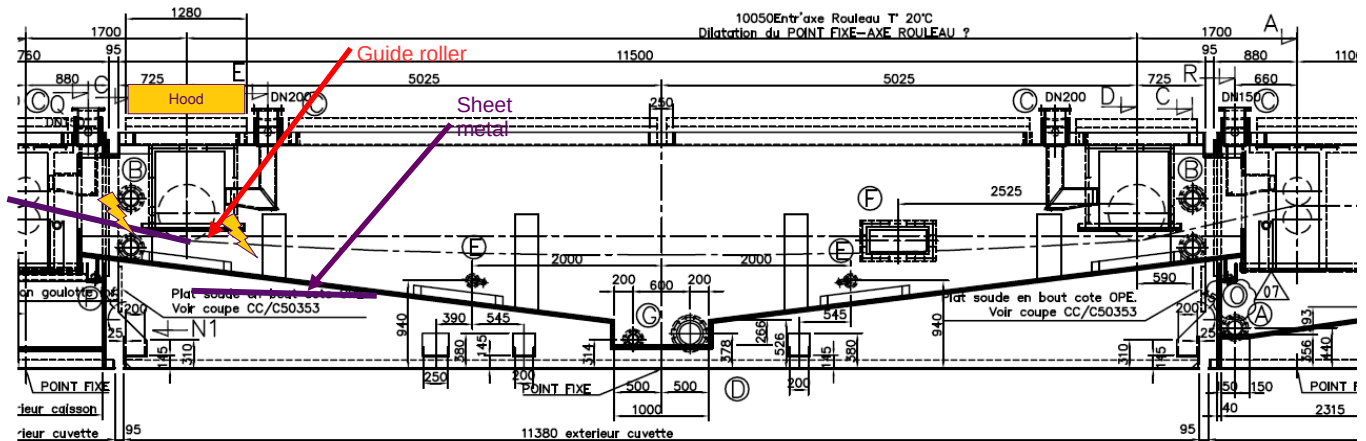
The 450 m long RD79 line is composed of several sheet metal treatment stations. This accident mainly affected the stripping installations. Investigations indicated that the most likely source of the ignition point was a welding operation taking place on a strip of sheet metal, which is typical in the process (occurring roughly once a month) and supervised by a specific procedure.

Less customary however was the fact that this operation had been carried out using a sheet metal strip guide roller, in a particularly narrow spot, which required the operator to wear both a head lamp and a mask.

The tests performed by the plant operator revealed that the material surrounding the roller, i.e. EPDM (ethylene propylene diene monomer) rubber, only required a small amount of energy to ignite. Placing a match in immediate proximity would cause it to slowly burn and be consumed entirely.

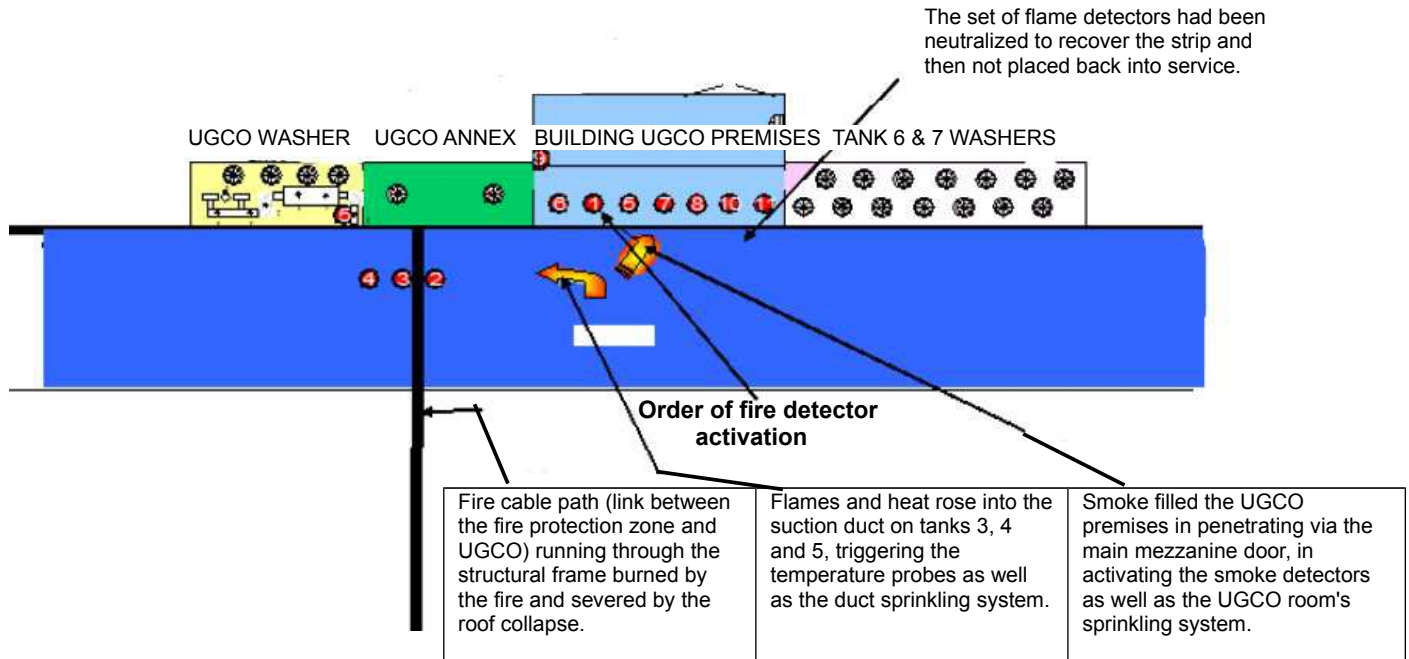
Diagram depicting the chronological order of fire detection activation (source: operator)

- 1 - P73 smoke detector on the mezzanine level of the UGCO premises - fire-fighter's beeper alarm.
- 2-3-4-5 - UGCO duct temperature probes - sprinkler activation in the ducts of tanks 3, 4 and 5.
- 6 through 11 - smoke detectors on the mezzanine level and on the UGCO premises - sprinkler activation after melting of the sprinkler head on the mezzanine level.
- Cut-off of the connection between the fire protection zone and the stripping detection after destruction of the cable path through the structural frame.
- Manual tripping of the sprinkler system in the structural frame of tanks 3, 4 and 5, followed by roof collapse, causing the sprinkler network to fall.

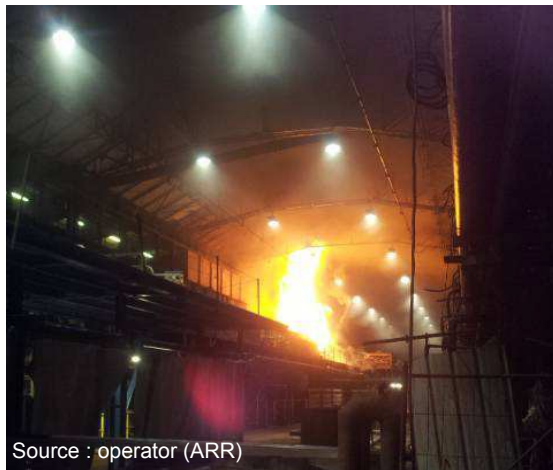
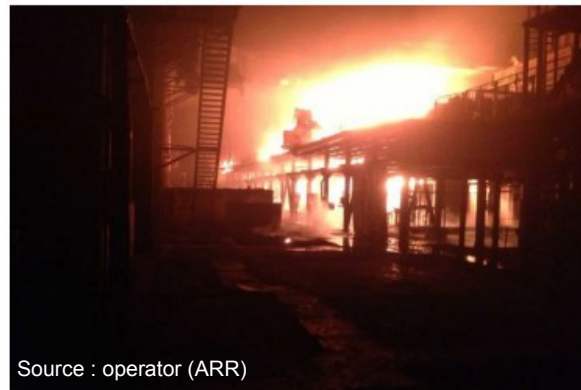
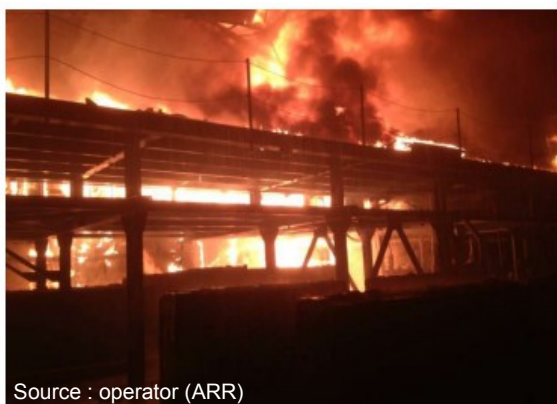
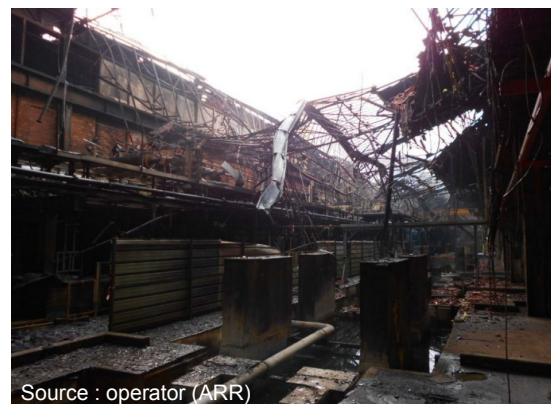
- complete destruction of tanks 3 through 7 and their supporting structures;
- complete destruction of the recycling basins on tanks 6 and 7;
- destruction of the vapour extraction systems on tanks 3, 4 and 5 (UGCO washer);
- destruction of the building over a 120 m length;
- partial damage of the asbestos cement roof located on the eastern lean-to of building 37;
- damage to overhead travelling crane 114.

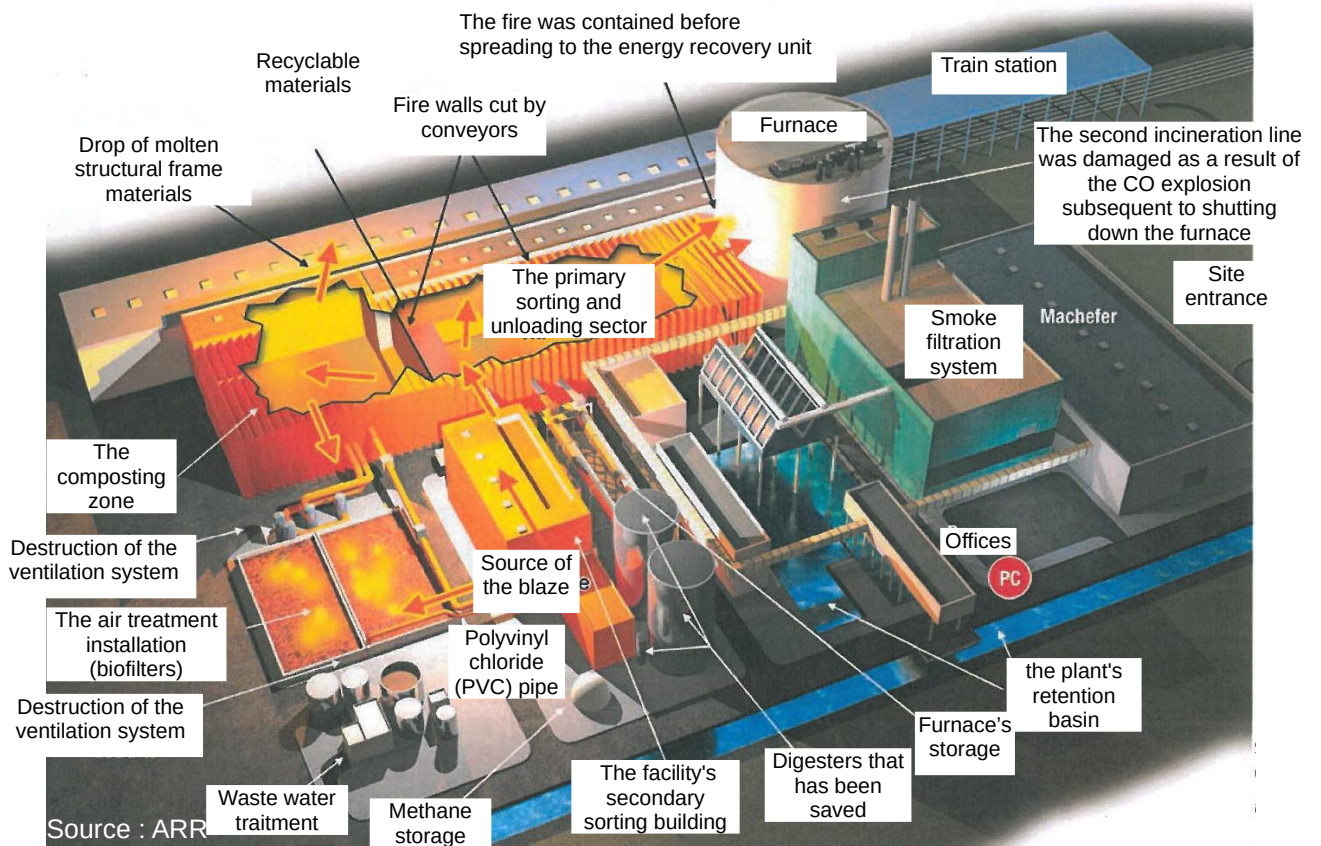
Diagram of how the fire spread inside the plant

On the night of 2 November 2013, fire broke out in the organic recovery unit located inside the facility's secondary sorting building. This unit was idle at the time. The blaze then quickly spread to the composting zone and ultimately to the primary sorting and unloading sector.

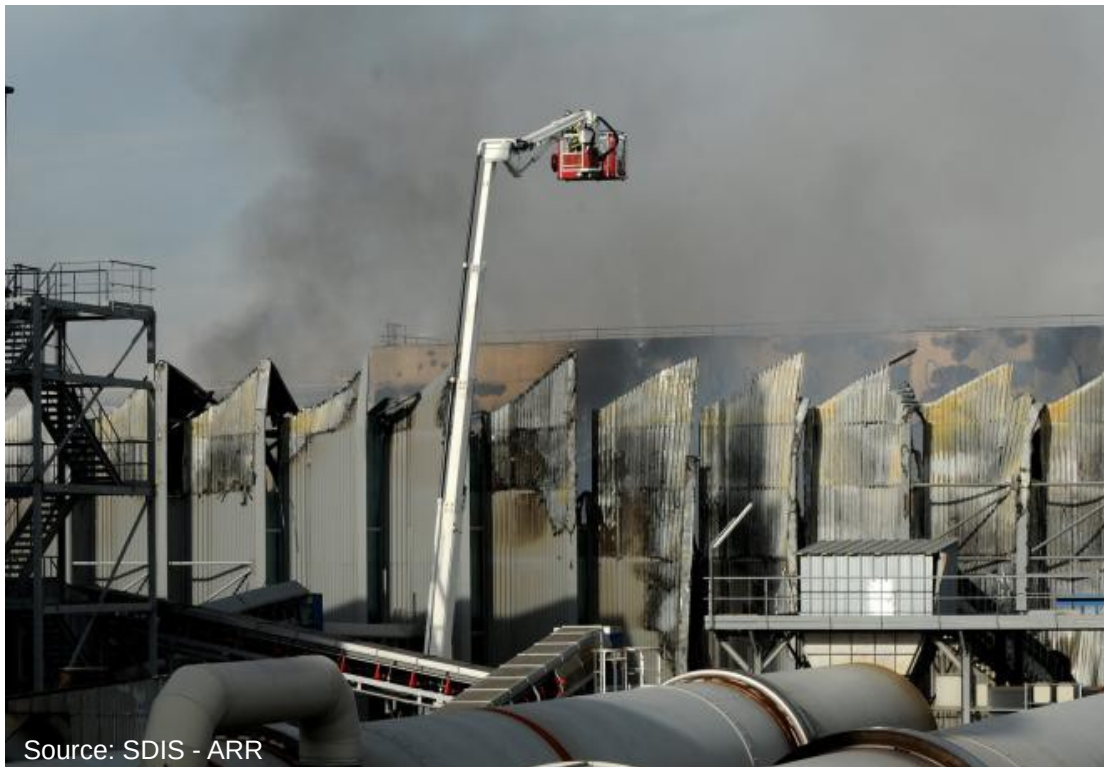
Primary sorting building ablaze

Within just a few minutes, the flames fanned by a wind blowing from the south-south-east spread this outbreak to a 6,000-m² compost storage and ageing zone.

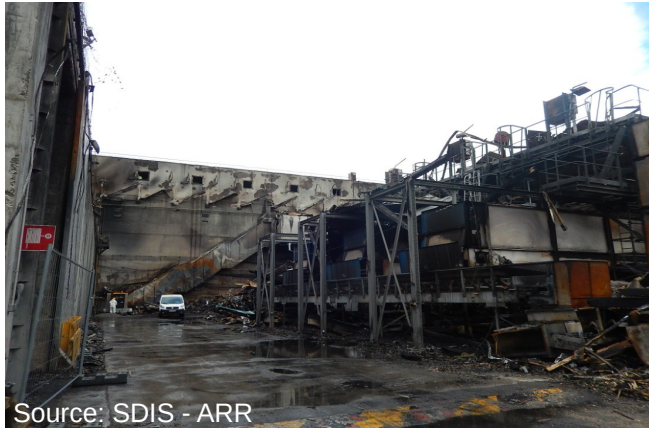
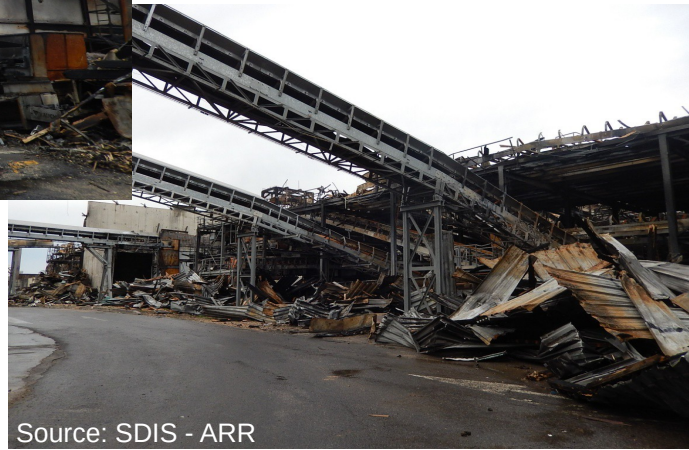
The primary and secondary sorting buildings as well as the composting platform were destroyed; these facilities accounted for over a third of all housed installations, for a total floor area around 18,000 m².

The dismantling of the primary sorting building and the "composting" building has been completed, while the secondary sorting building has been nearly entirely dismantled, except for a few pieces of machinery awaiting expert appraisal as per the insurer's request. The site rebuilding project application was officially filed on 17 September 2014.

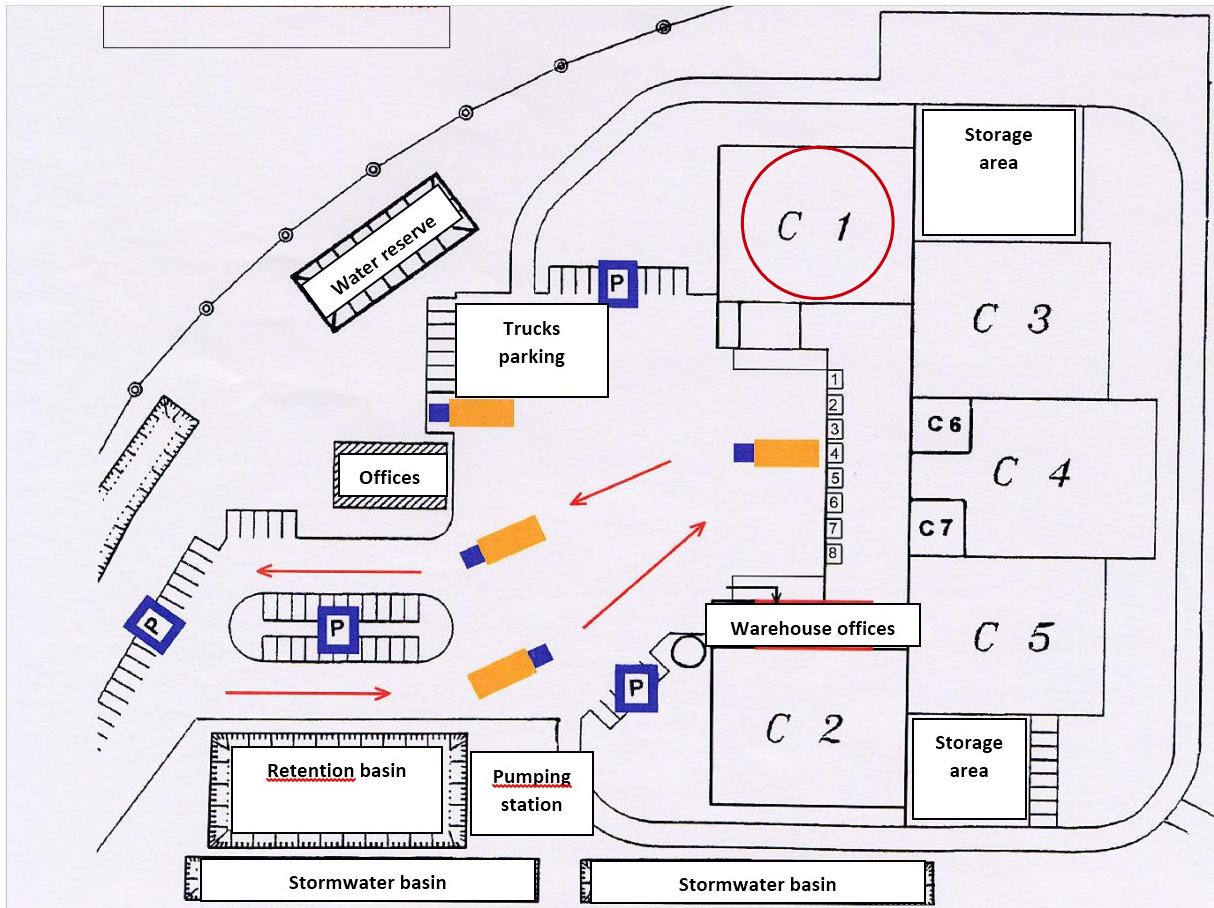
Figure 1 : Layout of the logistics platform (ARR)

The warehouse is composed of 7 storage cells ranging from 60 to 1250 m² with a 10 m height (3 m for the 60 sq. m² cells), each one of which is assigned to specific hazardous substances (see Fig. 1). The cell walls have a fire resistance rating of 120 minutes. Cell doors have been fitted with automatic closing devices, while the cells themselves are protected against fire by means of an automatic extinction system that relies on foam flooding.

The automatic foam extinction system features a 5000 litre emulsifier reserve plus a 120 m³ autonomous reserve of anti-freeze fluid. The system was designed to fill a cell in less than 5 minutes and flood 2 cells simultaneously. The warehouse was also equipped with ancillary facilities: boiler room, shipping dock, workshop for charging vehicle accumulators, shipping administration offices, and a few refrigerators for storing refrigerated products.

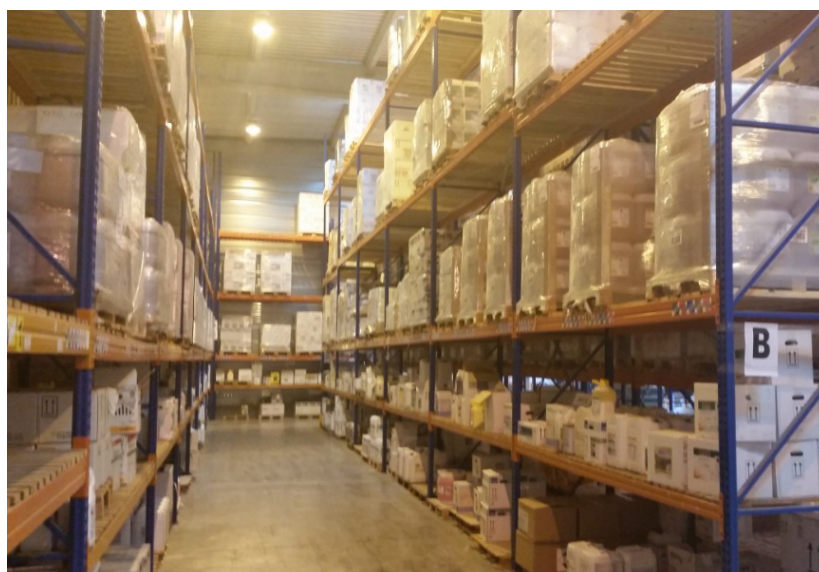
Figure 2 : Interior of Cell 1 (Source Operator - ARR)

Cell 1, laid out over a 1000 sq. m² floor area and 10 m high, stored flammable and/or toxic or highly toxic substances for humans (Fig. 2). Like the other cells, it had been fitted with metal storage racks.

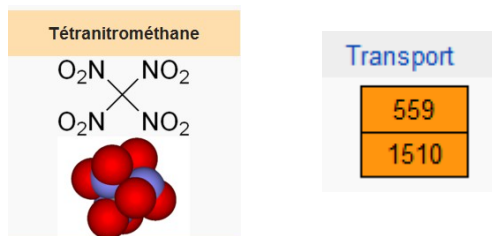
Among the numbers listed in the report, i.e. category no. 1510, the storage of combustible materials under the ICPE regulations was mistaken for the same UN number, which corresponded to Tetranitromethane, a toxic combusive product (see Fig. 4). Responders thus considered that, despite the absence of visible signs of ignition from the outside, a fire might have been smouldering within the foam and moreover fed by this combusive product. Accordingly, a physical investigation by a three-member team wearing self-breathing type masks was decided so as to remove this doubt.

Figure 4 : Tetranitromethane and its 4-digit UN code, identical to that under the heading entitled "Storage of combustible materials, products or substances in enclosed warehouses" listed in the French ICPE installation nomenclature

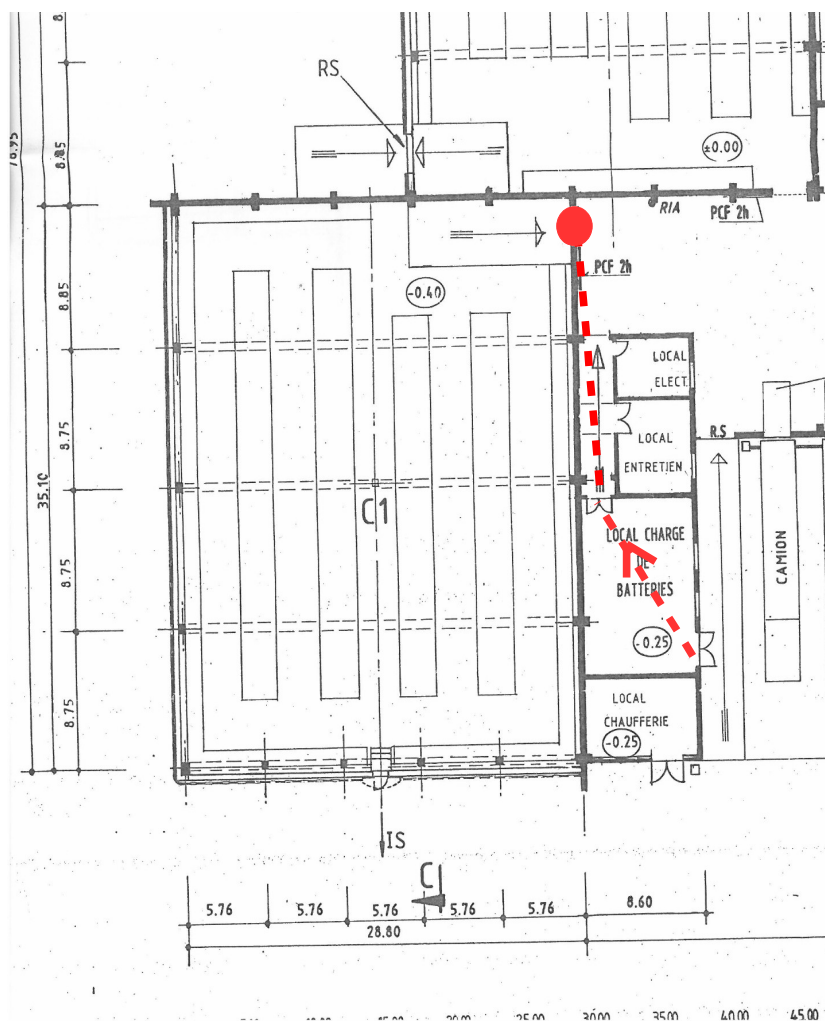
Figure 5 : Path followed by the three fire-fighter investigation team (ARR)

- Around 8:00 pm: Despite the absence of any visible signs of fire, fire-fighters decided to inspect Cell 1: three fire-fighters roped together wearing insulated self-breathing apparatuses penetrated into the foam that covered the adjacent premises in order to access the door to Cell 1 (Fig. 5). A few minutes later, two of them exited the cell in a state of physical exhaustion while the 3rd member was reported missing. Another reconnaissance effort found him unconscious lying on the floor in a state of cardiorespiratory arrest. He was quickly resuscitated and then transported to hospital in a critical condition.

The two surviving fire-fighters of the three-man reconnaissance team, as well as the members of subsequent investigation parties, reported that the foam inside the buildings did not display the same consistency as that observed outside. They all complained of real difficulty in advancing into the foam, which entailed coping with a highly viscous substance that constrained any kind of movement. They also expressed that the foam had been an obstacle to vision, to such an extent that a hand placed in front of the eyes remained invisible. Similarly, the foam acted as sound insulation, thus preventing verbal exchanges (besides radio) with the other two fire-fighters in the trio. In addition, they mentioned that shortly before exiting the premises, the foam wound up penetrating inside their breathing masks. The team's progress had been slowed to a point that they were not even able to enter Cell 1 and had to turn around barely after reaching the door (red dot in Fig. 5).

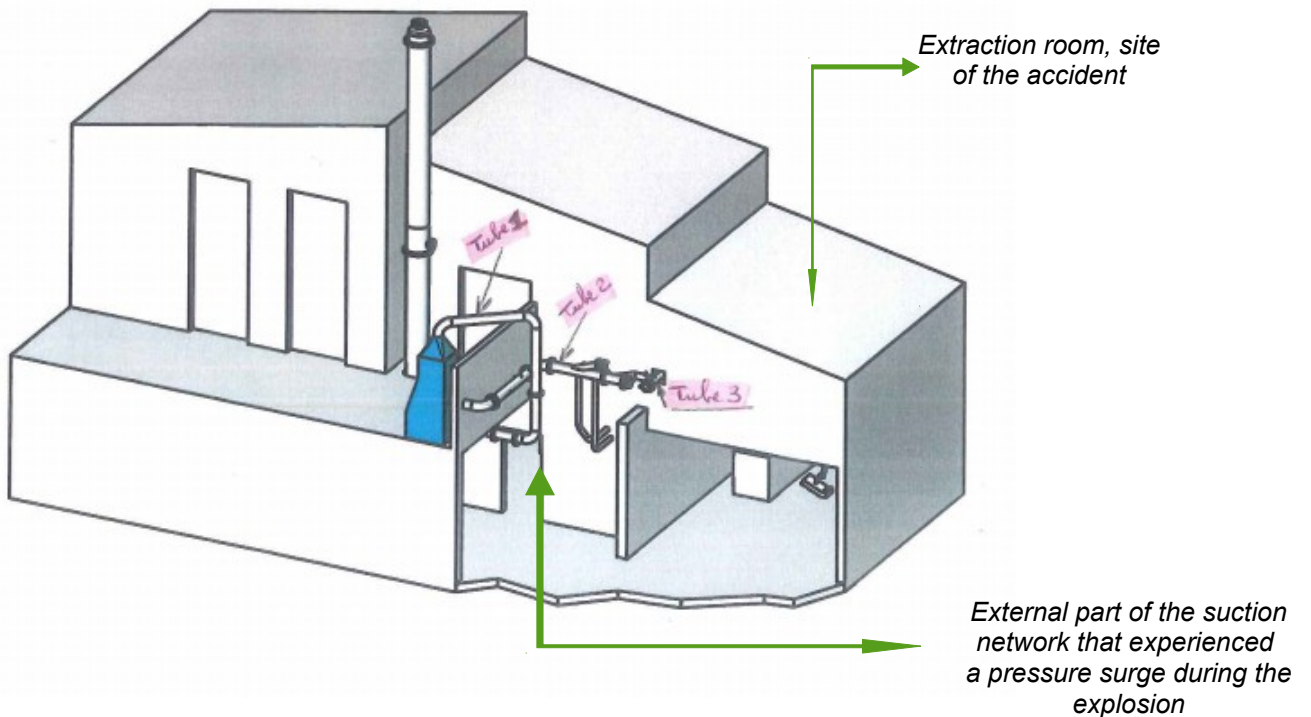
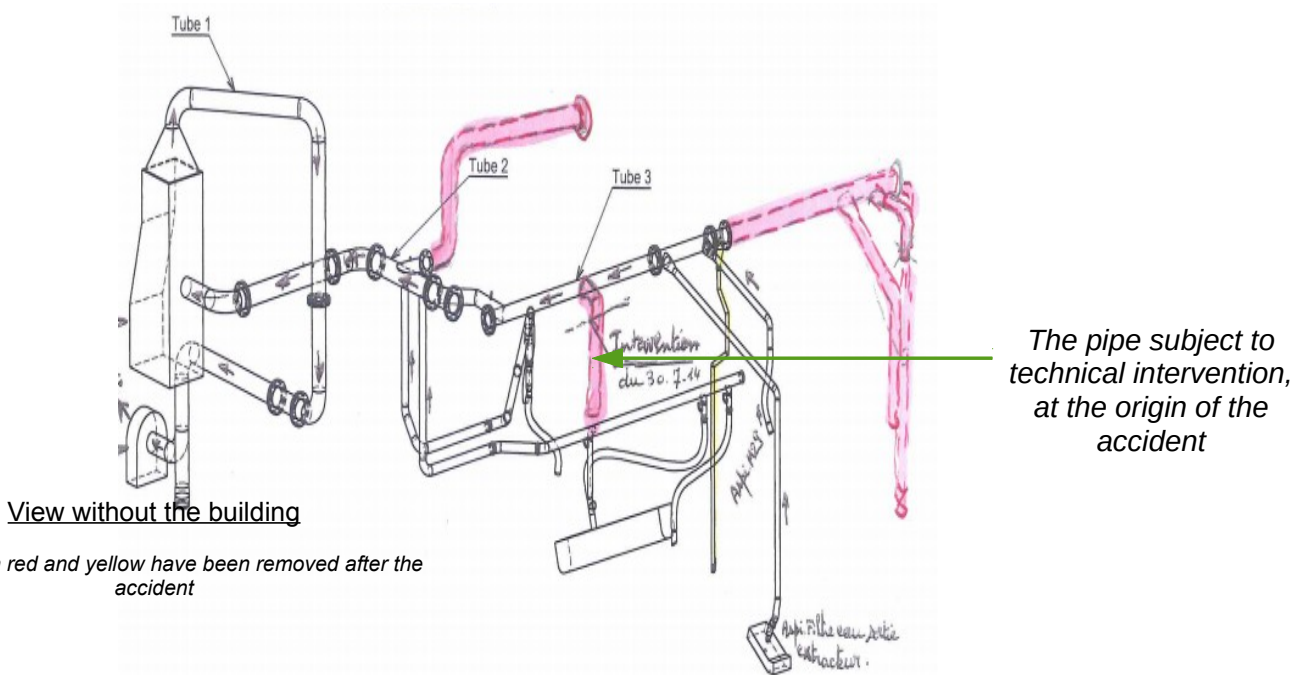
View without the building

The accident occurred inside the "extractor" room located on the ground floor of the production workshop. This room was equipped with machinery for extracting the solvents contained in the powders output by the double-screw extruder operating on the floor above. This extraction entailed washing with hot water circulating upstream in a worm gear. The solvent-laden water recovered was then channelled to a distillation unit for solvent regeneration. In conjunction with this step, the air filled with volatile organic compounds (VOC) was also collected by a suction network for distillation treatment prior to discharge. This network wound up at the origin of the accident.

The pipes in red and yellow have been removed after the accident

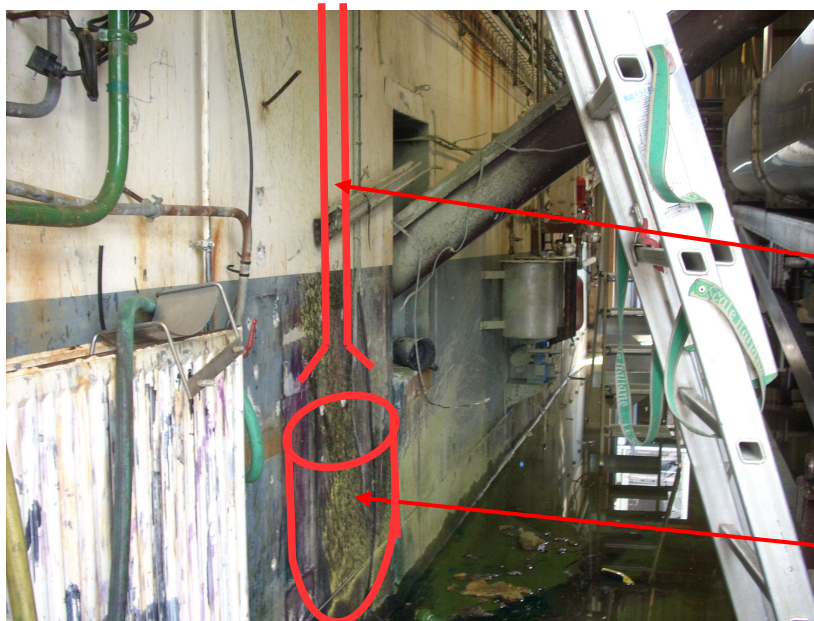
Around 4 pm, **this pipe experienced a pneumatic burst.**

Location of the suction pipe that was rendered inoperable, i.e. the origin of this accident

Location of the former dye tank (under the pipe at the origin of the explosion)

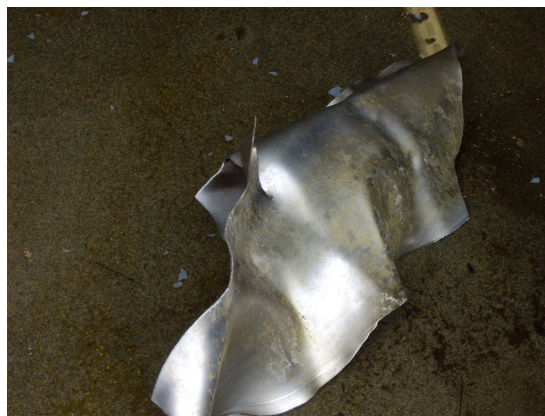
Metal debris, from the pipe blasted by the explosion, found on the floor. The picture on the left shows residue from pyrotechnic dust (yellowish) covering the inner pipe wall.

The fire most likely broke out due to ignition of this powder residue and/or pyrotechnic dust accumulated inside the pipe. This build-up was correlated with the **heating produced by friction of the metal saw blade on the stainless steel suction pipe (hotspot).**

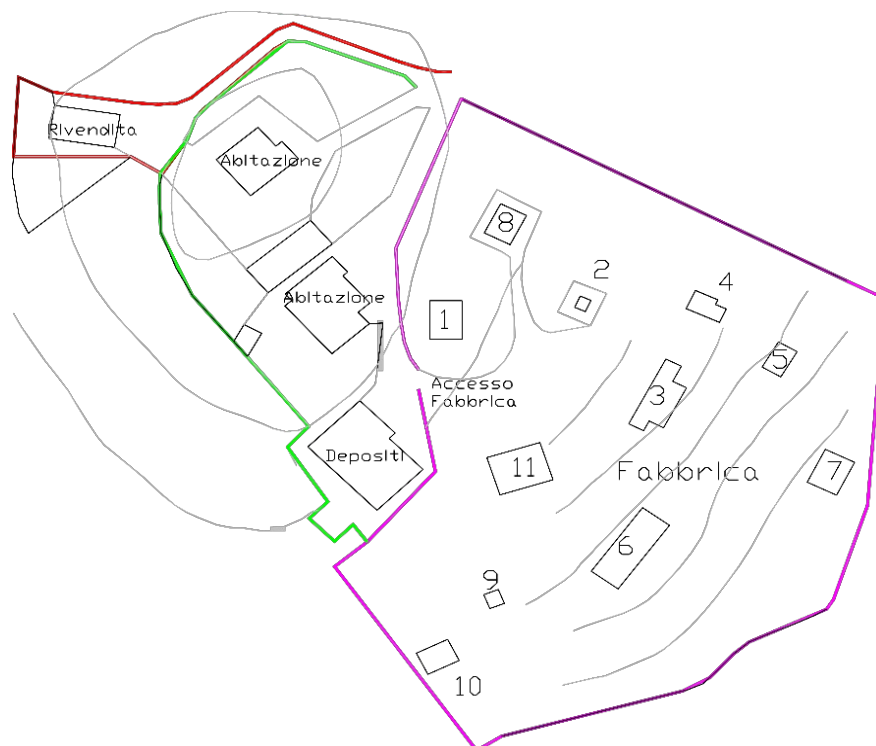
Illustration 1 : Layout of the plant

1. Unclassified products storage (products that do not fall under the Italian regulation on explosives storage and production)
2. Black powder storage (max 500 kg)
3. Fireworks laboratory
4. Products storage (max 4 t)
5. Products storage (max 9,6 t)
6. Mixing
7. Colours and various material storage
8. Products storage (max 9,6 t)
9. Engines installation
10. Coal crushing
11. Semi-finished products storage under authorization process (max 7 t). This building was not yet authorised at the moment of the accident.

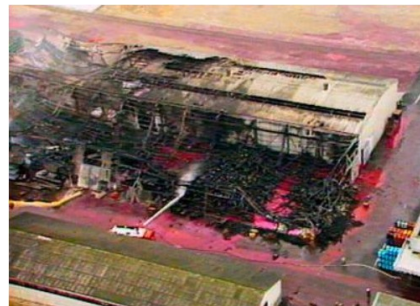
Fire broke out in a warehouse containing phytosanitary products south of Basel. 80-m high flames were visible 10 km away. Mercaptans in the smoke made the air unbreathable for kilometres around, and the RHINE River was polluted. The retention basin was insufficient: 15,000 m³ of extinction water flowed via the sewer network into the river, which turned a shade of pink (fuchsine); **30 tonnes of highly toxic products (e.g. insecticides, mercury) destroyed all aquatic life over a stretch of more than 250 km.**

The time interval between the fire outbreak and the alert sent to residents of Basel and neighbouring countries caused a major public outcry. The investigation assigned the origin of the fire to an accidental ignition of a pallet of Prussian Blue.

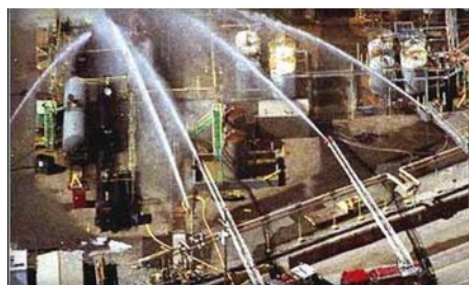
At 3:45 am inside a chemical plant, 2 employees were unloading a tanker car containing methyl mercaptan (MM) when a process pipe broke loose: approx. **70 tonnes of gaseous MM** were released into the atmosphere. Fire-fighters sprinkled the car where smoke was emanating. At 4:09 am, the toxic gas ignited, engulfing the car and producing a fireball 61 m high by 15 m wide. The car exploded (BLEVE-type explosion) emitting both MM and its decomposition products into the atmosphere. The unloading hose on a nearby car containing chlorine was destroyed: **12 tonnes of chlorine** out of the 81 contained in the car were released. The toxic cloud drifted towards the Canadian border marked by the river running alongside the site. At 12:47 pm, the leak was finally stopped.

This accident **took the lives of 3 plant employees** and **injured 49**. Some 2,000 people had to be evacuated. The river was closed to all forms of navigation. The investigation concluded that a corrosion-erosion phenomenon had caused the pipe to break and singled out safety rule compliance breaches. The State of Michigan negotiated a \$6.2 million settlement with the industrial group to compensate local residents, consisting of \$500,000 in fines and \$5.7 million to improve safety and training in addition to compensating the local population.

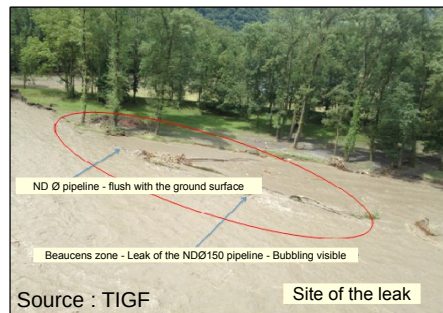
ARIA 44067 - CANATRANSGAZ - 19 June 2013 - 65 - PIERREFITTE-NESTALAS

When the GAVE DE PAU water course flooded at around 3 am, the operator of a gas pipeline (nominal diameter: 150; year of initial service start-up: 1962; underground depth: > 1 m), located roughly 100 metres from a water course, detected several anomalies (pressure variations) at the Pierrefitte-Nestalas station. Fire-fighters were notified at approx. 3:20 am. At 4 that morning, on-call technicians recorded a number of facility access difficulties: roads were cut, etc. Pressure continued to drop, and the leak flow rate was estimated at 9,000 Nm³/h at 8:30 am. A strong gas odour could be smelled in the vicinity. Implementation of the Monitoring and Response Plan commenced at 9 am.

A discharge point was identified around 10 am upstream of the Beaucens switching station. The current flowing in this water course had caused a total break of the pipeline and was responsible for destroying the bank where the line had run. The pipe had been unearthed, carried, bent and broken, all due to the strength of this current. Helicopter flyovers of the flood zones were performed from 10 am to noon in order to detect other high-risk situations between the towns of Tarbes and Lacq.

Once the waters had receded and after creating a secure zone (through excavation), works to isolate the leaking pipe section began around 7:30 pm and were completed by 1:30 am on 20 June. A curved bottom was installed over the decompressed section.

To ensure customers' gas needs were being met, notably for winter 2013-14, the distribution network grid was activated. Given the degraded operating conditions, the gas pipeline was rebuilt just a few hundred metres from the previous alignment. It was expected to be operational by the end of 2014.

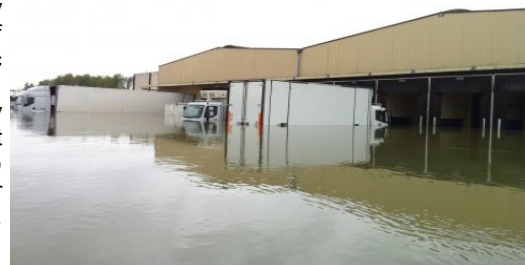
Loading platforms at the neighbouring firm (ARR)

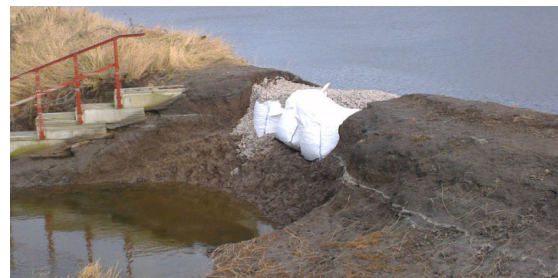
Figure 3 : Breach in flood defence with temporary staunching, source Inter Terminals

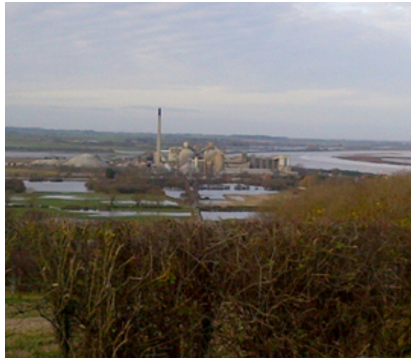
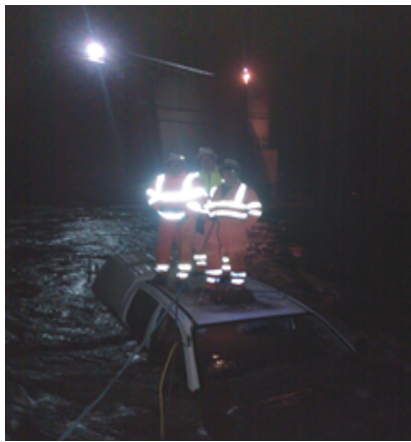
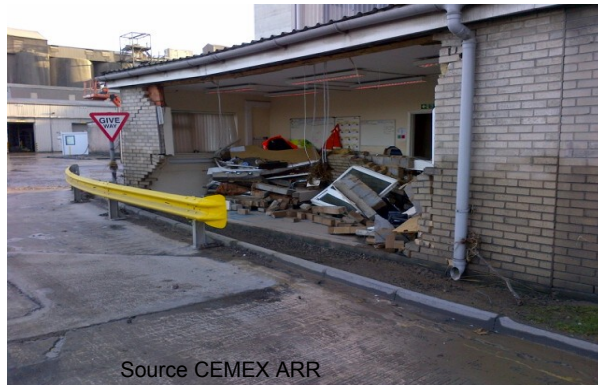
The flood water and silt caused catastrophic un-repairable damage to control systems, the power supply network, compressed air systems, buildings and the cement kiln which was currently operational due to insufficient cooling time. High and low voltage systems were wiped out by water tracking into the terminated ends of the cables. Production was not possible due to the flooding.

The site was without electricity for many weeks and production did not start until the summer of 2014. The main lesson learned was to protect electrical systems such as transformers from flooding by building walls around them or raising them above the level of flood water.

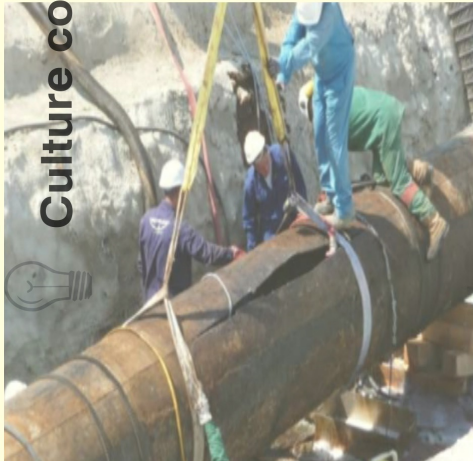
Transverse rupture (a) and longitudinal rupture (b) of a pipe subjected to internal pressure.

We consider that the pipe is closed at both ends. Up until the breaking point, the stress forces are in equilibrium with forces being exerted by the pressure. The axial force due to pressure equals $pr^2\pi$, and the stress σ_{ax} acting upon the annular surface $2r\pi e$ ensures the equilibrium: $pr^2\pi = 2r\pi e\sigma_{ax}$, which in turn yields: $\sigma_{ax} = (pr)/2e$. For a longitudinal rupture, pressure p acts upon the cross-section $2rl$ giving rise to the stress σ_{az} on cross-section $2el$, hence: $p2rl = \sigma_{az}2el$, which leads to: $\sigma_{az} = (pr)/e = 2\sigma_{ax}$. This expression, referred to as the "boiler formula", indicates that the azimuthal stress is two times greater than the axial stress, thus drawing the conclusion that rupture always occurs in the longitudinal direction.

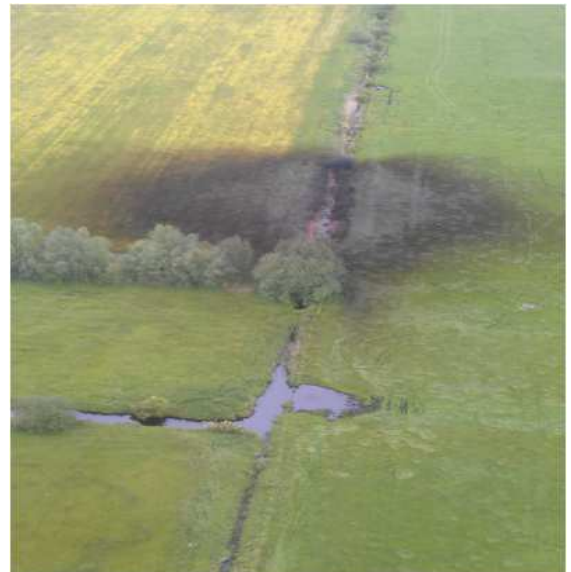
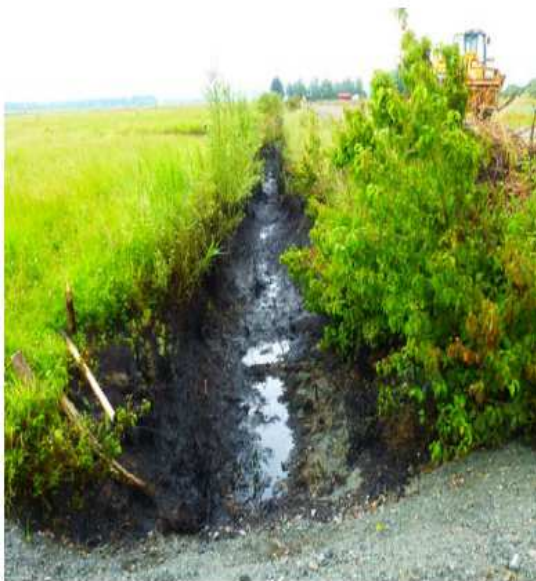
The oil spread and fouled 820 meters of trenches (submerged at the time), with the oil pooling at the bottom over 650 meters of this length. Both flora and fauna were immediately affected by oil at the surface.

The oil geyser resulted in a falling oil spray that stuck very tightly to parts of plants above ground. 14,000 m² of meadow, used mainly for the production of animal feed and beef cattle grazing, were adversely affected by the oil spill. Some 48,000 m² of surface were sprayed by oil (micro-droplets on the above-ground parts of plant life).

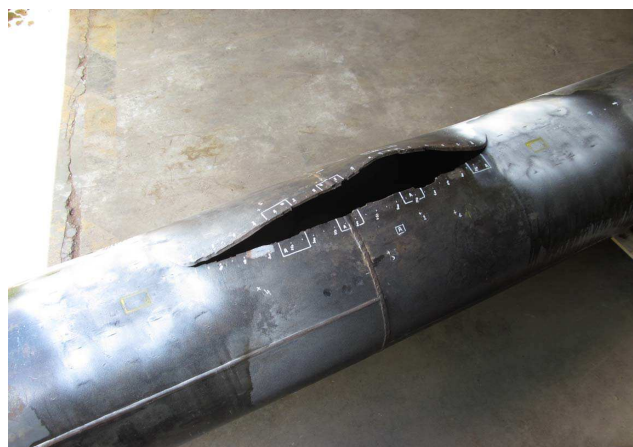
The oil leak occurred subsequent to the widening of an 87 cm long opening positioned along the upper generatrix of the pipeline on both sides of a circular coupling weld between two rolled-welded tubes. The longitudinal welds on this pair of tubes were located away from the rupture zone. An approx. 4 meter length of pipeline was removed and appraised by an expert. The section of burst pipeline displayed along its upper generatrix many signs of shock, dents and scratches as well as macroscopic deformation in the form of flattening and ripples. The outer surface of the circular coupling weld was also damaged, thus indicating that the damage occurred after installing and welding the tubes.

The morphology and location of this external damage reveal that it was probably caused by heavy equipment, subjected to a scraping effect from a power shovel and/or a track roller crossing over the ground.

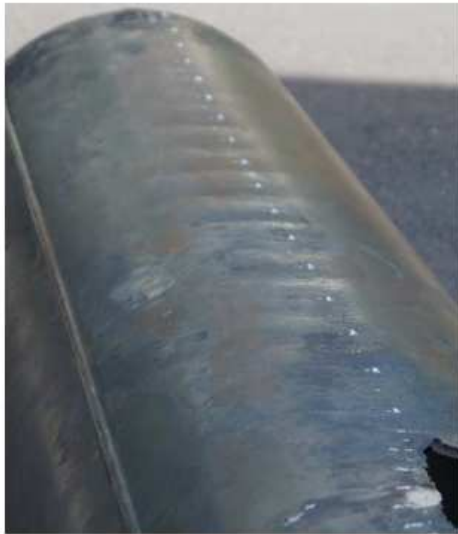
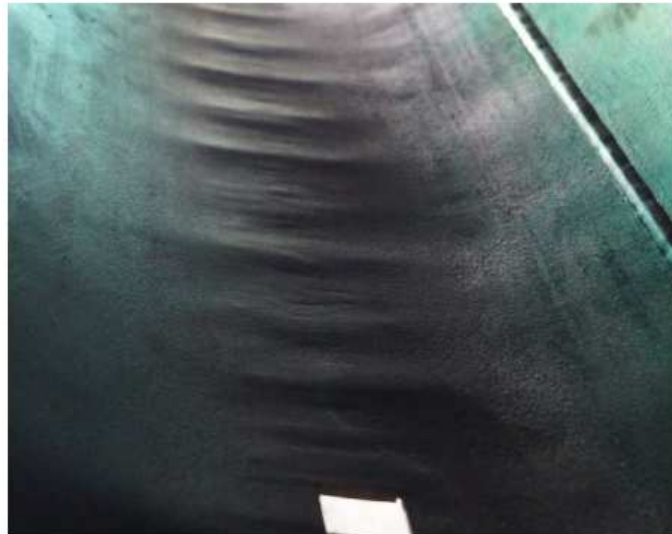
The tube appraisal conducted by an inspection body established that the sudden pipeline break, followed by gradual development of multiple longitudinal corrosion cracks due to stress, was initiated from the outer skin of the pipeline, in the strain-hardened zone with mechanical deformation.

Inside the rupture zone, six lunula corresponding to pre-existing longitudinal cracks representing some 35% to 50% of the wall thickness could be identified. These lunula were characterised by an advanced state of oxidation, or even corrosion, that did not match the ultimate rupture zones and moreover proved that they predated the actual rupture. The presence of radiating bands from the external surface suggested crack onset from this surface. The remainder of the pipeline surface offered a clean appearance without any loss of thickness due to corrosion. Furthermore, no corrosion on the tube's internal surface could be detected.

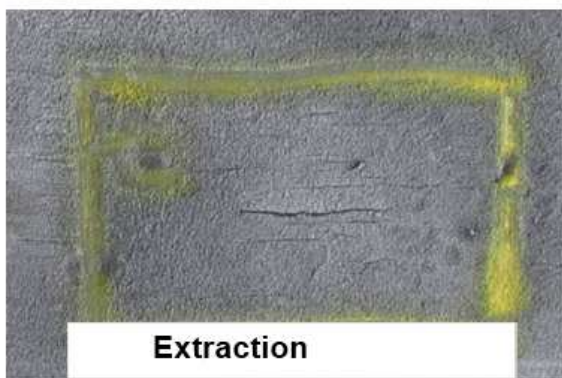
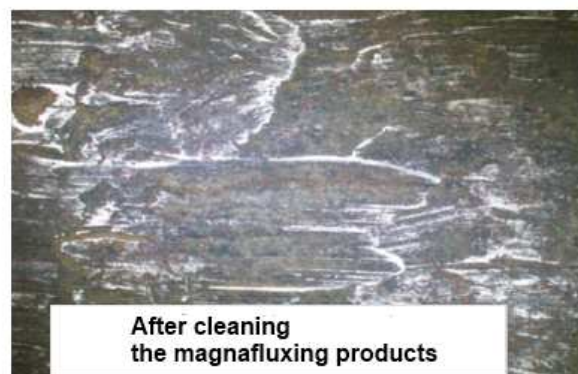
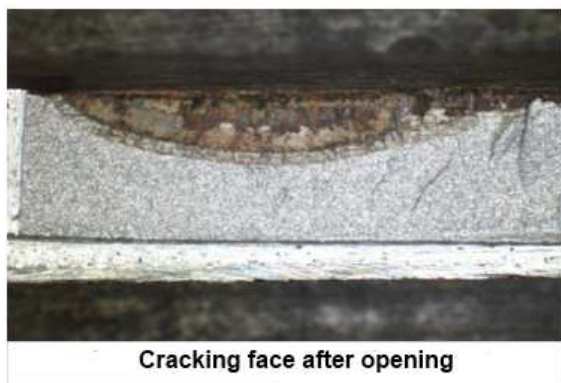
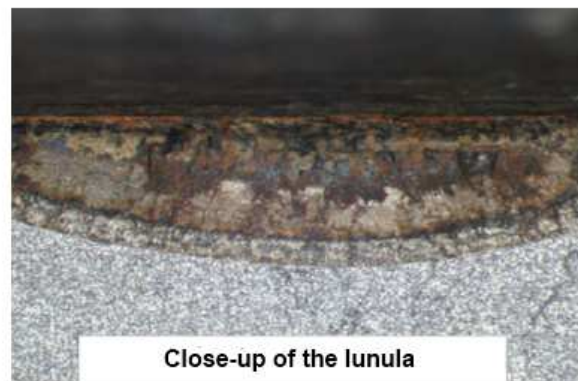
Outside the rupture zone, on the outer surface of the liner and along the upper generatrix, the magnetic particle inspection evaluation revealed the presence of crack-type anomalies associated with the identified mechanical damage that had strain-hardened the metal and caused the tube to flatten over its upper generatrix. Mechanical stresses at the level of the connection with the non-flattened zone had thus formed.

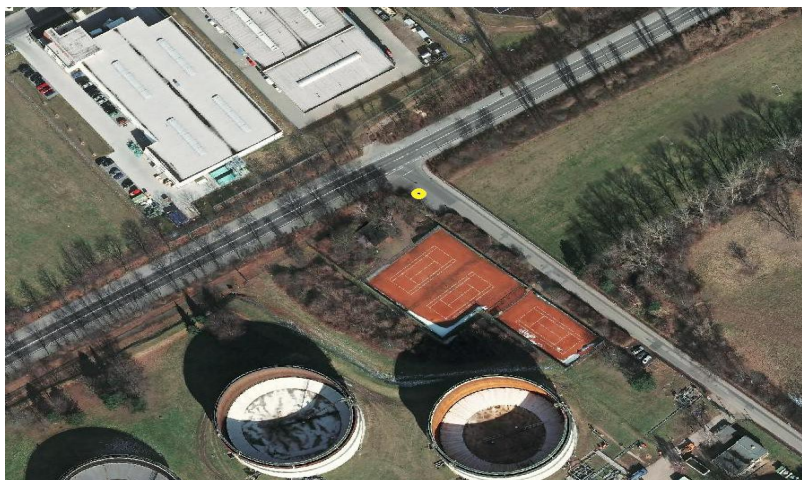
On Saturday 25 February 2012, obvious changes of the filling level of two tanks at the Wesseling site of the refinery were observed. As cause a leakage of the connecting pipeline number 7 was assumed and verified by pressure and leakage checks. The pipeline was blocked on 26 February and discharged on 28 February. The location of the leakage outside of the tank field and the refinery was identified by noise emission analysis and verified by digging up (Figure 2). It was shown by later calculations that, over a time period of 28 days, 846 tons (or 1057 m³) of kerosene were emitted into the soil. The leakage rate was below 2 m³/h (0,5 l/s) and could not be detected by the installed leakage detection system because it was only able to detect a minimum flow rate of 5 m³/h (1,4 l/s).

Figure 2: Location of the leakage (yellow dot)
