Explosion of a chlorine pipe in Champagnier

ARIA 29864 - 05/21/2005 - ISERE (38) - CHAMPAGNIER

24.1E – Manufacture of other basic inorganic chemicals

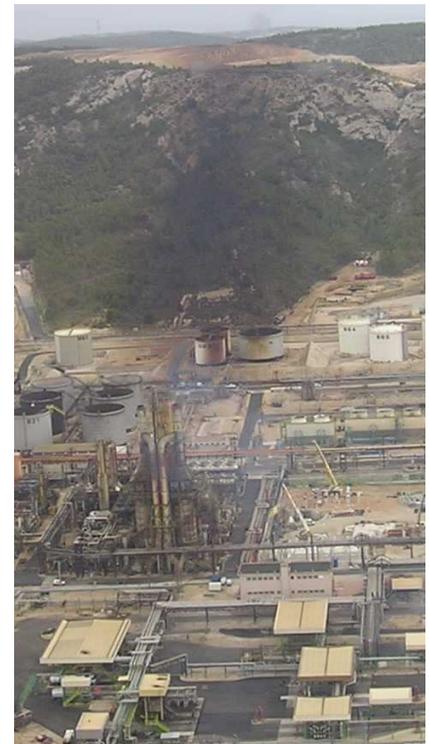
Photo DR

The operator analysed the accident and the initial measures were taken: installation of a pressure sensor on the tower head to shut down the furnaces in case a high pressure threshold is met, shut-down of heating and closure of furnace supply line valves (shutting down the tower supply line) the pressure drop threshold in the column is exceeded (upper threshold difference between the pressure at the base and at the head of the tower). Costs of cleaning and compensations raised 1.7 million euros.
