Explosion of a wood chip refiner and fire

January 20 and 25, 2005

Corbenay – [Haute-Saône]

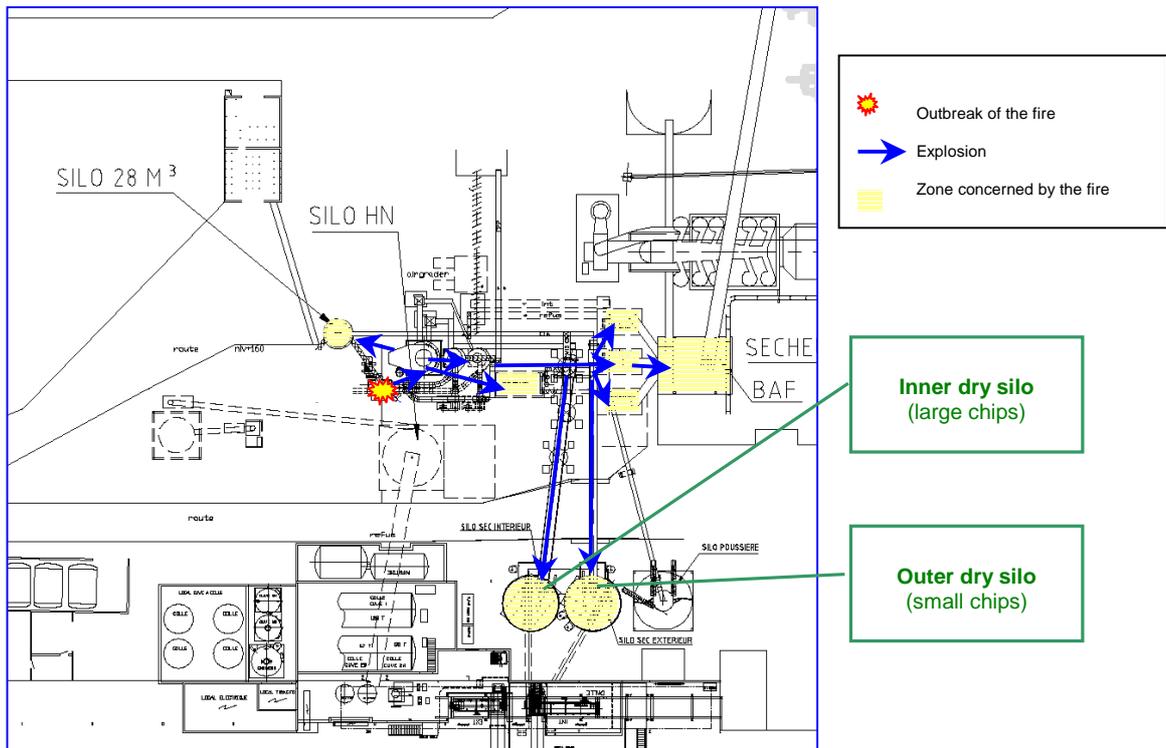
Schematic diagram of the chronology of explosions on January 20, 2005

January 20, 2005 at 2.58 am, at part of the refiner breaks (the mill grinder that transforms large dry chips into small dry chips). The resulting spray of sparks is carried along by the suction and ventilation equipment.

At 2.58'02", the refiner's cyclone explodes. The force of the explosion causes it to rupture, despite the presence and operation of the vents. The fire spreads to all the adjoining installations: redler conveyors, suction equipment, air graders, sorters, dry silos, etc.

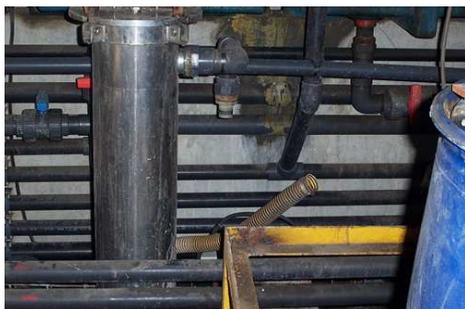
On Wednesday, September 14th, 2005 around 8.15 pm, a technician discovered a leak on the multiple treatment line slightly before the end of his shift; a filter outlet pipe on a tank containing alkaline copper cyanide had become disconnected causing the bath (approx. 1,000 l) to flow into the concrete catchpit.

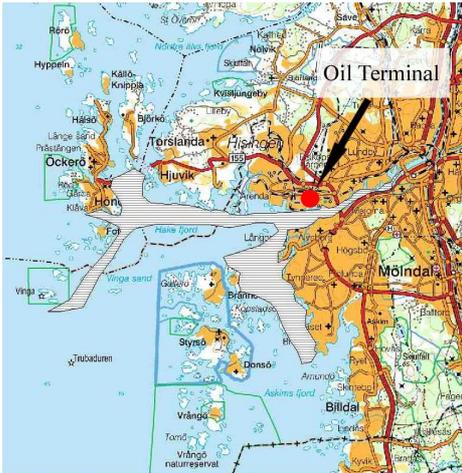
The area outlined on the map shows how the oil was spread in the coast archipelago outside Göteborg. The oil spread in two main directions, south and west from the harbour of Göteborg.

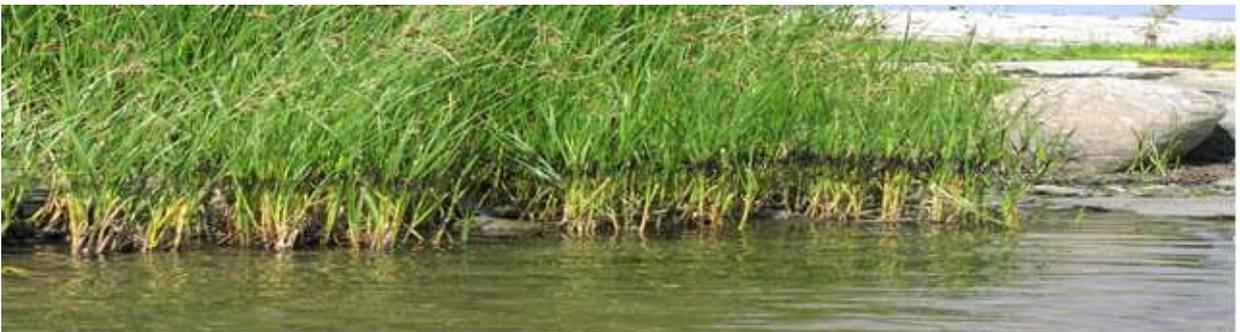
Environmental consequences of the spill of heavy fuel oil in the oil harbour.

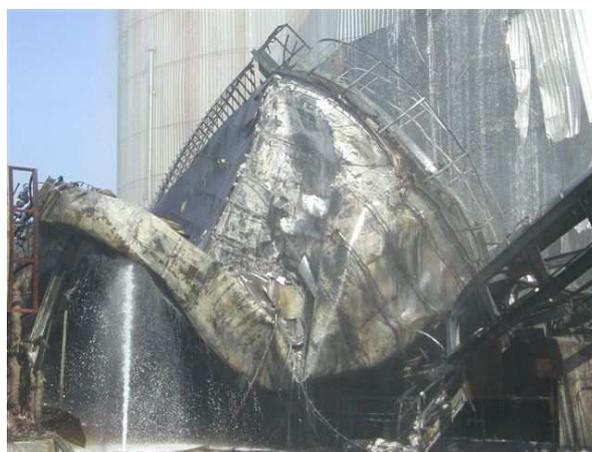
Fig. 3

The missile-tank exploded fell down on a 2nd bitumen tank (TK166) of 8000l of capacity. The missile roof entered in the TK166 shell, then squeezed itself into the TK166 basin (Fig. 2,3).

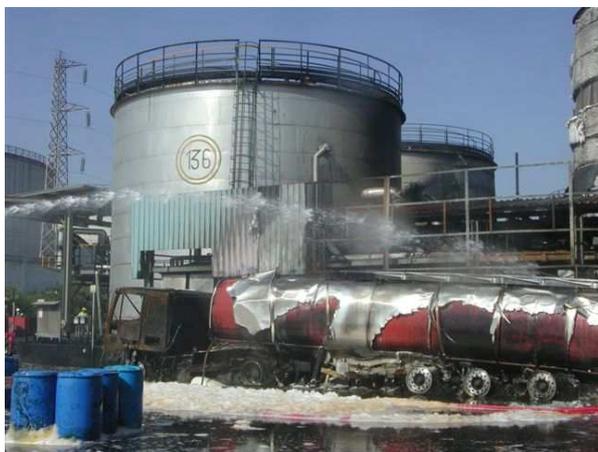
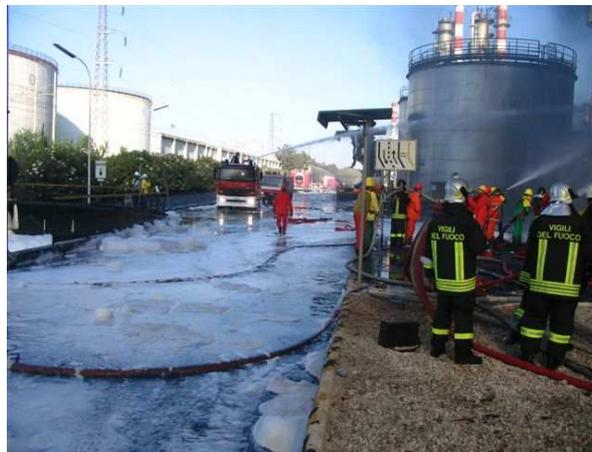
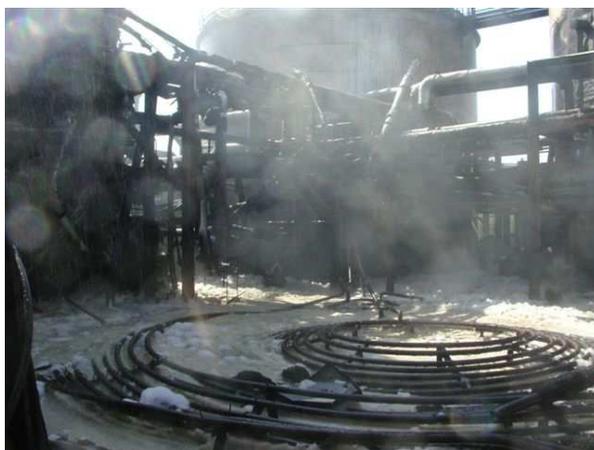
Fire was handled through water and foam, while tanks and browsers involved were been cooled (Fig. 4, 5, 6).

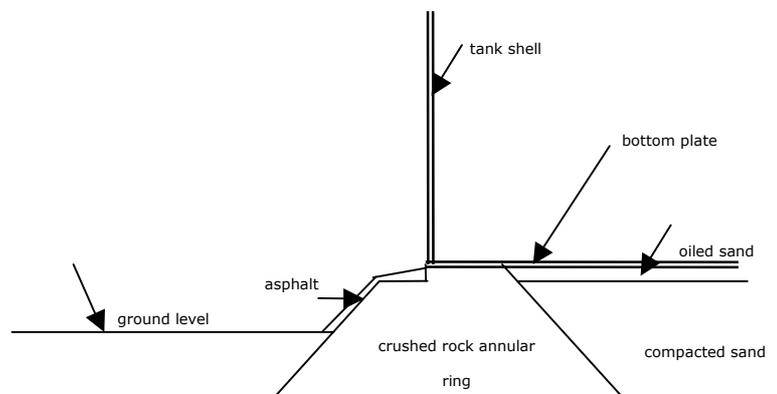
Figure 2: Schematic view of the tank foundation

The foundation of storage tank D2 consisted of a crushed rock annular ring. The rocks had a diameter between 50 mm and 150 mm. The crushed rock annular ring had a height of approximately 120 cm of which a part was below the ground level. The crushed rock ring had a width of approximately 340 cm at the bottom and 100 cm at the top. The shell was situated in the middle of the width of the crushed rock ring. The inner part of the annular ring was filled with compacted sand. Above this sand there was a layer of 5 cm consisting of oiled sand, to avoid external bottom corrosion. Figure 2 provides a schematic view of the foundation of storage tank D2.
