## >Welcome address

DRIRE ILE-DE-FRANCE (the Regional French Authority on Industry, Research and Environment)

## Opening address

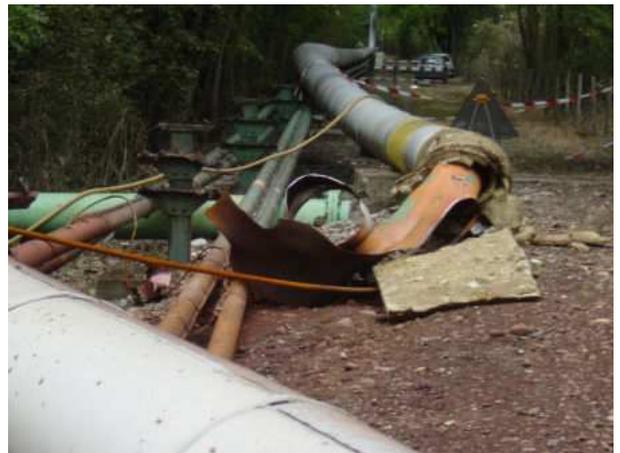
Source : DRIRE Rhône-Alpes

An incident in **April 2001** (branch connection left open during rainy season while the chlorine transport line had been placed in a trough during the replacement of an insulation valve of a pressure sensor) allowed humidity to enter and hydrate a part of the ferric chloride contained in the passivation film. This hydrated ferric chloride was deposited in its solid form in the operational pipeline between April 2001 and May 2005.

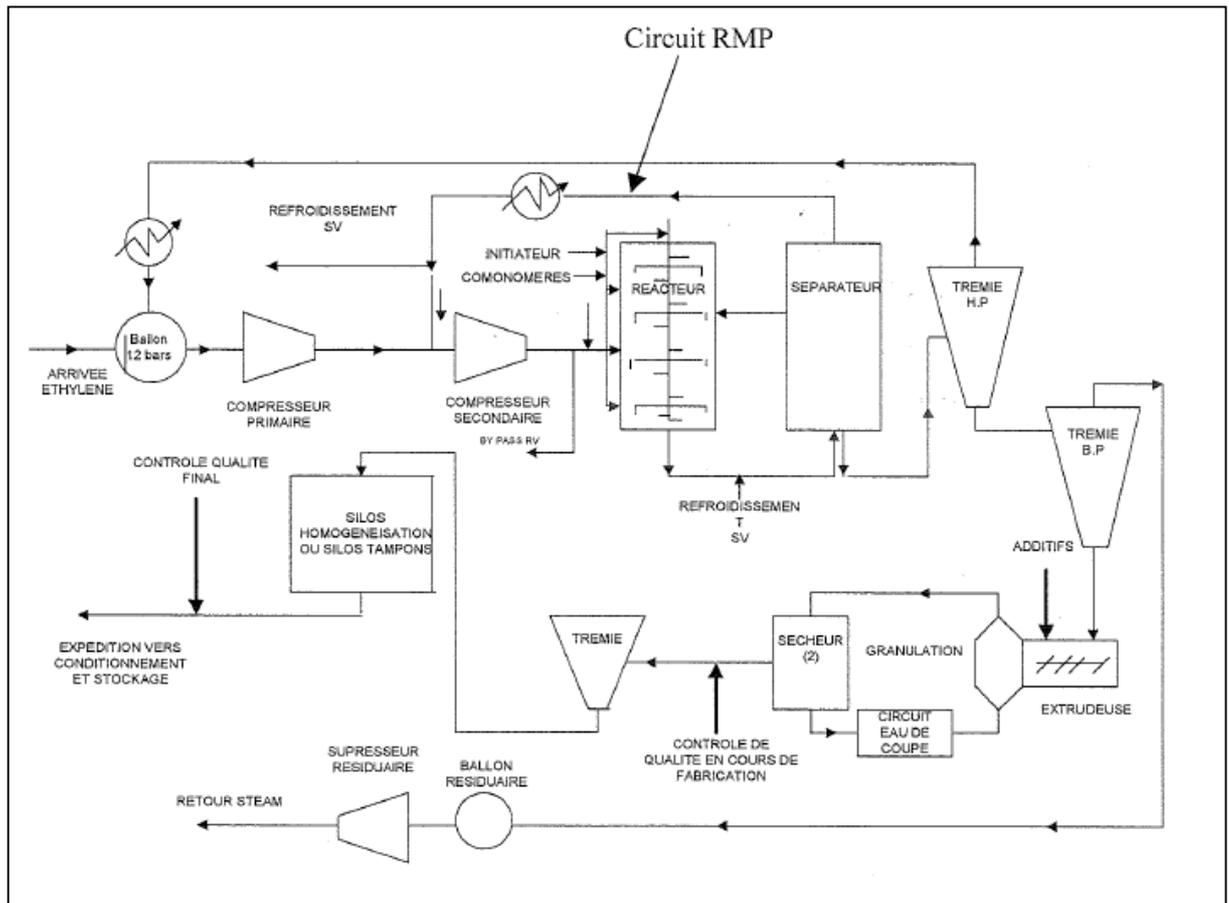
Figure 1: Simplified diagram of the process

A simplified description of the reaction is as follows (see figure 1): the ethylene undergoes polymerisation in a reactor pressurised between 1,000 and 2,200 bar and at temperatures ranging from 150 to 300 °C. The pressure is controlled by a valve located at the outlet of the reactor; this valve also is used to extract the reagent / polyethylene mixture. The mixture is then directed to the separator of the Medium Pressure Return line where it is separated into two phases (approximately 20% polymers and 80% ethylene as the conversion rate of the reaction is in the order of 20%). The polyethylene drawn from the lower part is then conveyed to the high then low pressure hopper. The ethylene is also conveyed with the polymer phase.

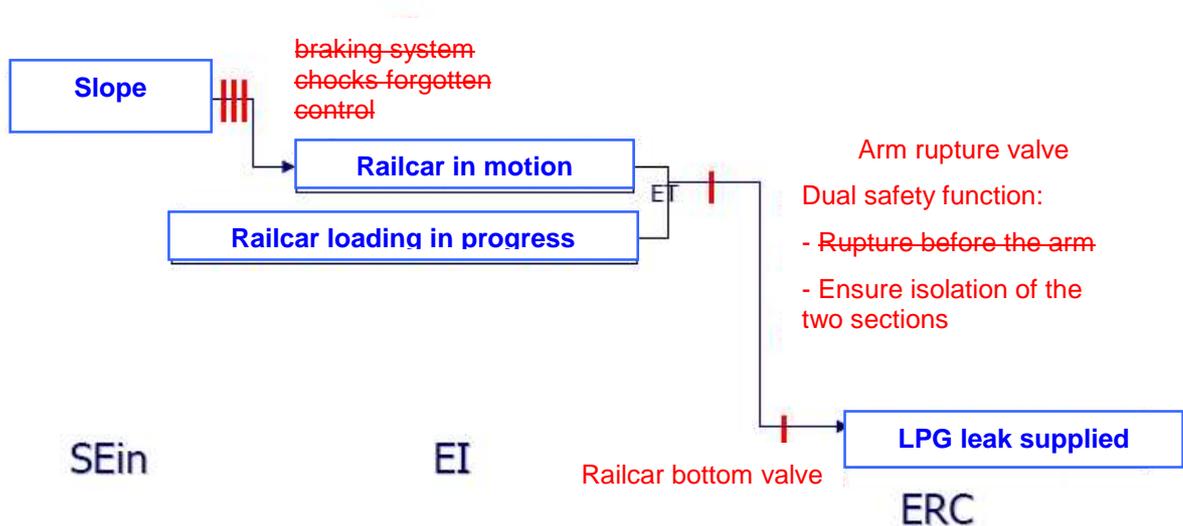
Furthermore, the coupling ruptured on the railcar side. The expert assessment conducted on this element showed an insufficient original thickness and extensive corrosion.

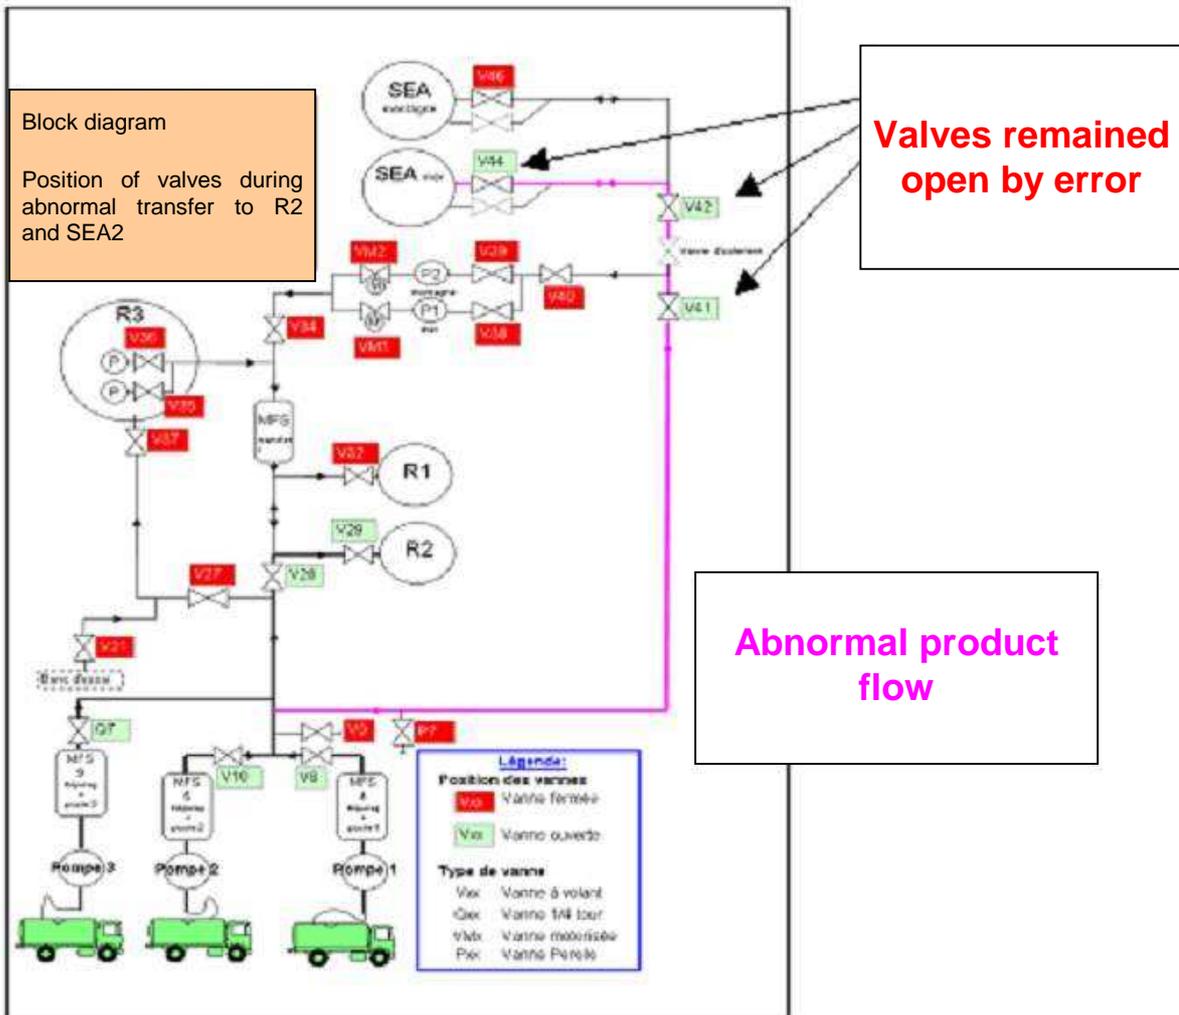
The high level detection safety alarm on the SEA2 tank did not function.

**At around 8.30 am**, a worker of the depot B noted jet fuel pouring from the two vents on the SEA2 tank: a phone call was made to the facility A to stop the transfer operation. The facility's emergency shutdown was activated which immediately stopped the transfer operation.

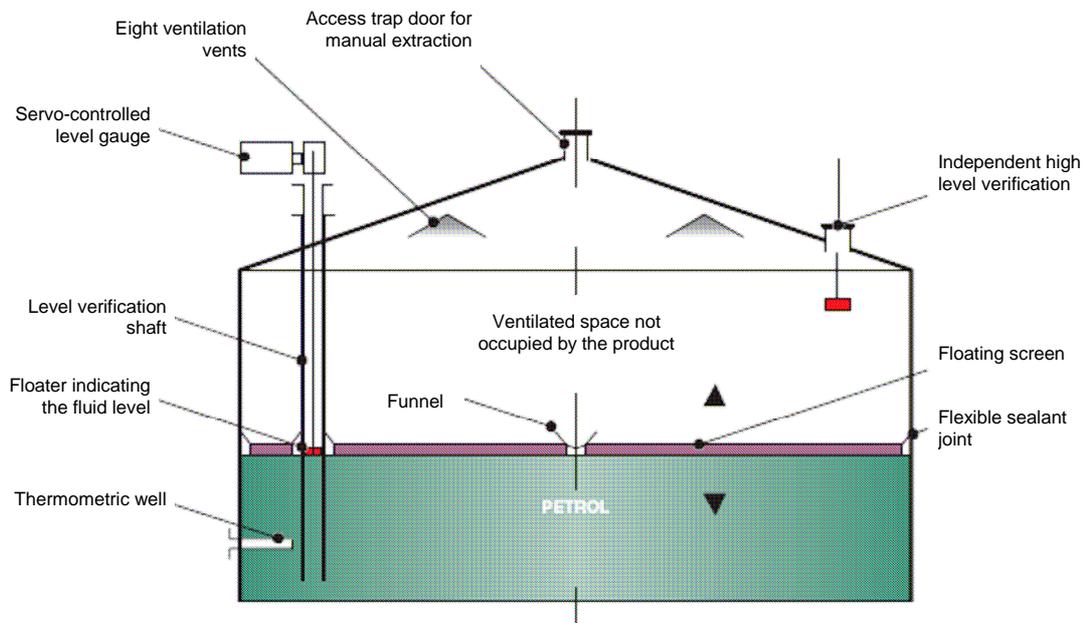
Diagram 2: Control instrumentation present on Tank 912

Moreover, a control room switch allows cancelling the transmitted signal sent to the fuel supplier during the "high level" test periods. When placed in the active mode, a red indicator lights up on the control panel.

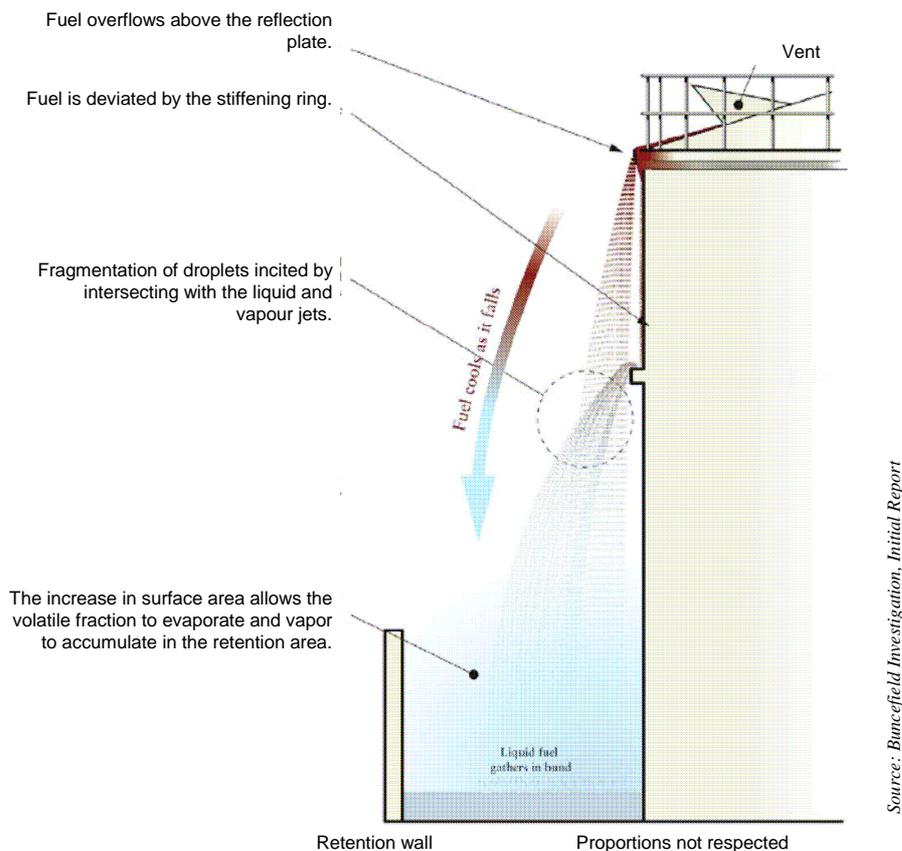
Diagram 3: Tank 912 overflow phenomenon

- Initially, yet to a more minor extent, product flow deviation by means of a tank stiffening ring (see Diagram 3).
- But more importantly, the high concentration of non-stabilized butane (10%) in this type of "winter" fuel incited both a high amount of gas evaporation even at relatively low temperatures (high vapour pressure: 70 - 100 kPa) and the formation of a butane cloud (estimated at several tons, given the quantity of gasoline that poured out).

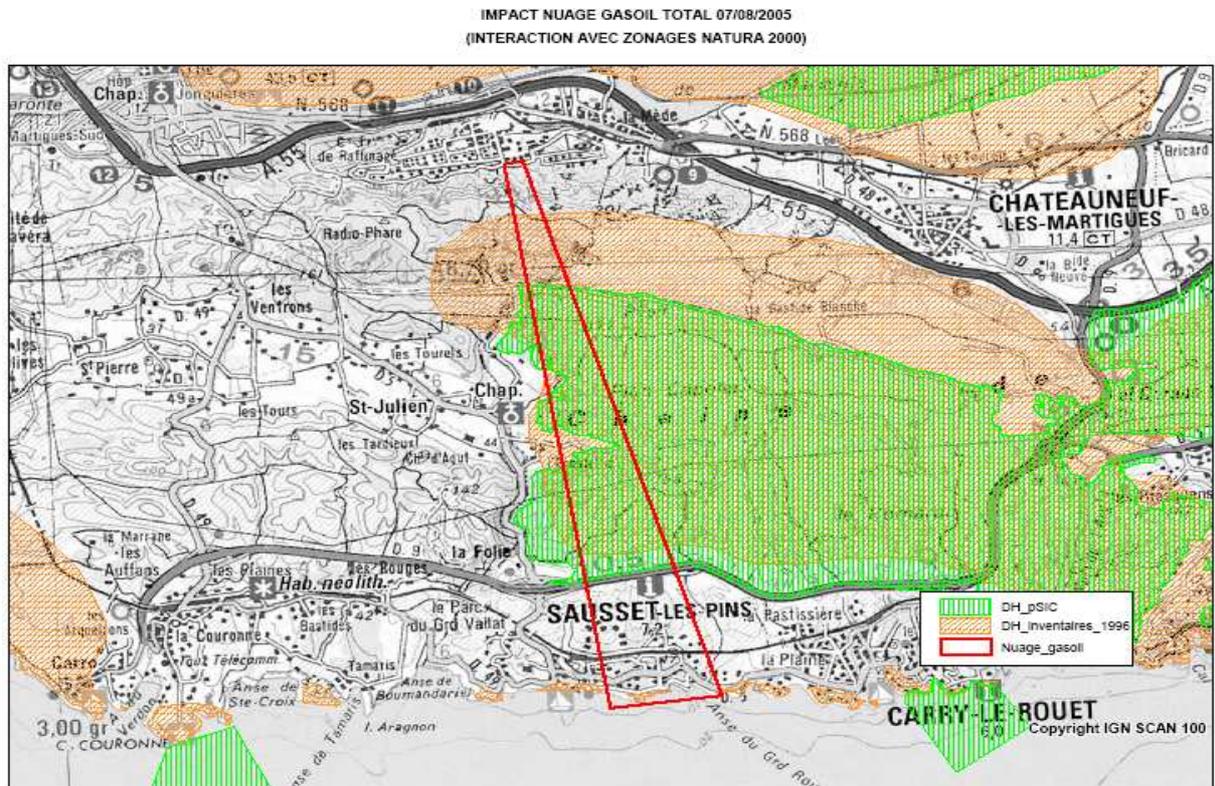
General aerial view of the unit and traces of spill in the environment south of the site
