LESSONS LEARNT
from industrial accidents

IMPEL Seminar
Aix-en-Provence, 16 and 17 November 2011

Table of contents

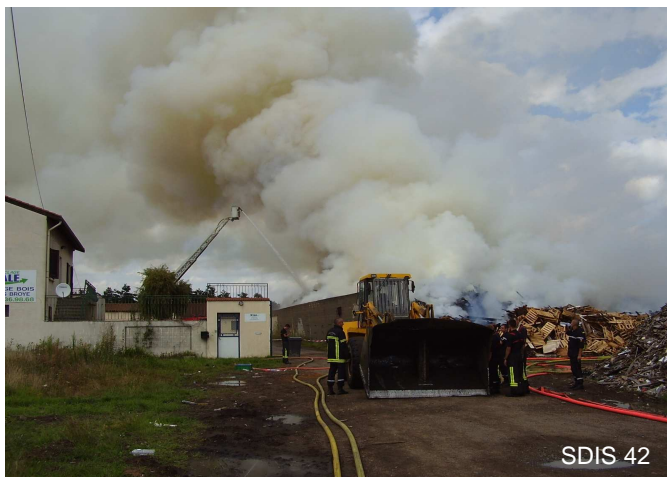
On 22 August 2008, a fire broke out around 4 am at a wood storage zone (containing pallets), spanning 2,000 m² of land area with heights in some spots reaching 10 m. Emergency response units quickly arrived at the scene with over 60 fire-fighters deployed. An impressive column of smoke drifted towards the agricultural areas.

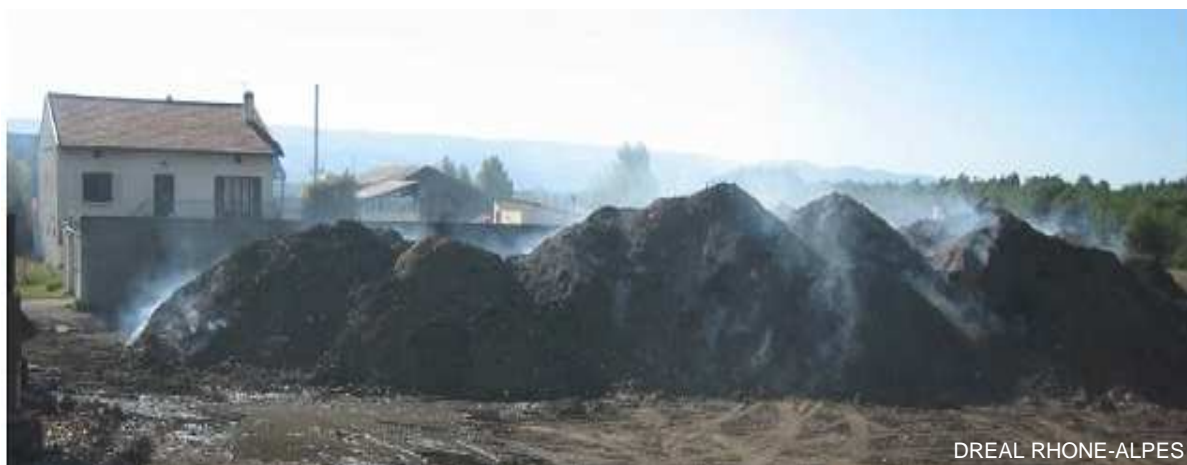
Several days were needed to bring the fire under control, as winds fanned the flames. Also, fire-fighters were forced to change strategy at the end of August, following a pollution incident at the Veauchette ponds due to the fire extinction water. Fire sources had to be isolated from the rest of the stockpile, which led to mixing wood with earth.

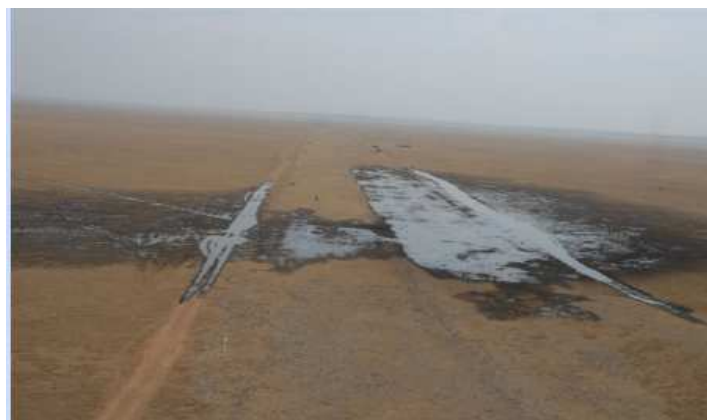
5,400 m³ of crude oil were discharged over a 5-hectare land area amidst the nature reserve. The oil spill was measured by a certified land surveyor.

Polluted zone (SDIS 13, Fire and Emergency Services)

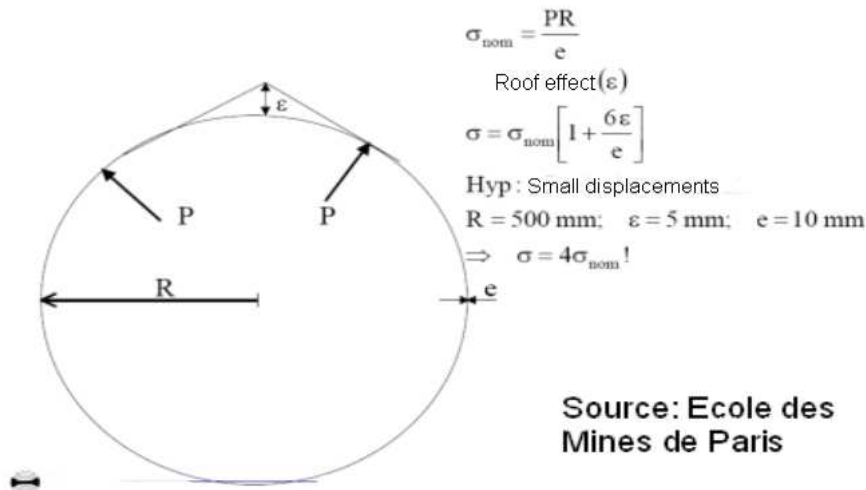
HARMFUL ROOF EFFECT

The most recent tube inspection had been performed in 2003; five tubes underwent inspection, including the one that eventually burst. These inspections confirmed the presence of roof effects, yet they only varied slightly and moreover no cracks were detected when applying ultrasound techniques.

Following the accident, a delamination defect was exposed at the level of the longitudinal weld of another tube displaying the roof effect and positioned not far from the tube that burst. The facility operator compared this observation with the results of the 2003 inspection of the broken tube.

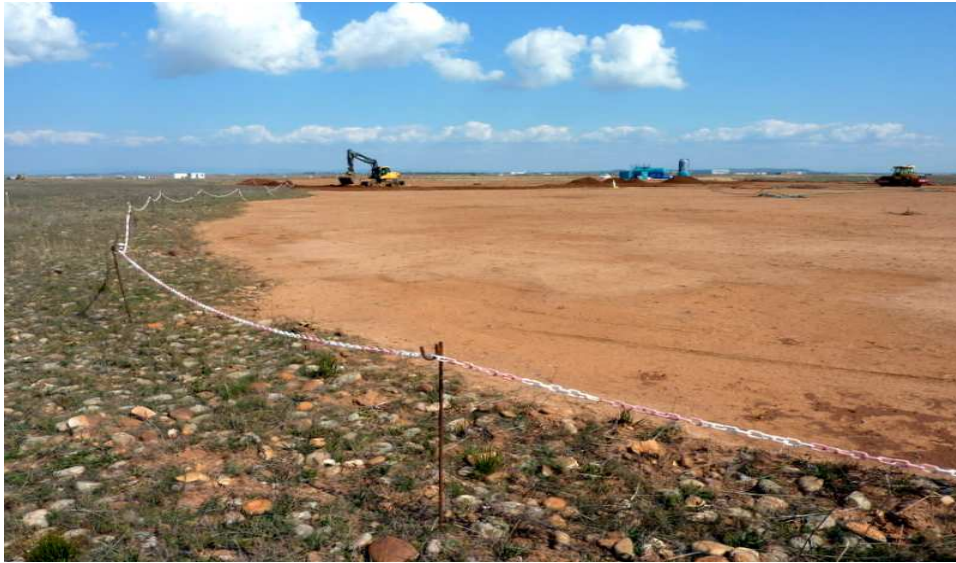
Restored and compacted zone - RR

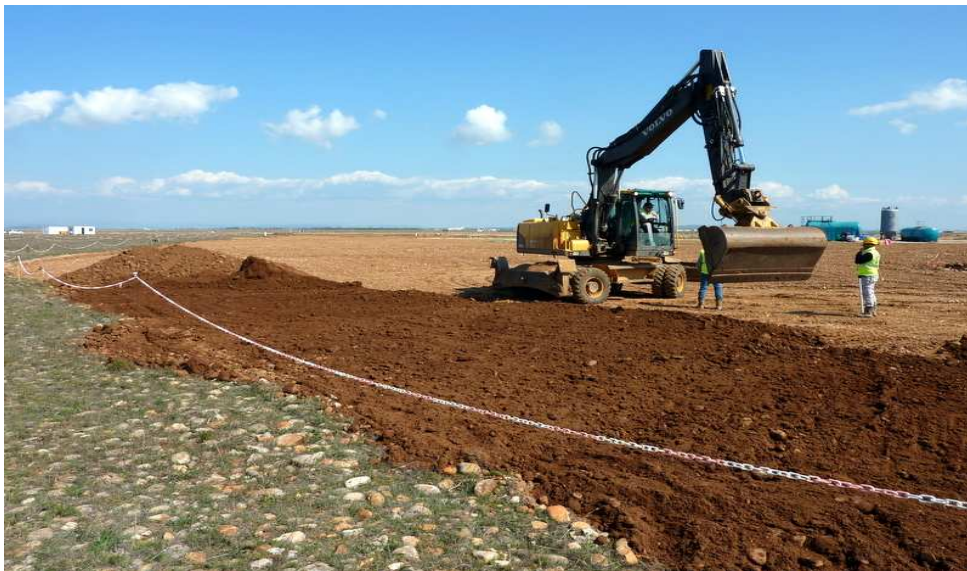
Spreading of the surface layer - RR

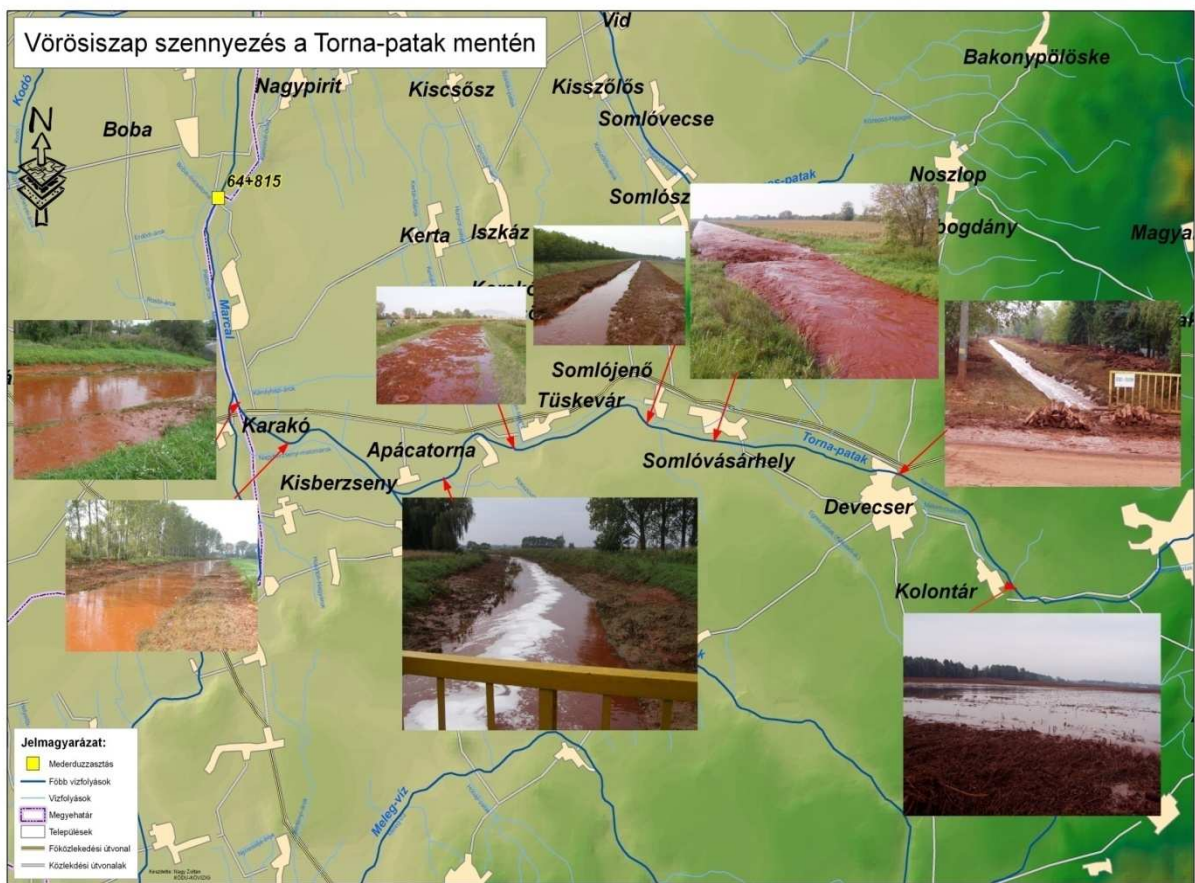
4. Contamination along the TORNA Creek

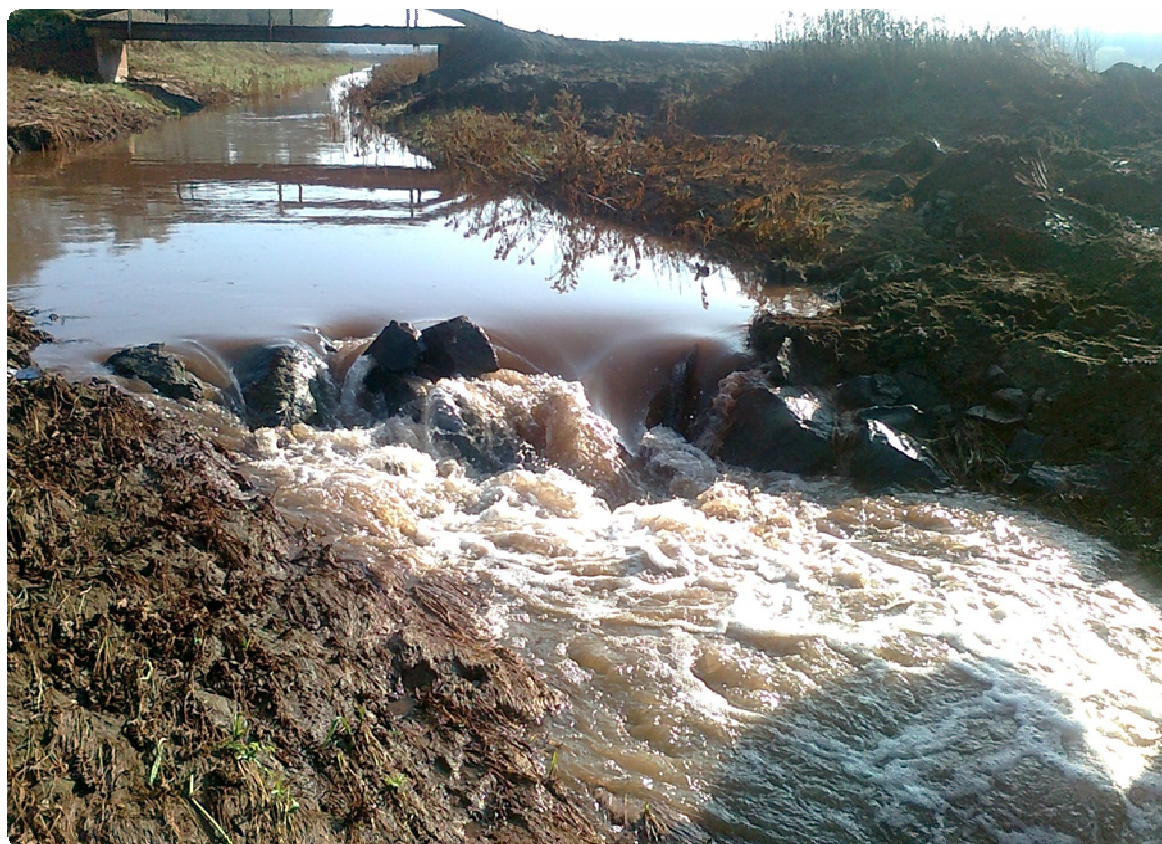
Hungary took intensive measures on the whole length of the MARCAL River before the arrival of the pollution plume to settle down the suspended solids possibly contaminated by heavy metals. For this reason decision was made to construct 7 so called “riverbed barriers” (artificially created obstacle under water – on the river bottom - to stop the heavier fractions of contamination (the red mud) in the riverbed).

5. Riverbed barrier

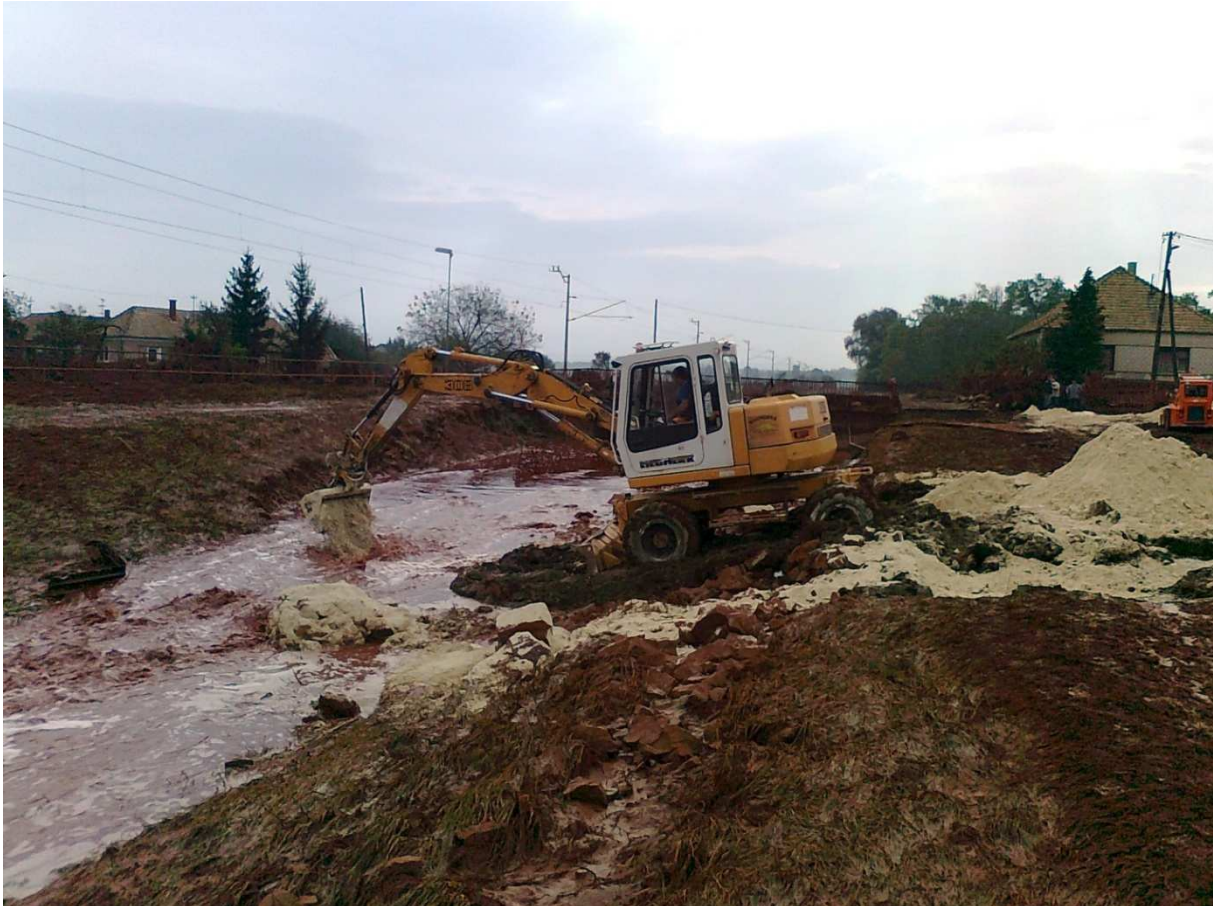
Protection of water quality also demanded immediate action. The most important measures were neutralisation of water and the capture of floating matter containing heavy metals. Gypsum (23,500 tonnes) and acetic acid (cc. 1,800 m³) were used to reduce water pH levels. The mixing of gypsum as it began to be applied was aided by the use of high-pressure fire-hoses and aeration equipment. In the settlements involved gypsum was also added directly on affected areas.

7. Decontamination (gypsum dispersion, below Kolontár Bridge)

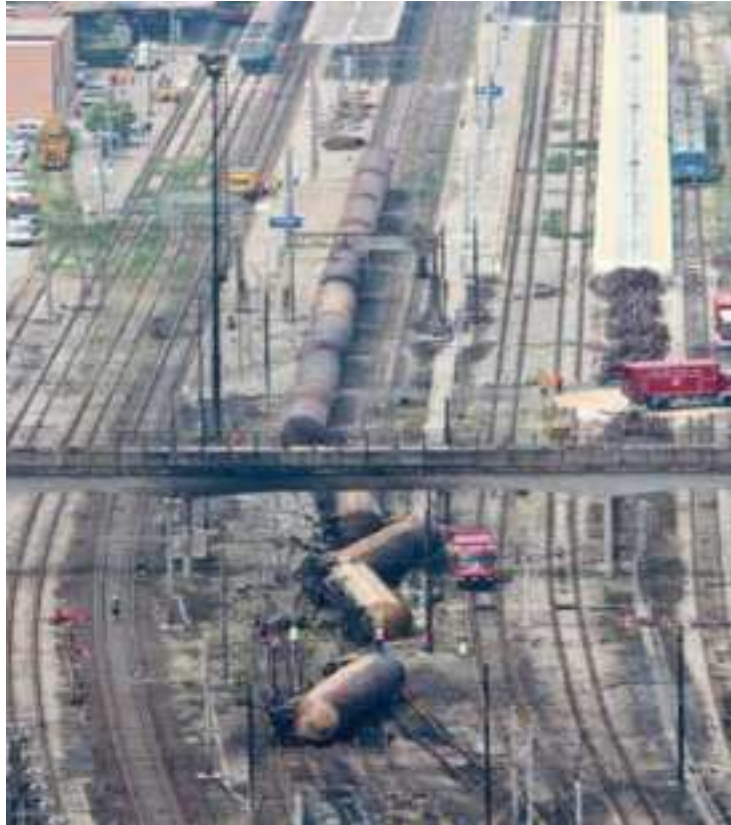
Fig. 2

On the 29th of June 2009, shortly before midnight, the 50325 train derailed while crossing the station of Viareggio and five of fourteen rail tankers overturned (fig. 2) [4]. The train was travelling at about 90 km/h (below the speed limit set at 100 km/h) [1] [5]. The first rail tanker plowed the ground and breached probably after the hit with a signaling stake beside the railway or with a rail switch (this point is at the time of writing under investigation during the trial) : the impact caused a hole, about 40 cm long and about 2 to 5 cm wide [3] [2], from which all the LPG escaped (45 t). No loss of containment occurred from the other 13 rail tankers vessels.

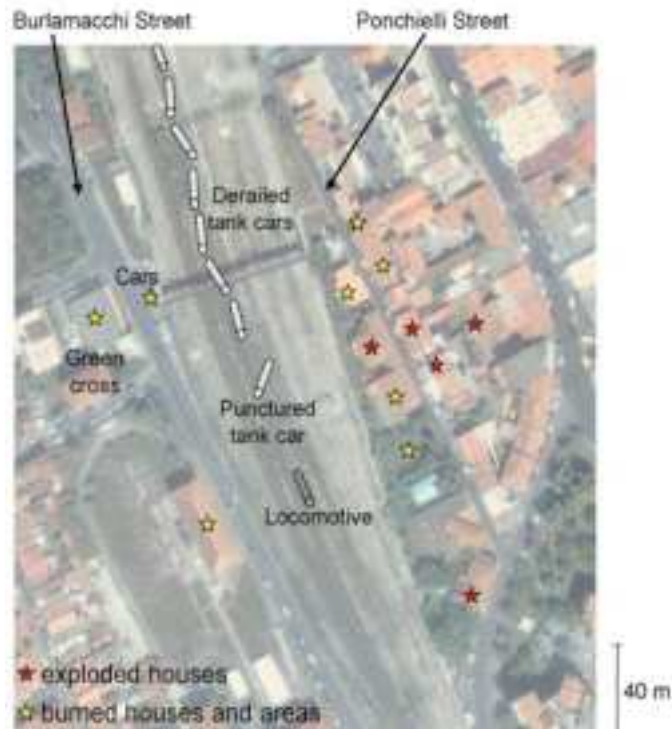
Fig. 3 RR

The buildings along via Ponchielli, and the neighbouring streets were on fire, with approximately 200 metres of flames on both sides of the road. Five houses collapsed due to inner explosions. Almost all the remaining houses of via Ponchielli burned due to the subsequent fires that engulfed also other areas surrounding the station (fig. 3) [4] including trees in a small public children's park some bushes and parked cars and trucks (fig. 4) [4]. The poolfire from the liquid-phase LPG could be noticed far away with flames as high as 20-25 m [2] [3].

Fourteen people died immediately: some under the collapse of buildings or suffocated by the smoke inside their houses ; some burned because standing inside the flash area. The fatalities rose to 22 people the day of the state funerals. Finally, there were 32 fatalities (one woman had a heart attack), the last person died exactly two months after the accident. More than thirty people were seriously injured. About 1100 people had to evacuate their homes for safety reasons.

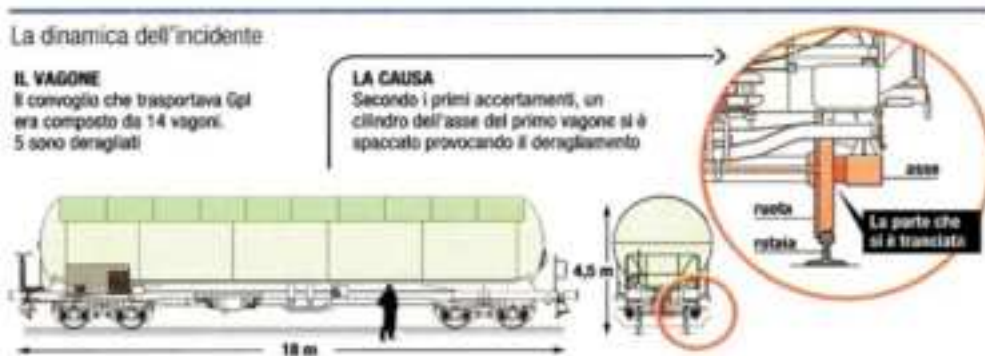
Fig. 5

- 1) Mechanical failure of the front axle of the first wagon. The failure occurred exactly between the wheel and the axle (fig. 5) [7] probably when the train was at the entrance of the station, and the train derailed after about 700-800 m [7], then the truck (the whole complex wheels-axle) was projected at about 70-80 m away [7], and the first wagon overturned (fig. 6a). The section of the rupture looks smooth on more than 90% of the surface (fig. 6b and 6c) [4], the other part of the section appears instead coarse and corrugated. These elements seem to suggest a fatigue-type rupture [1] [4], that developed in a relatively medium - long period, and consequently raise questions about identification of the problem, control inspection procedures and adequacy of verification techniques applied: is there any evidence that this kind of rupture happened in the past ? Was a risk analysis conducted identifying this kind of failure and possible consequences? Do tanker control inspection procedures require specific attention to the system wheels - axle? What is required in terms of integrity test of that specific part? Is the kind of test required sufficient to identify the potential problems ? Is the time period between controls short enough to prevent that kind of failure? In case of transportation of dangerous substances are these controls sufficiently stressed?

- a) fatigue-type rupture of the axle, if confirmed by the conclusion of the investigation, will point out the need to reinforce the check-inspections, in particular in terms of :

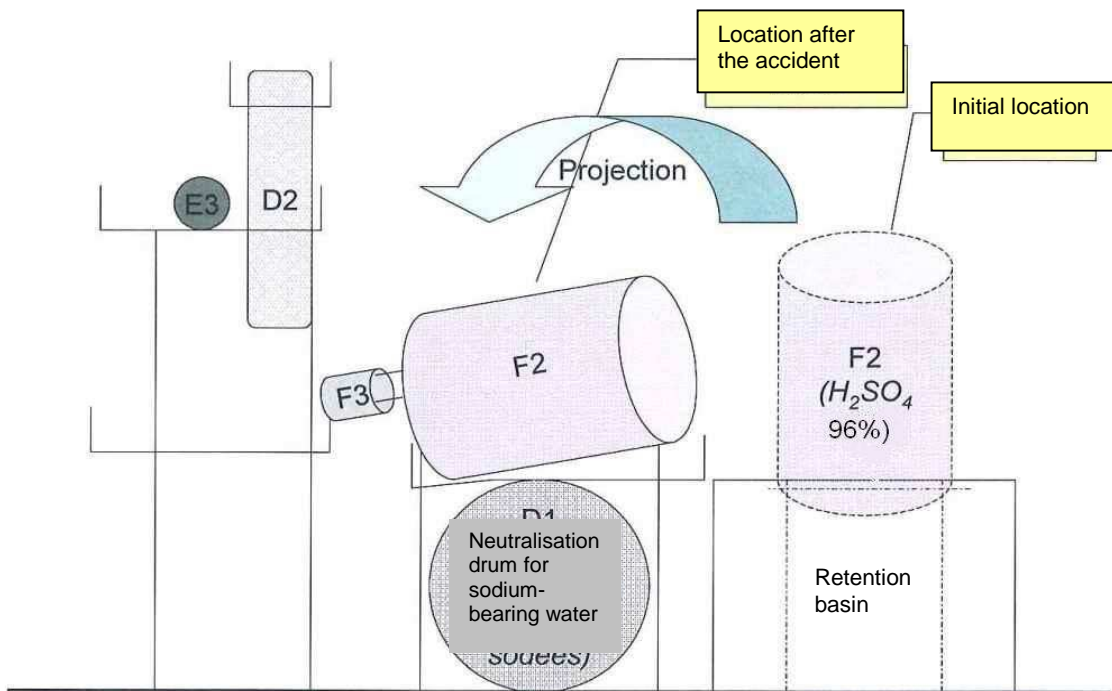
Diagram of the accident scene

This tank had already been repaired in 1989 following an incident that caused its delamination, yet without breaking any fastenings, due to a release of carbonic gas during the sulphuric acid neutralisation step (ARIA 23705). A support bracket had been added in response to this initial accident, and the cleaning procedure was also revised.

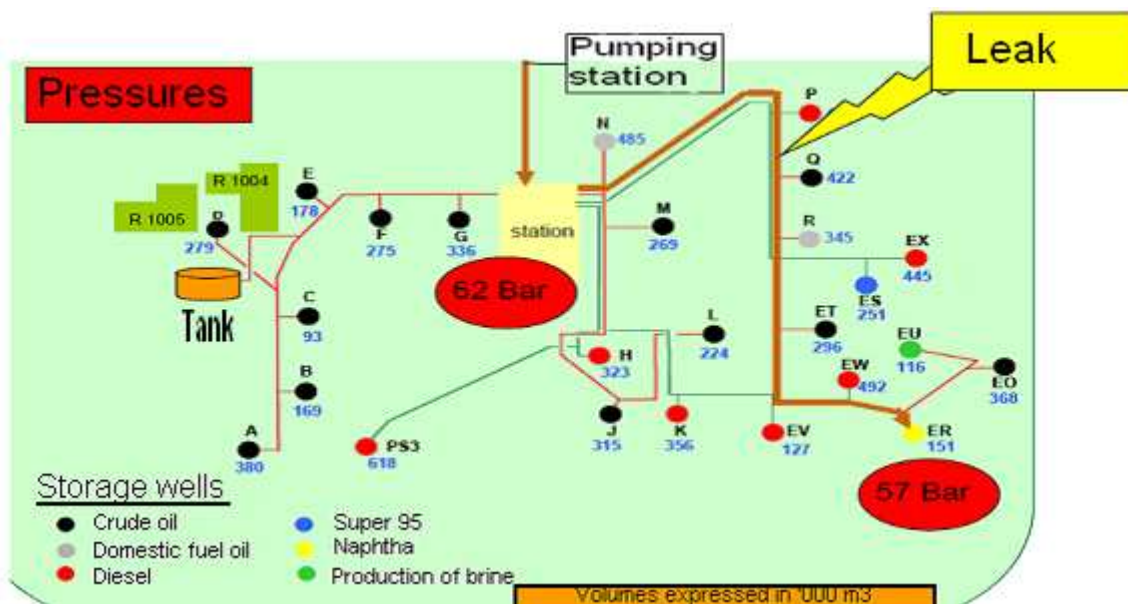
The infrastructure was an underground section of pipeline connecting a pumping station to a saline cavity (denoted ER 151 on the drawing), featuring the following primary characteristics :

- Diameter (DN): 500 mm ;
- Maximum service pressure: 66 bar ;
- Pressure at the time of the accident: 62 bar ;
- Underground depth: 2 m ;
- Component material: Steel (type: API 5L X42) ;
- Nominal tube thickness: 7 mm ;
- Product being transported at the time of the accident: naphtha, whose flash point is on the order of 41°C. The Lower Flammable Limit is 0.6% to 0.8%, while the Upper Flammable Limit is 6%-7%. Moreover, the vapour pressure equals 0.3 kPa at 20°C.

Installation layout and leak location (all rights reserved)

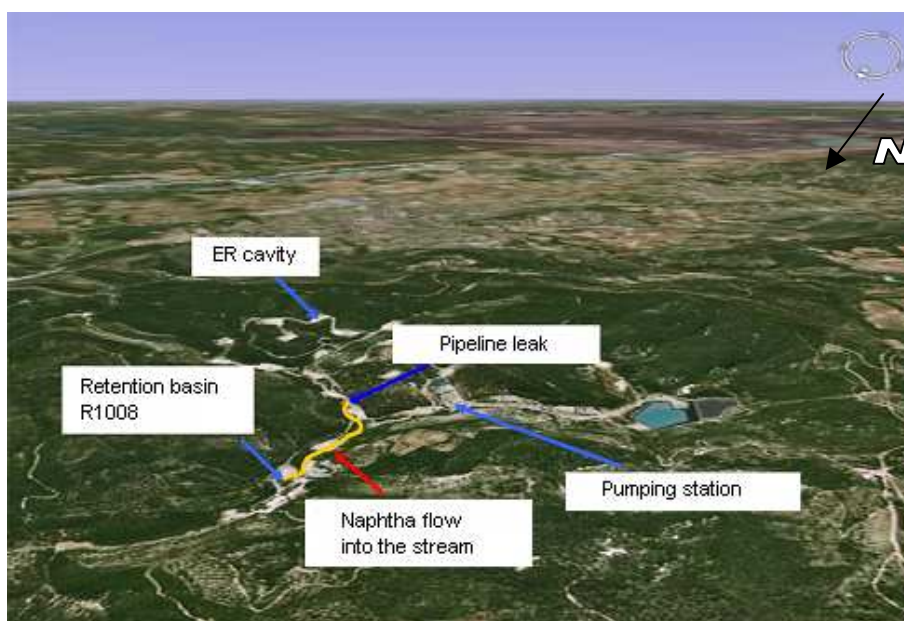
7:43 pm : The leak was located; naphtha was flowing on the road and into the stream for ultimate discharge at the outlet.

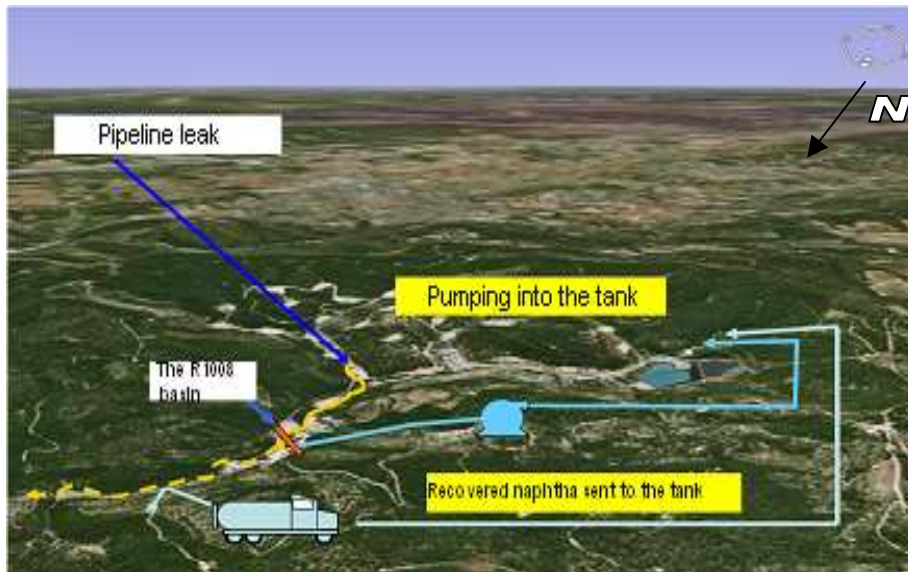
12:20 am: Use of mobile pumping facilities, then stationary pumps in order to recover naphtha from within the basin. A specialised subcontractor wound up pumping 150 m³ of naphtha.

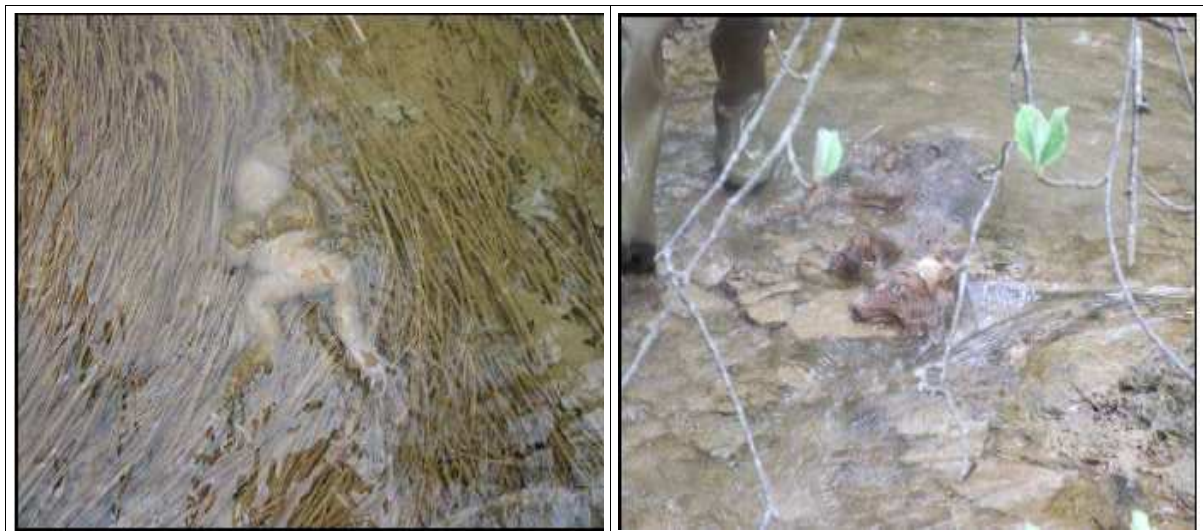
Impacts on both flora and fauna within exceptional protected habitats were observed: dead mammals, amphibians and invertebrates.

Fatal impacts on toads and foxes (all rights reserved)

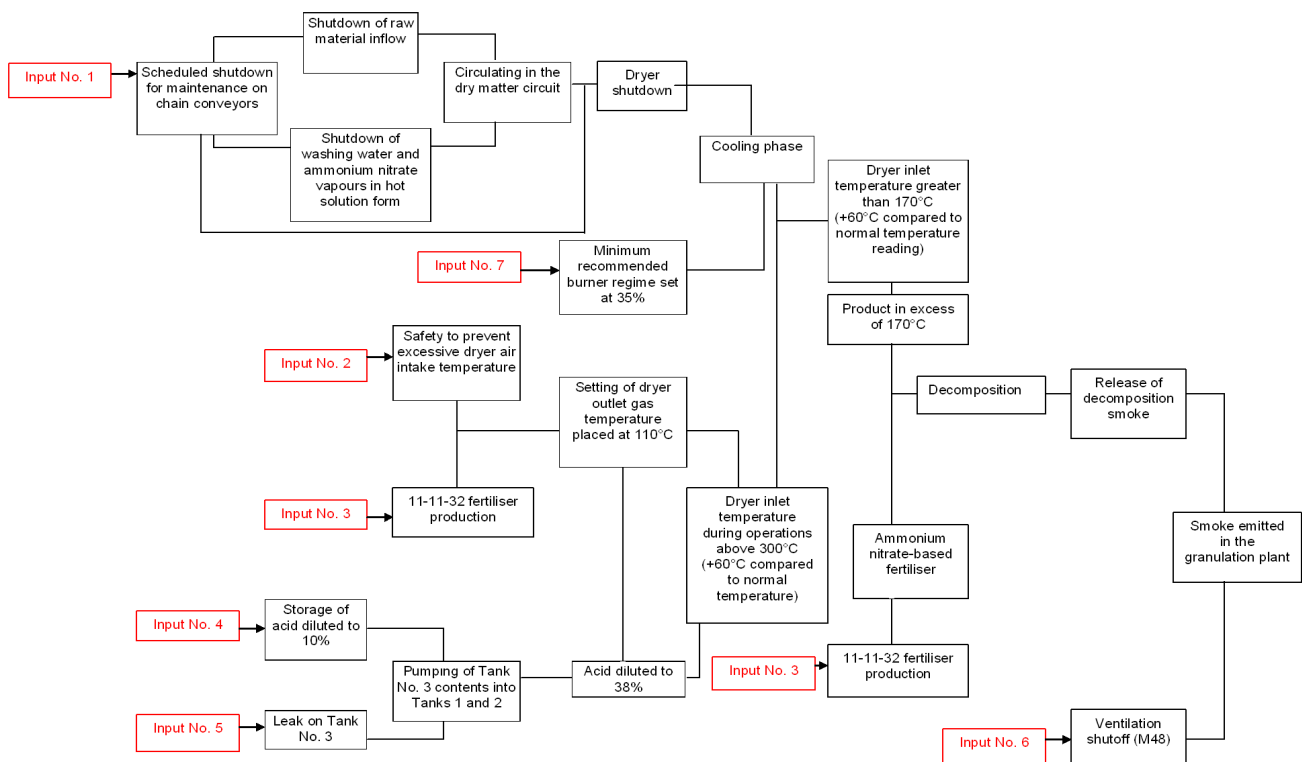
The use of a lower concentration phosphoric acid (38%) than that typically used (53%) caused a thermal disequilibrium of the dryer installation. The slurry of ammonium phosphate powder on aggregates therefore contained more water to be evaporated, resulting in a lower dryer outlet gas temperature. Since this temperature had been set at 110°C, the drying inlet air temperature was automatically raised in order to compensate for this disequilibrium. A temperature close to 300°C was recorded at the dryer inlet instead of the more customary 240°C.

This technically-motivated shutdown procedure transitioned the plant into a dry granulation operating mode with periodic interruptions of the rotating tubes, to ensure the product stayed dry in the granulation loop and avoid clogging by product riprap on the tube walls. Nonetheless, the temperature reached at the dryer inlet, after the cooling phase (according to a procedure that was strictly followed), was 170°C in stead of 110°C due to the high initial temperature (300°C). Start-up temperature for the dry fertiliser decomposition process (above 170°C) was reached inside the dryer inlet tube, thus leading to fertiliser decomposition and the release of yellow smoke. No alarm was sounded since the alarm threshold (370°C) for the hot air intake temperature probes had not yet been exceeded.

Causal tree of the accident

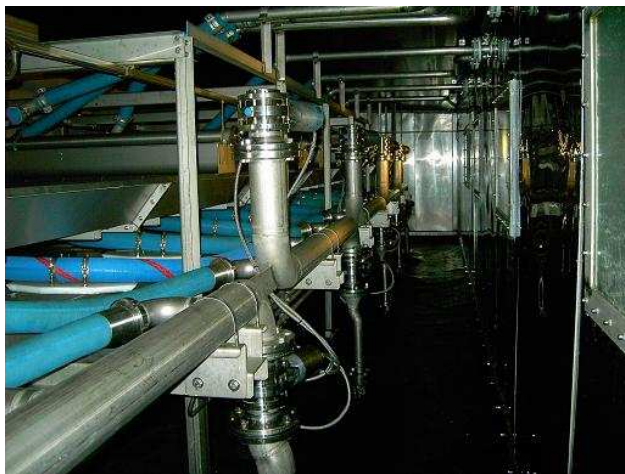
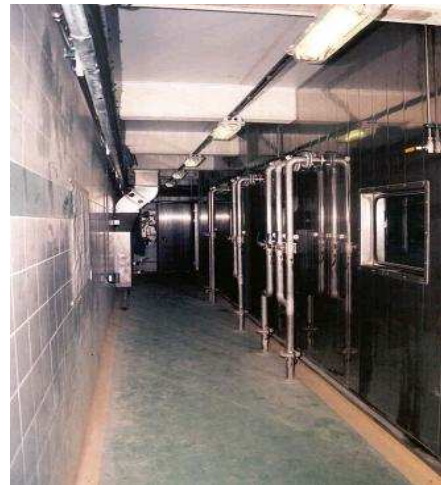
In 1999, the CMC demand was high and the production capacity needed to be doubled. Two new vacuum belt filters were installed in the old factory. No safety facilities such as Explosion Release Control (ERC) equipments were present or installed in the old building.

Good practice is to use a GT (Gas Tight) type vacuum belt filter when a solvent is used during the purifying process. However, due to the experience of this company (difficulty for maintenance, adjusting the belt) and the costs involved (GT Type 3 times more expensive than RT type)) the company decided to buy two RT Types vacuum belt filters and build the enclosure on their own behalf.

Since possible ignition sources were present in the enclosure, the prevention of an explosion entirely rested on upon the prevention of an explosive atmosphere. A nitrogen purge unit was used to prevent an explosive atmosphere in the enclosure.

This company also made a study of new ways of purifying CMC cake and will replace in 2012 their vacuum belt filters by Rotary Pressure Filters (RPF). A RPF is a compact installation with less space (smaller risk of explosion hazards) and with all moving equipment (possible ignition sources) outside the installation.

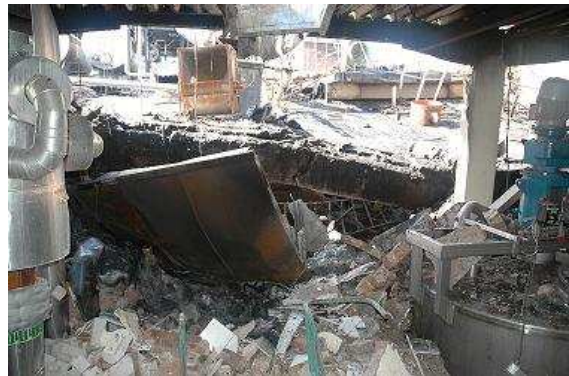
RR

At about 4.15 pm, the supervisor opened the slurry valve in order to continue the production process. Immediately after opening the valve an explosion occurred and destroyed the enclosure and surrounding compartments of the factory and set fire to the building. The stored CMC in the expedition part of the factory smouldered for 38 hours.

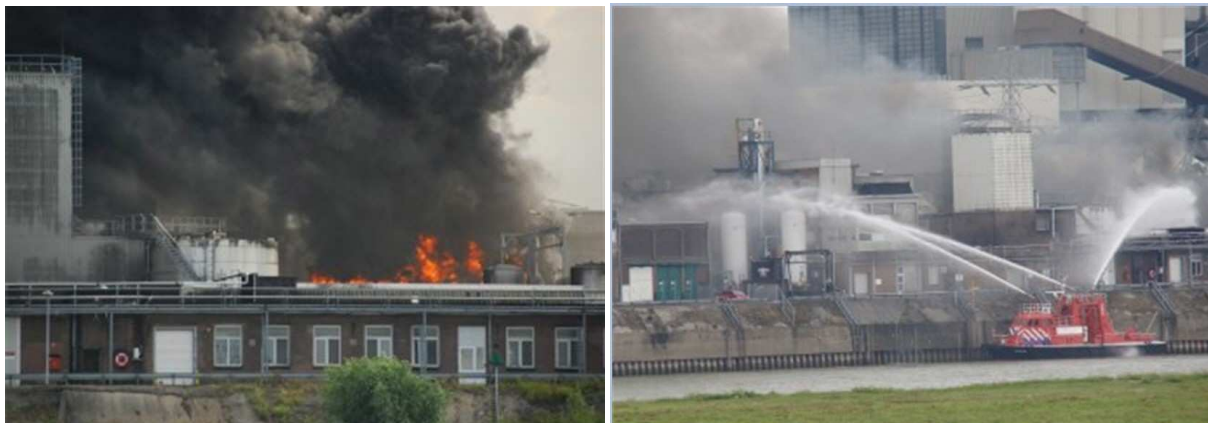
Short after the accident, a security perimeter of 500 m was set up and significant human and equipment resources were put in action including one hundred firemen, twenty-five vehicles and a fireboat to attack the fire from the river. The fire lasted 38 hours.

Fire fighting operations (picture: De Gelderlander R.R.)

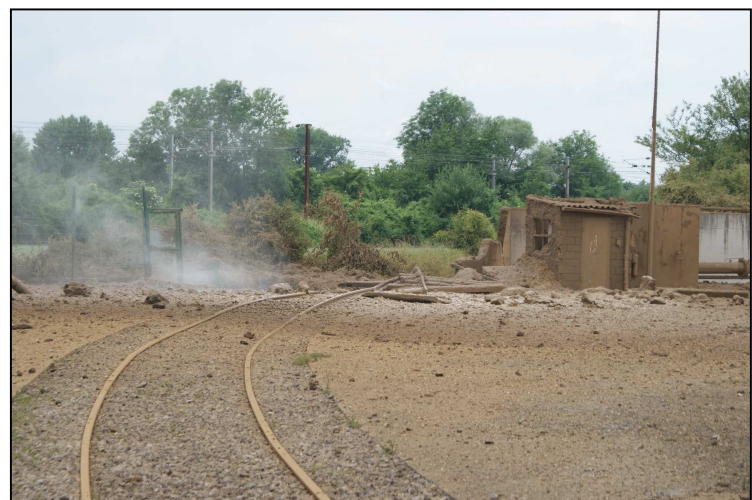
DREAL Lorraine

On 13 June 2010, the pipeline burst around 1:30 pm on the plant's premises at the boundary with public property, where the pipe passes in a concrete pipe underneath the railway that serviced the plant.

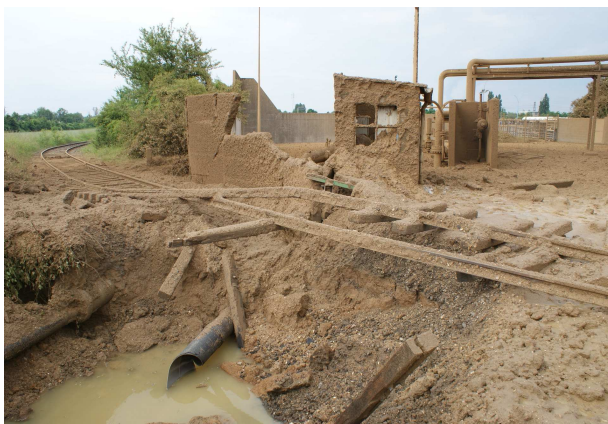
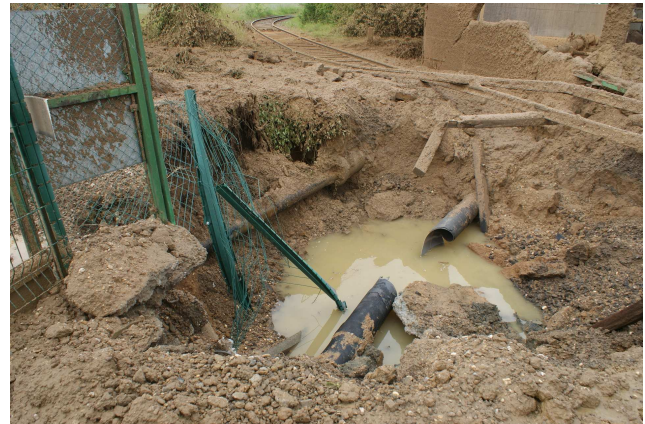
- The oxygen pipeline, "rolled out" in a strip over 1 m, was immersed in water.
- A crater was formed (diameter: 7 m, depth: 3 m). The TNT equivalent was evaluated by the operator at 0.14 kg.
- Pieces of the railway, along with sludge and fragments of pavement and concrete, were projected some 50 m (1-kg debris found 60 m away and 15-kg pieces blasted 30 m).
- A concrete wall located a few metres from the pipeline was partially destroyed.
- The fence was twisted and damaged.
- No fire outbreak was detected on the tube structure, although the onset of combustion was observed on a 220/24 V transformer installed in an electrical utility room 3 or 4 m from the break.

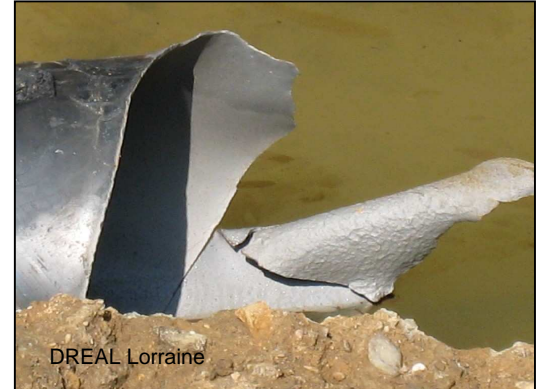
Corrosion seems to be the most likely source of this pipeline break. The metallurgical appraisal found the presence of generalised corrosion over a section where a casing crossed the alignment at the point of the accident, making it plausible to conclude that several factors acting in unison were the underlying cause :

- presence of an electrolyte (water), which moreover had a high chloride content
- delamination of the pipeline's anticorrosion lining
- defective cathodic protection
- an over-oxygenated atmosphere.

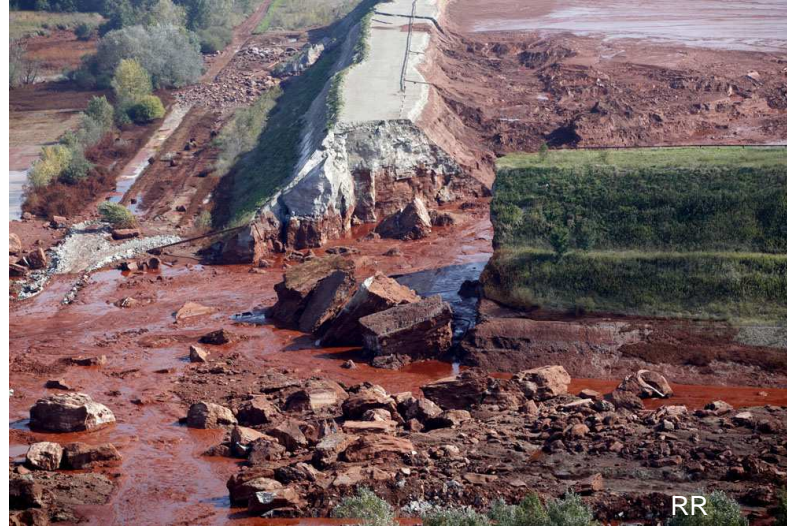
Massive red sludge release after the failure of a containment dam

Around noon, a red sludge basin at an aluminium production site employing some 1,200 personnel broke over a 50-m length, releasing 1 million m³ of highly basic sludge; 10 people were killed and another 286 injured (due to chemical burns and ocular irritation), of whom 121 had to be hospitalised. A total of 284 residences were destroyed and 400 evacuees had to be housed as an emergency measure.

In its official announcements, the Hungarian government noted an excessive filling of the basins. An NGO circulated photographs dating from June 2010 showing a leak. Local residents filed a class action suit against the operator, who had not drawn up any emergency plans. The operator denied all liability and cited the unusually high quantity of rain that fell during 2010.

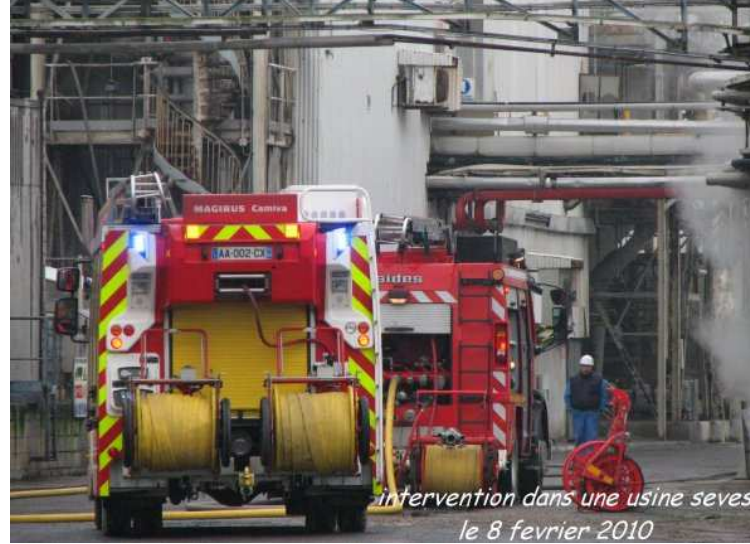
Thermal decomposition of fertilisers inside a dryer

The acidic dilution stemmed from an incident that had occurred 10 days prior, involving the unit's three H_3PO_4 tanks, two containing a 53% acid and the other a diluted corroded acid ($< 30\%$). With its shell leaking at a height of 1.5 m above the bottom, tank contents had been transferred into the other two tanks, thus diluting the acid used for manufacturing purposes.

The operator modified production standards, by introducing a "hot air intake temperature" alarm threshold adapted to each production run ($260^\circ C$ for ammonium nitrate fertilisers), along with the relevant maintenance shutdown procedure by indicating temperature controls and thresholds correlated with the steps required for installation shutdown, plus an internal emergency plan reminder to avoid stopping the fan in the event of toxic gas emissions.

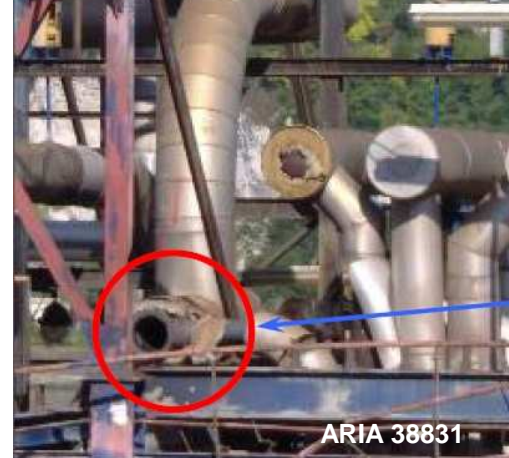
Rupture of an overheated water vapour pipe

The site operator only reported a slight amount of rust at the level of the break in the convex support and a hole on the inner wall of the outlet tube. A metallurgical assessment of the base indicated that slow creep had initiated on the outer skin, which combined with flow into the material layer was the cause of pipe rupture. This hypothesis relied on the detection of oxidised, yet non-deformed, pipe openings in the presence of intergranular microcracks on both the pipe and its base. The origin of this creep was explained by the metallurgical composition of the base, i.e. ordinary carbon steel containing no alloys and not adapted to temperatures above 425°C. The pipeline was made of a slightly-alloyed P22 type steel, which was more resistant to creep and compliant with the original specifications defined 32 years prior for both material elements. Inspections carried out at the time on the convex base did not detect any noncompliance of the steel, given that non-destructive technology had not yet come of age. This creep might have been accelerated as a result of heat treatment performed at 700°C during equipment installation, once the assembly had been welded. Periodic inspections dedicated to pressurised equipment on the damaged pipe were only recorded into the log 25 years after service start-up, at the time of applying for facility recertification. The initial recertification was rendered official without any underlying structural documentation (misplaced), and subsequent inspections never focused on the section of pipe that would burst.

Nine months before the accident, the in-house inspection team had requested adding the mode of "degradation by high-pressure vapour pipe vibrations" to the unit's pipe inspection routine, following a break in the drain valve of a high-pressure pipe when restarting operations at the unit. On the day of the accident, this mode had not been included in the inspection programme. Classified Facilities inspectors requested a materials control of all unit pipes before restarting operations; this additional step revealed 12 other noncompliant steel components (a tee junction, tap, base, flange, etc.).
