Chlorine leak in a liquefaction workshop of a chemical plant

January 13, 2004

Vieux-Thann – [Haut Rhin]
France

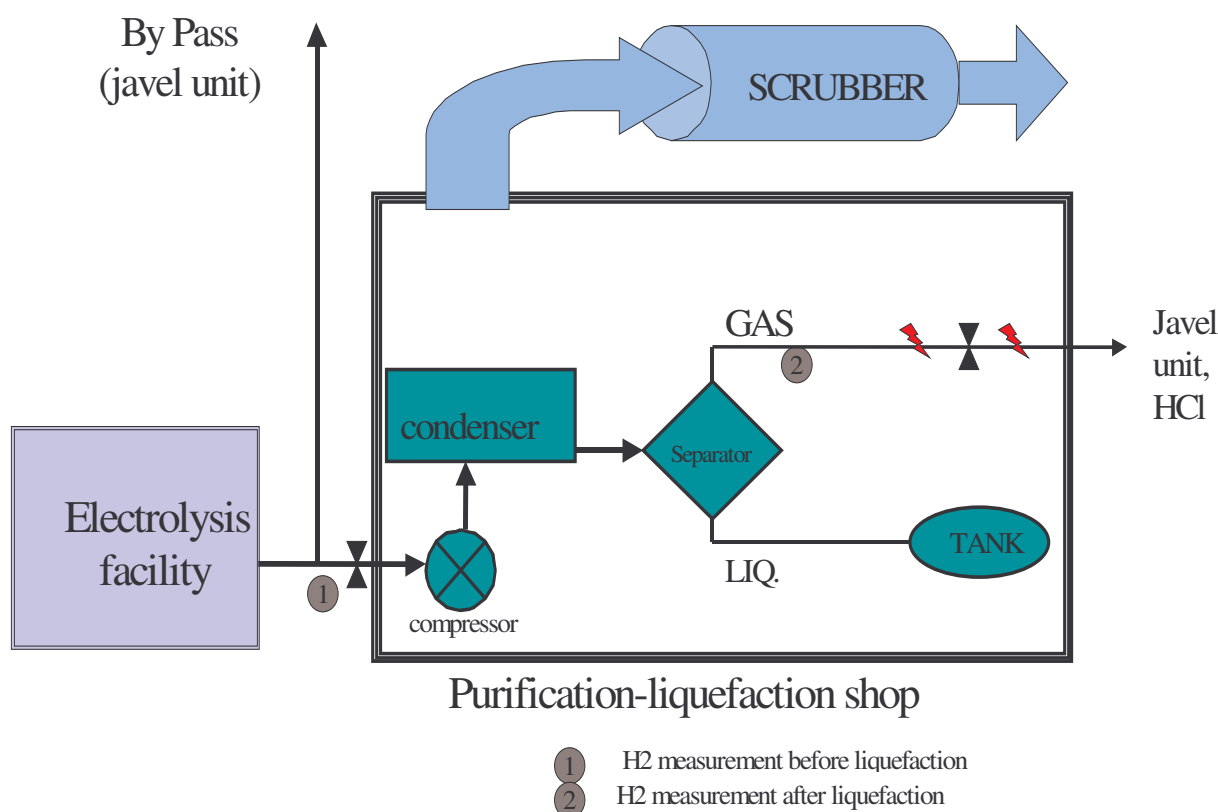
No employee or resident of the area was injured. A pipe was damaged in three locations. The quantity of chlorine released into the confinement building was indirectly estimated at 600 kg. The quantity released into the environment was limited to just a few kilos while the confinement building was depressurizing. Nearly all of the chlorine leaked was treated in the neutralisation tower for accidental releases.

The expert assessment conducted immediately following the incident showed that the leak, located along the limit of the confined zone, resulted from the combustion of the steel in the chlorine on a pipe transporting the gaseous chlorine: at two locations (located near zones in which the pipe size was reduced: valve and venturi), the pipe had disappeared over several centimetres, including a flange. A hole of diameter equal to that of the pipe (8 cm) was created in a third location.

The operator identified the cause of the iron/chlorine combustion process as a hydrogen-chlorine fire whose ignition energy is sufficiently low to start spontaneously due to an output restriction or a significant flow rate. The increase in the output to 1,000 kg/h could have also supplied the ignition energy required.

Besides the verification of the installations and the replacement of damaged parts, several actions were implemented to prevent the incident from happening again:
