# LPG release and flash in the LPG road-tanker Loading facility of a refinery

23<sup>rd</sup> of April, 2004

Germany

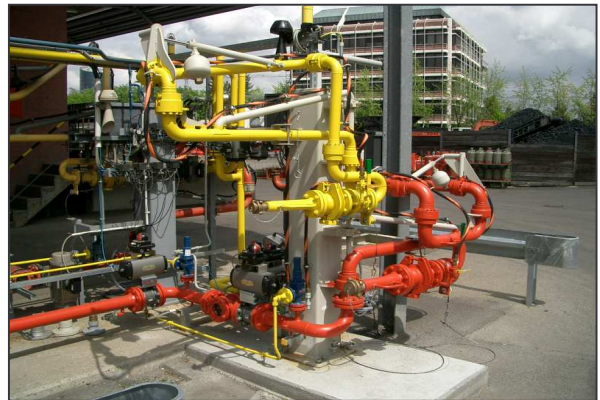
The accident took place in a LPG road-tanker loading facility in a refinery. The picture gives a glance on this kind of installation.

On the site involved, for a loading operation, the LPG tanker is connected to the loading installation via a jointed loading-arm. Loading is carried out under “spray loading”, in which the liquid phase is pumped through the foot valve into the vapour phase of the road-tanker’s tank. No vapour phase exchange takes place.
