Explosion of a tank in TDI production unit

November, 28th, 2002

Mestre – Italy

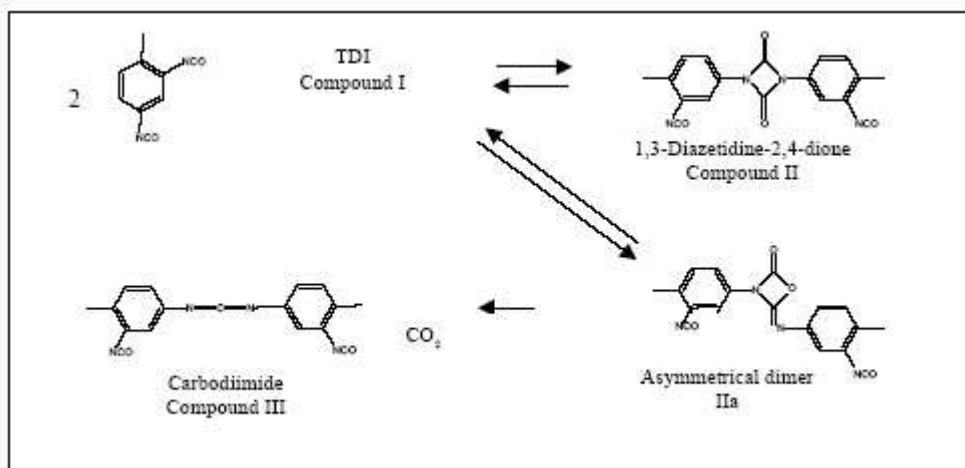
Fig. 5 - TDI dimerization with developing of carbon dioxide

The test results agree basically with the values registered by the DCS during the accident, and demonstrated the development of two distinct reactions, one exothermic reaction (fig. 6 and 7) and another one developing carbon dioxide (fig. 5).
