Vinyl chloride leak in a chemical plant

February 3, 2004

TAVAUX (Jura - 39), France

Polymerisation

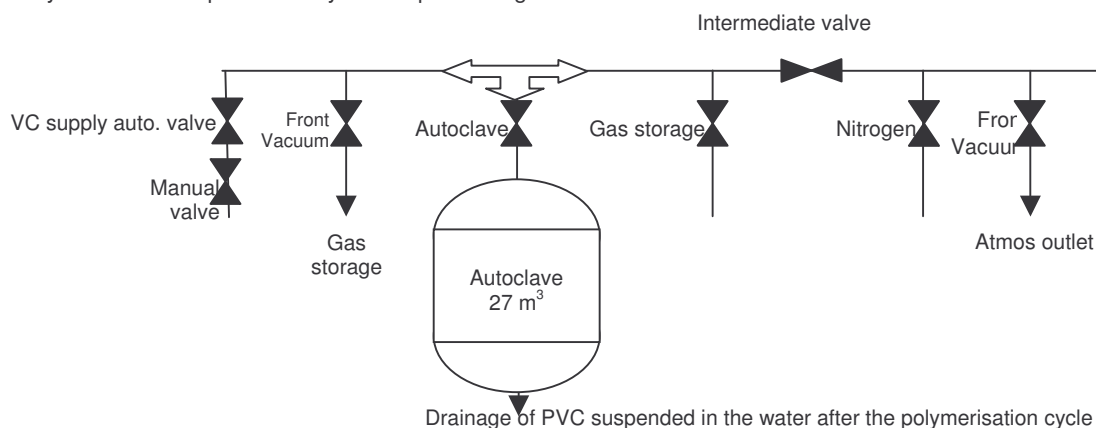
Comment: The intermediate valve isolates the autoclave from any circuit not intended to convey VCM.

Upon returning to autoclave No. 11 at around 5.06 am, the operator neglected to close the degassing valve on the "Front Vacuum" system and authorised the filling operation, which directed part of the VCM to the "Front Vacuum" and caused its loss of confinement through a 14 m stack.

There is thus no instrumentation on the shut-off valves of the other systems (Front Vacuum, Back Vacuum, Gas storage, nitrogen, ...) that is taken into consideration in the VCM loading sequence. There are procedures to check the position of these valves prior to the VCM filling operation. These procedures require that the operator allow the automatic VCM filling valve to be controlled by the PLC. However, the interruption of the operator intervening on autoclave No. 13 caused the sequence of the preliminary manoeuvres of autoclave No. 11 to be lost and authorised the operation when the employee returned even though the "intermediate" manual valve and the "Front Vacuum" valve were not closed.

- ☐ pressure measurement on the "front vacuum line for 03/17/04, in order to confirm the presence of VCM in the "front vacuum" network,
- ☐ fractioning of the VCM load into 2 steps: initially 200 kg, followed by a 2-minute delay before continuing the loading operation if no leak is detected. The loading operation is continued upon PLC authorisation (after the 2 min. time delay) accompanied by operator acknowledgement in the control room. The modification on the 13 autoclaves was deployed as of 04/01/04.
