Fire in a hydrodesulfuration unit of a refinery

June 26, 2004

Feyzin – [Rhône]
France

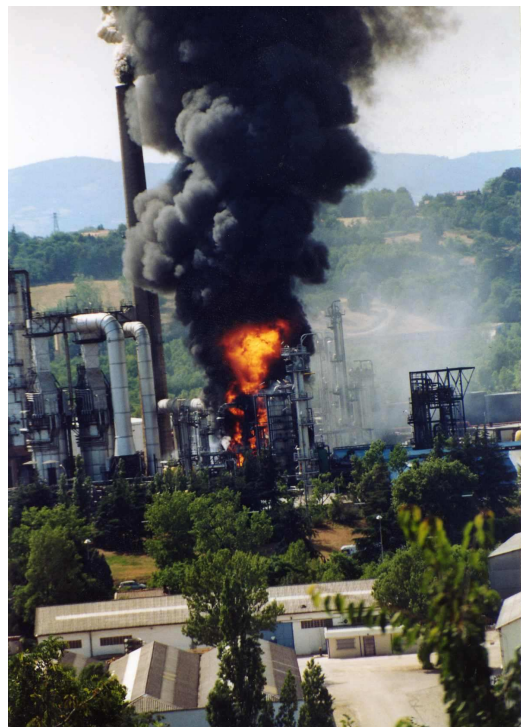
The ignition of the products coming from the reaction loop (reactor 42R202) continued intensely for a few hours in the furnace's convection chambers and flue exits.
