Explosion of a fireworks fabrication and storage facility

June 01, 2004

Villeneuve sur Lot – [Lot et Garonne]
France

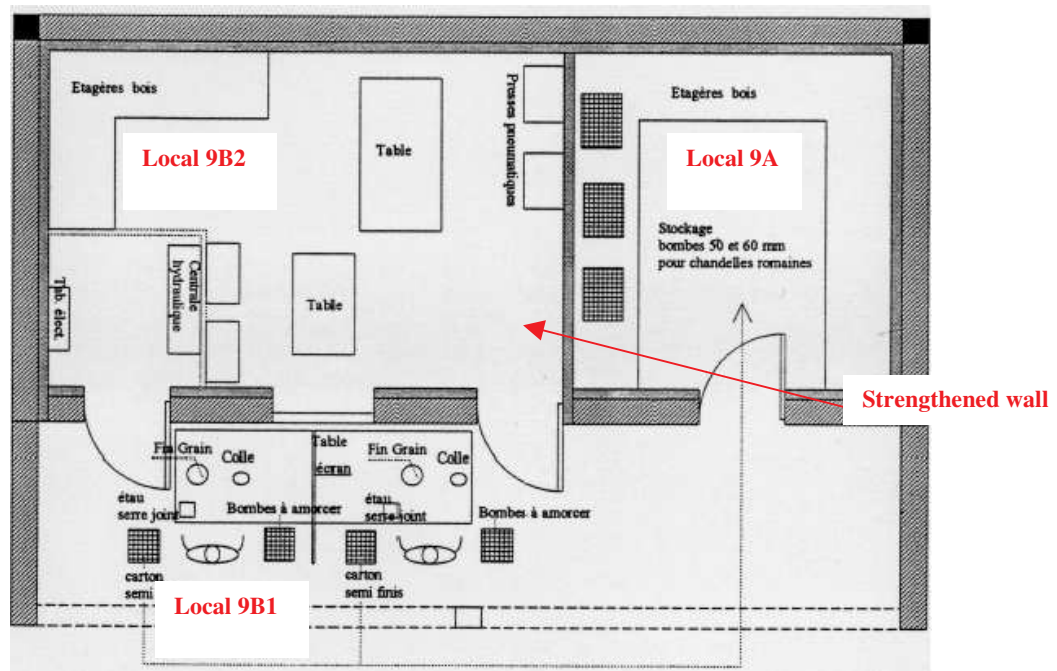
The workshop (building 9), involved in the accident, was dedicated to the manufacture of candles. It contained two workstations and a storage facility. Three consequential activities are performed:

- ✓ the shell assembly area, under the building's awning (facility 9B1). The operation consists in manually filling the lower part of the plastic shell with a bursting and star charge, and then to bond it with the upper part and arm the shell formed;
- ✓ intermediate storage of these products in storeroom 9A. The shells are stored in plastic boxes stacked on 5 levels on the wall separating this area and facility 9B2;
- ✓ the shells are loaded into the candles in facility 9B2. This operation consists in using a low-power hydraulic press to insert a series of armed shells and cups filled with powders into a cardboard tube with a closed base. The composition of these powders ensures the ejection of the shell from the tube.

The authorisation to operate this building prohibits the simultaneous shell assembly and candle loading operations. The shell storage facility was authorised to contain a maximum of 300 kg of active ingredients, characterised as non-detonating products (closed and armed shells). The maximum capacity of the two assembly and loading workshops was 5 and 2 kg of detonating products, respectively, owing to the handling of the powder.
