Toxic leak on factory piping

October 6, 2003
Saint Chély d'Apcher – [Lozère]
France

Metallurgy
Piping
Ammonia
Maintenance
Nut rupture
Intervention
procedure
Personnel training

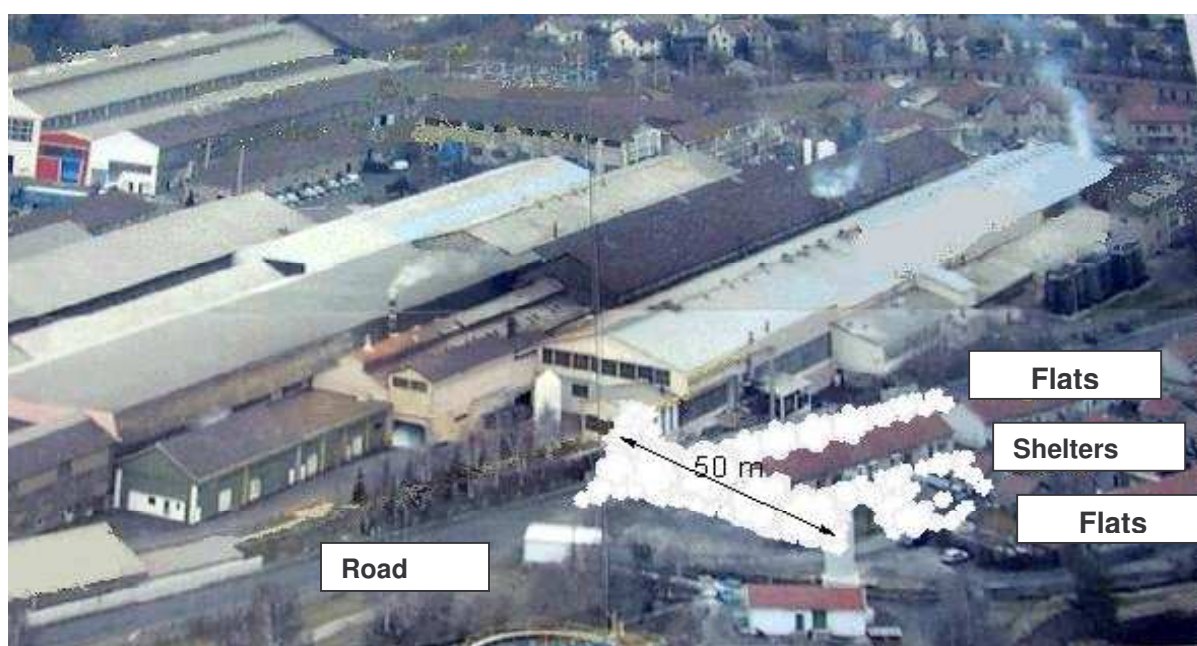
Fig. 1. General view

The metal manufacturing plant, operating on the *commune* of Saint Chély d'Apcher (Lozère), produces magnetic sheets with non-oriented grains. A leak on an anhydrous ammonia pipe occurred October 6, 2003.

Ammonia is used in the cracking unit to produce the hydrogen required in the manufacturing process. The installations concerned include a tanker truck unloading area, 2 storage tanks, and a transfer pipe leading to the cracking unit. These installations, although rather old, have gradually been modernized over the years. The ammonia is maintained in a liquefied state under pressure at ambient temperature, i.e. at a service pressure ranging from 3 to 8.10^5 Pa. The 2 tanks have a unitary capacity of 16 tons. The storage facility is of semi-confined type (construction with a reduced opening on 2 sides and an automatic water curtain). The transfer pipe (diameter 33 mm, length 250 m) holds 146 kg of ammonia. It is broken down into 3 sections by automatic valves slaved to an ammonia detection system.

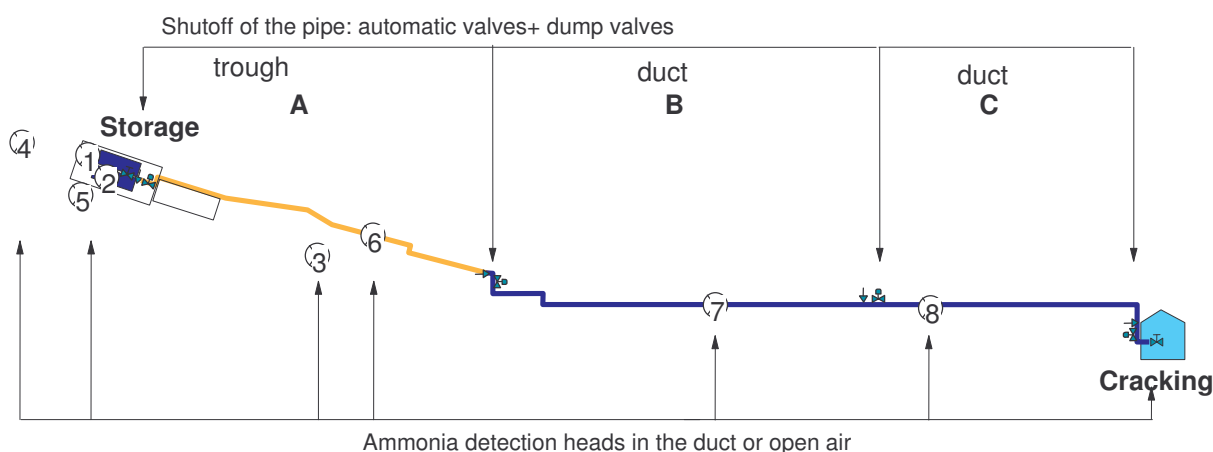
Fig. 2. Ammonia pipe equipment and diagram

Monday, October 6, 2003. The night-shift operators smelled an ammonia odor. A foreman reported a weak although visible leak, on the valve fitting on an ammonia transfer pipe. The 1 m/s vent was coming from the south. The temperature was 5°C.

Wearing a respirator, he installed a ladder and went up to tighten the fitting located at a height of 3 m. The leak was stopped. However, in order to orient the opening of the valve outlet upwards, he tightened the fitting a little more and it ruptured.

The leak lasted approximately 10 minutes (the time required for manual shutdown + drainage of the pipe section) in the middle of the 8 mm branch connection. The operator estimated that approximately 60 kg of ammonia had been released.

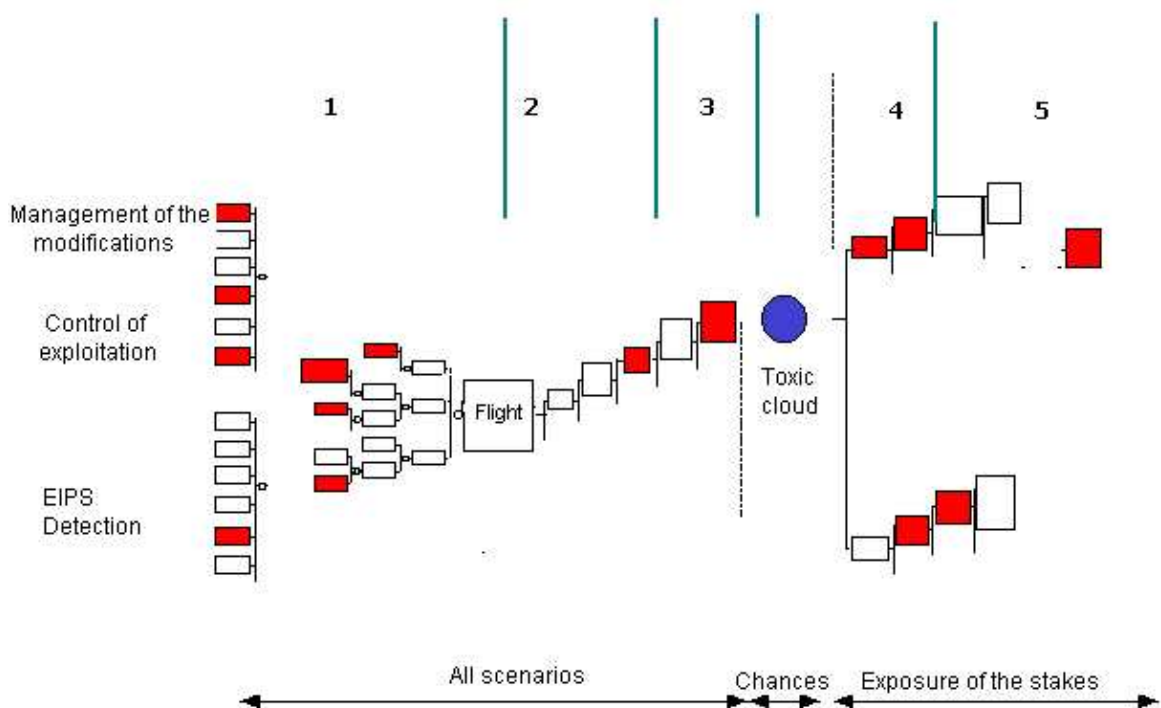
The accident prevention and effect limitation system was designed as a 5-tier defence program in order to then encompass a systematic examination of each layer of defence.

The defence system features: 3 "internal" layers of defence and 2 "external" layers of defence

1. Primary confinement (ammonia tanks + piping).
2. Limitation of quantities released in the event of a leak.
3. Secondary confinement.
4. Distancing of the stakes involved.
5. Protection of interests (housing - siren and instructions for local residents).

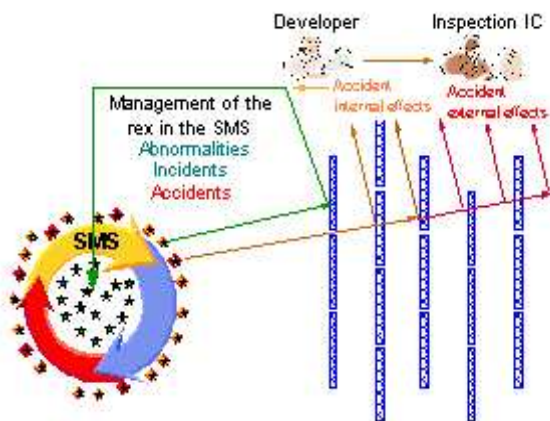
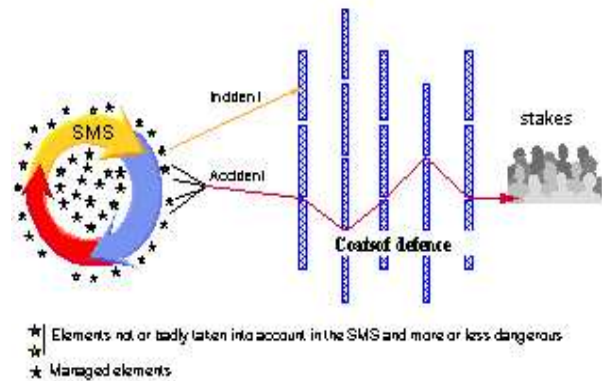
In this case, the layers of defence were breached by

- ★ Elements not or badly taken into account in the SMS and more or less dangerous
- ★ Managed elements
