# Implosion of a styrene storage tank during truck unloading operations

January 7, 2005

Tertre - Belgium

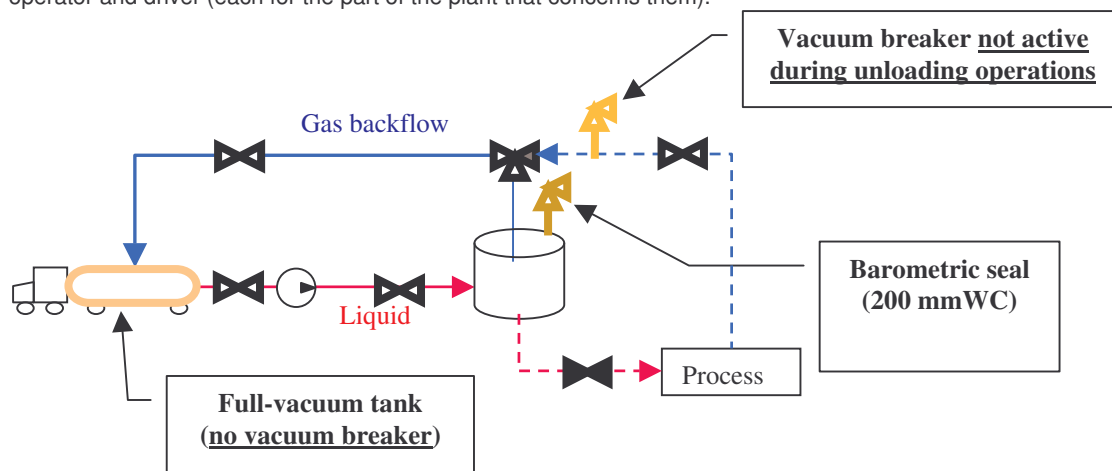
A truck comes to unload the styrene two times per week. Using a checklist, the alignment is ensured visually by the operator and driver (each for the part of the plant that concerns them).

The protective equipment installed on the storage tank and tanker efficiently protect the unit against the following two accident scenarios:

Incorrect alignment of the gas return during the truck unloading operation generating a vacuum in the tanker truck (vacuum breaker or "full-vacuum" tank resisting a partial vacuum) and an increase in pressure of the storage tank (valve)

Significant intake by production causing a vacuum inside the storage tank (vacuum breaker protection)
