Meeting – Bordeaux, June, the 11<sup>th</sup> and 12<sup>th</sup>, 2002

## LESSONS LEARNT FROM INDUSTRIAL ACCIDENTS

Classified installations / IMPEL inspectors

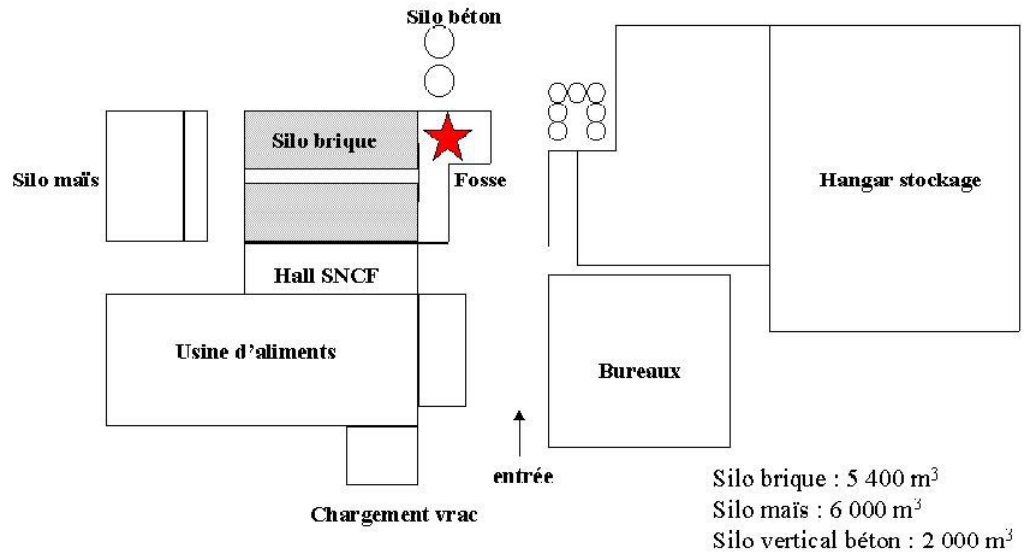
Diagram of the installation – site where explosion occurred is shown

The damaged brick silo consists of a reception/shipping station, a handling tower, the warehouse, roof space and two underground galleries.

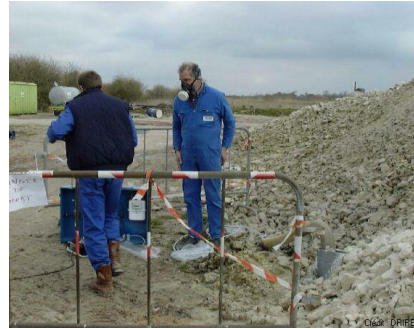
The results of the measurements taken in the sump are as follows:

- ✓ sump totally full: NTR,
- ✓ sump drained to the level of the pipe bringing the drainage runoff: 222 ppm of H<sub>2</sub>S. (Note: when the pump was stopped, the concentration of hydrogen sulphide in the sump went from 222 to 6 ppm in approximately 20 minutes).
- ✓ Sump completely drained: 550 ppm of H<sub>2</sub>S. (In the bottom of the sump, the concentration of hydrogen sulphide reached 2,270 ppm).
- ✓ Average methane content: 300 ppm (0.03%).
- ✓ Oxygen concentration: approximately 20%.
- ✓ Carbon dioxide concentration: 0.1 to 0.2%.

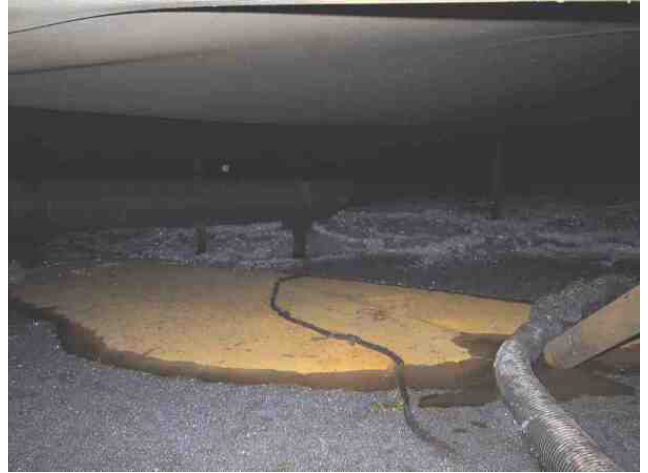
At roughly 4 pm, an explosion occurred while the 2 contractors were inside the tank.

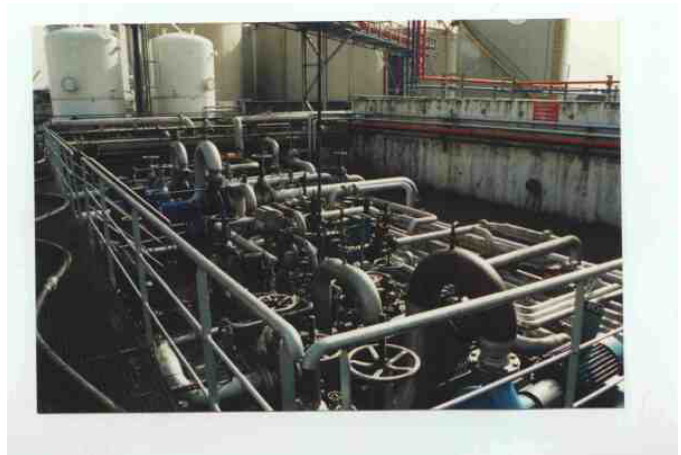
**October 12, 2001, at 5.20 am**, an operator of the depot was alerted by a driver and heard an unusual noise in pump station No. 1. He discovered a leak of furnace fuel oil FFO (heating oil): the pump station's retaining pit contained approximately 80 cm of FFO.

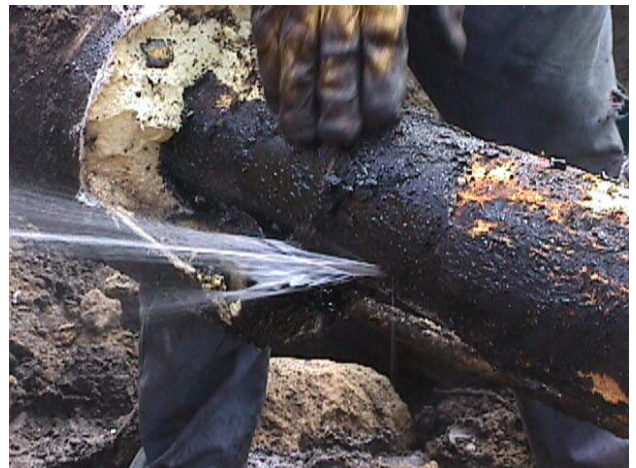
Chemical analysis was used to confirm that the steel analysed corresponded to the grade of the material used in the construction of the pipeline.

The micrographic examination conducted near the leak in the pipeline showed a significant loss in thickness as well as several corrosion spots. Ripped material was noted at the location of the perforation. The presence of numerous corrosion craters in a zone outside the penetration was also observed.

In addition, the presence of oxides on the external wall and on the edges of the rip possibly indicate that the leak was not recent.

These investigations enabled the operator to conclude that the breakthrough on the pipe occurred after a significant loss of thickness located in the zone having widespread corrosion caused by chlorines on the external wall due to the presence of brackish water. The brackish water comes from water table variations, particularly under the influence of the "salt wedge" (the rise of salt water into the water table). A localised defect in the pipeline's protection is most certainly allowed the salt water to come into contact with the pipe and cause the corrosion.

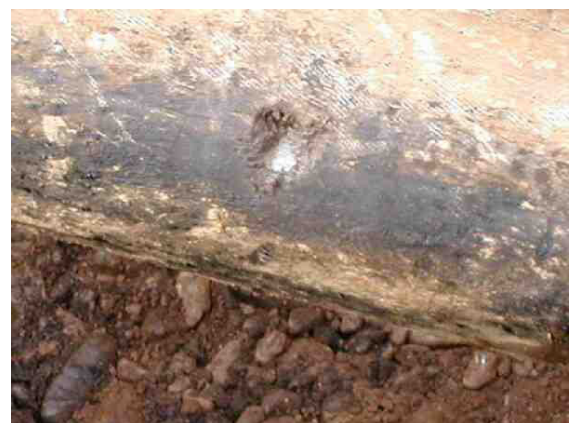
The operator thus began its search inland on February 22, 2002 by digging trenches at the fault nearest the power plant located in the bed of channel designed to drain away water in the case of a flood.

The following points were developed during the manual digging operations:

- ✘ degradation of the pipeline's position markers,
- ✘ mechanical deterioration of the covering,
- ✘ decreased tube wall thickness (two series of ultrasound measurements)

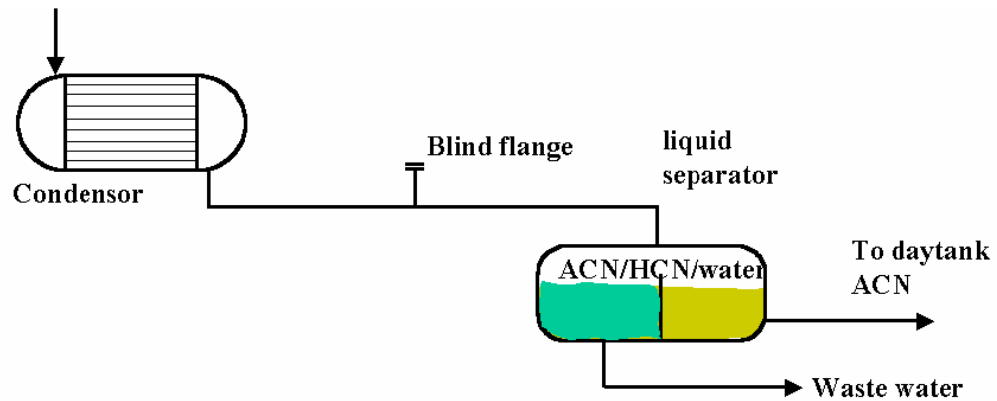
A leak occurred in the part of the process whose normal operating conditions are 30 – 40°C and nearly atmospheric pressure. It took place in a pipe between a condensor and a liquid separator, as mentioned on the diagram here-under. About 4 000 l of liquid were emitted containing about 200 kg of hydrogen cyanide. At one point, the pipe involved contained stump, which should be closed with a blind-flange. However, it appeared that the blind-flange was not present and that the stump was ruptured.

In hindsight, it is expected that this situation was present during at least 1 week before the accident. Moreover, probably the stump was plugged due to polymerised product. However, due to a high level in the crude product storage tank and the omission of opening a proper release valve, an overpressure took place. This caused the loss of process fluid.

Immediately, the operator applied a water screen to prevent loss of the HCN outside the battery limits. Frequent monitoring of the atmospheric HCN concentration was applied, because of the short distance to the nearest urban population about 500 m. The operator immediately shut down the ACN-plant.

The ruptured pipe was replaced and the same pipe in the other ACN-plant was inspected. At that time, no deviations were detected in the other plants so the ACN-plants were restarted.

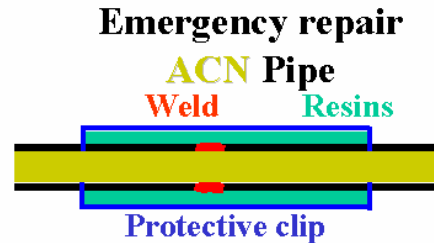
For the control, an emergency repair as shown on the drawing was found. Normally, such repair is a temporary measure but this one was carried in 1994.

It was reasonable to expect that during the next maintenance stop (1996), the pipe would be properly repaired.

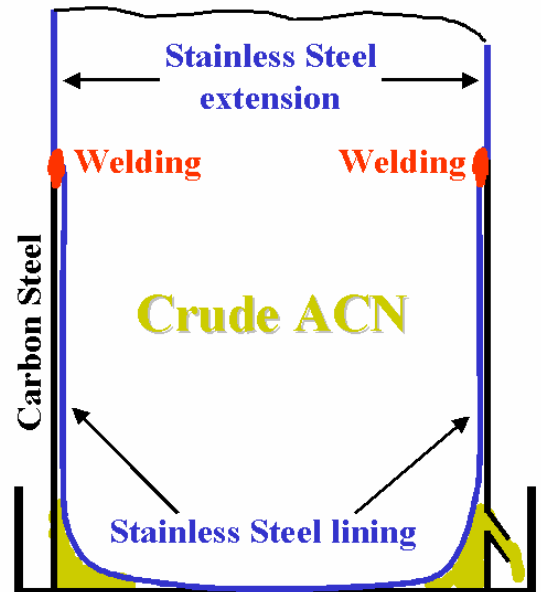
The product contained 10% hydrogen cyanide. The leakage from the tank was caused by a ruptured weld in the stainless steel inner tank lining. This lining had been constructed in 1974, after a leakage due to cyanide stress corrosion. On the drawing, it is possible to see that the upper side extension of the tank was made of stainless steel.

The lining was 2 meter high.

Due to the rupture, the crude product was able to attack the carbon steel material of the tank. Because there was an opening to the environment at the bottom of the tank, the incident was immediately observed.

After investigations, it seems that also in this case, stress corrosion was the probably cause. The operator explained that this lining was made as a low-cost investment.

After this incident, the operator exchanged this tank with a tank completely made of stainless steel. A comparable other storage tank will be replaced in due time..

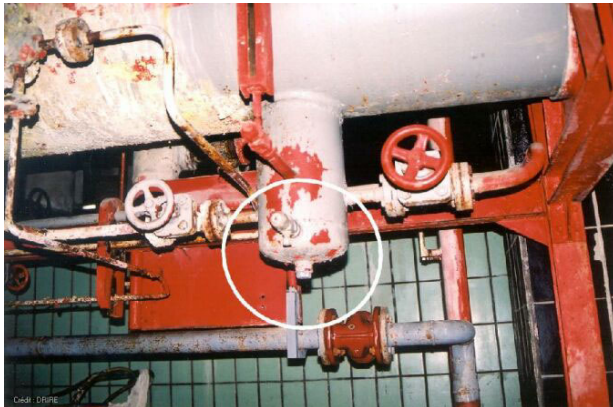
A welder from an outside company was engaged to perform work on the cooling water circuit of one of the three condensers. The end cap of the condenser shell was, in fact, eroded at the level of its bolted mounting flange. Water had been leaking for two days and the management had decided to repair the oxidation by means of localised welding.

When he arrived the next day, the welder found that the part to be repaired was still humid and asked a plant mechanic to complete the purge of the water circuit. The latter, who was badly informed, thought that the purge plug under the condenser would allow him to carry out this operation. He therefore unblocked the plug and left the welder to proceed with the additional purge. In fact, it was the ammonia condenser purge.

The operator therefore had insufficient knowledge of the circuits and the works were badly prepared. The installations were not equipped in accordance with the regulations regarding the limiting of ammonia emitted.

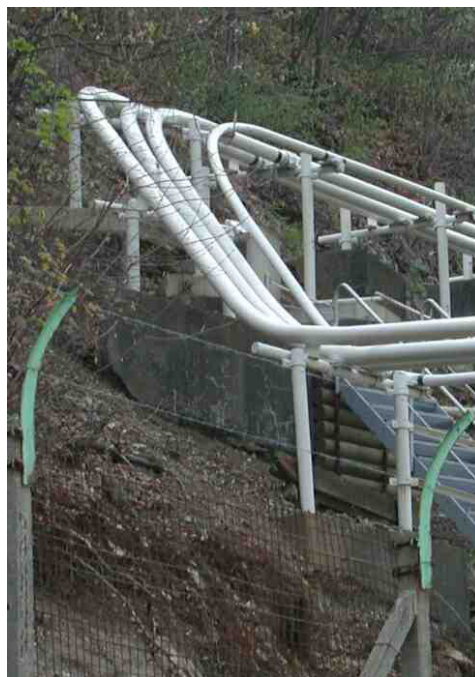
*Chloroducs at the site*

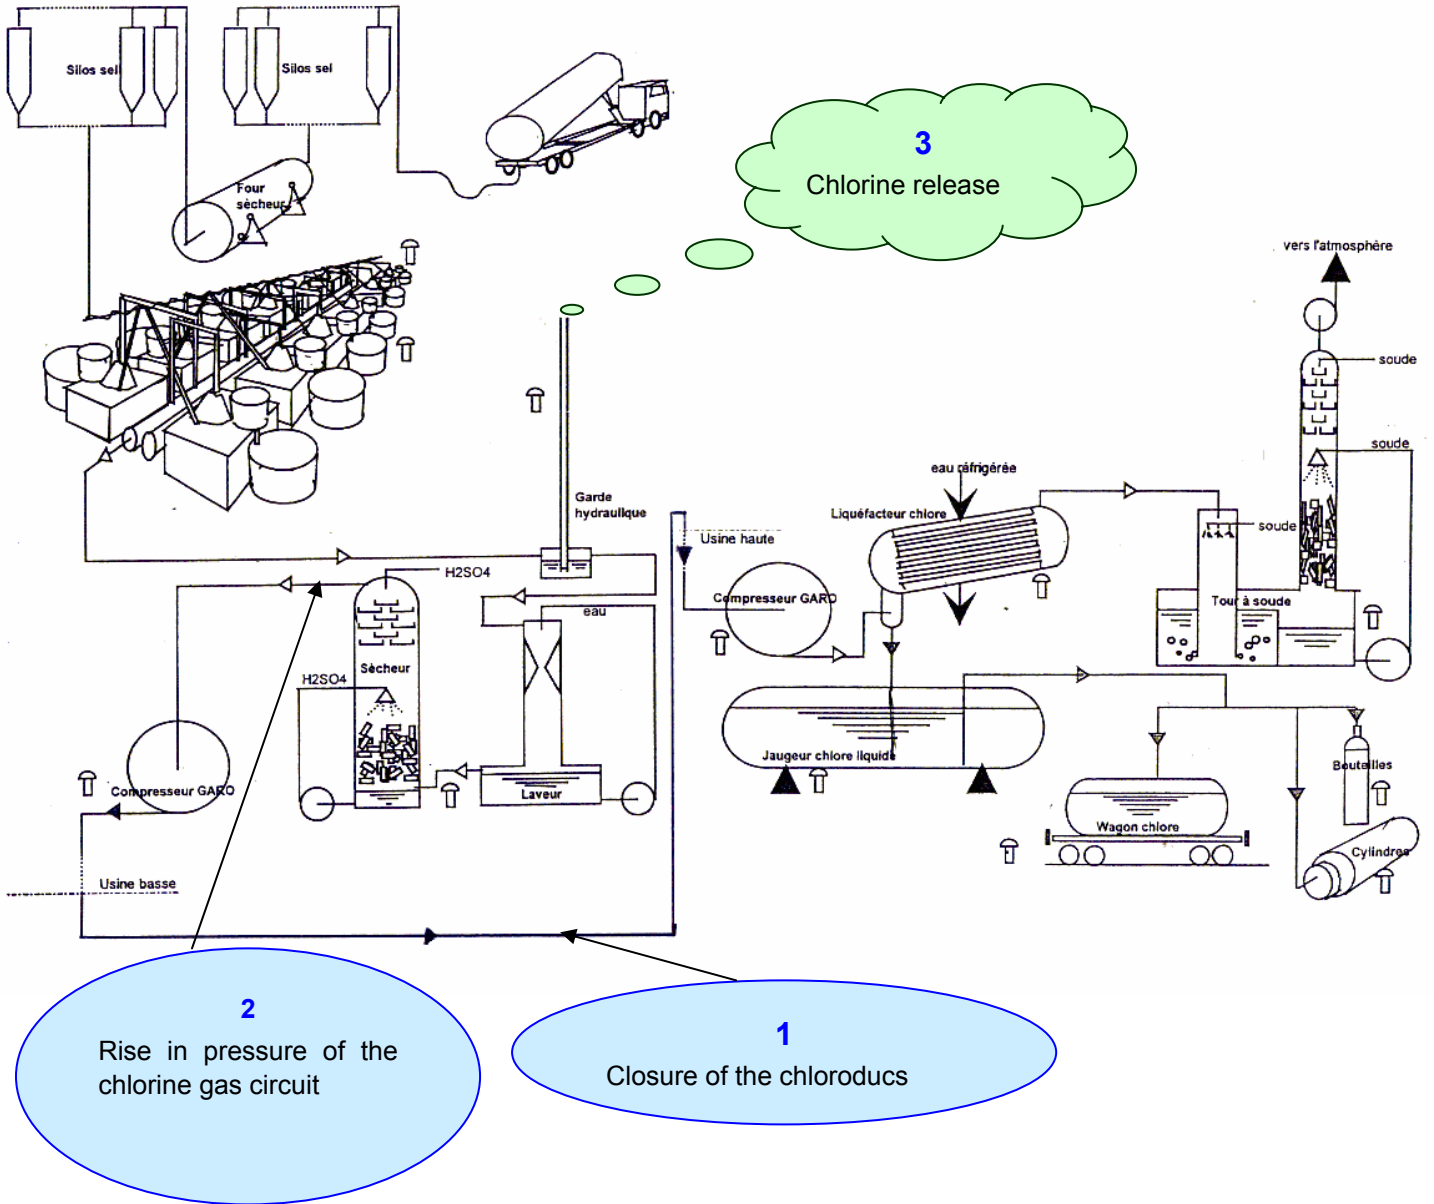
**•Cause:** Operator error during the chloroduc switchover operation, leading to the simultaneous shutoff of both manifolds for a few instants.

More in-depth reports by the operator highlight an organisational problem, in terms of equipment management: In reality, 2 keyboards were available to the operating crews in the control room from which the changes, among different operations, are made. One was connected and the other one was not. The manoeuvres, performed on an inactive keyboard, were thus not taken into consideration. This is considered one of the causes that lead to the incident.

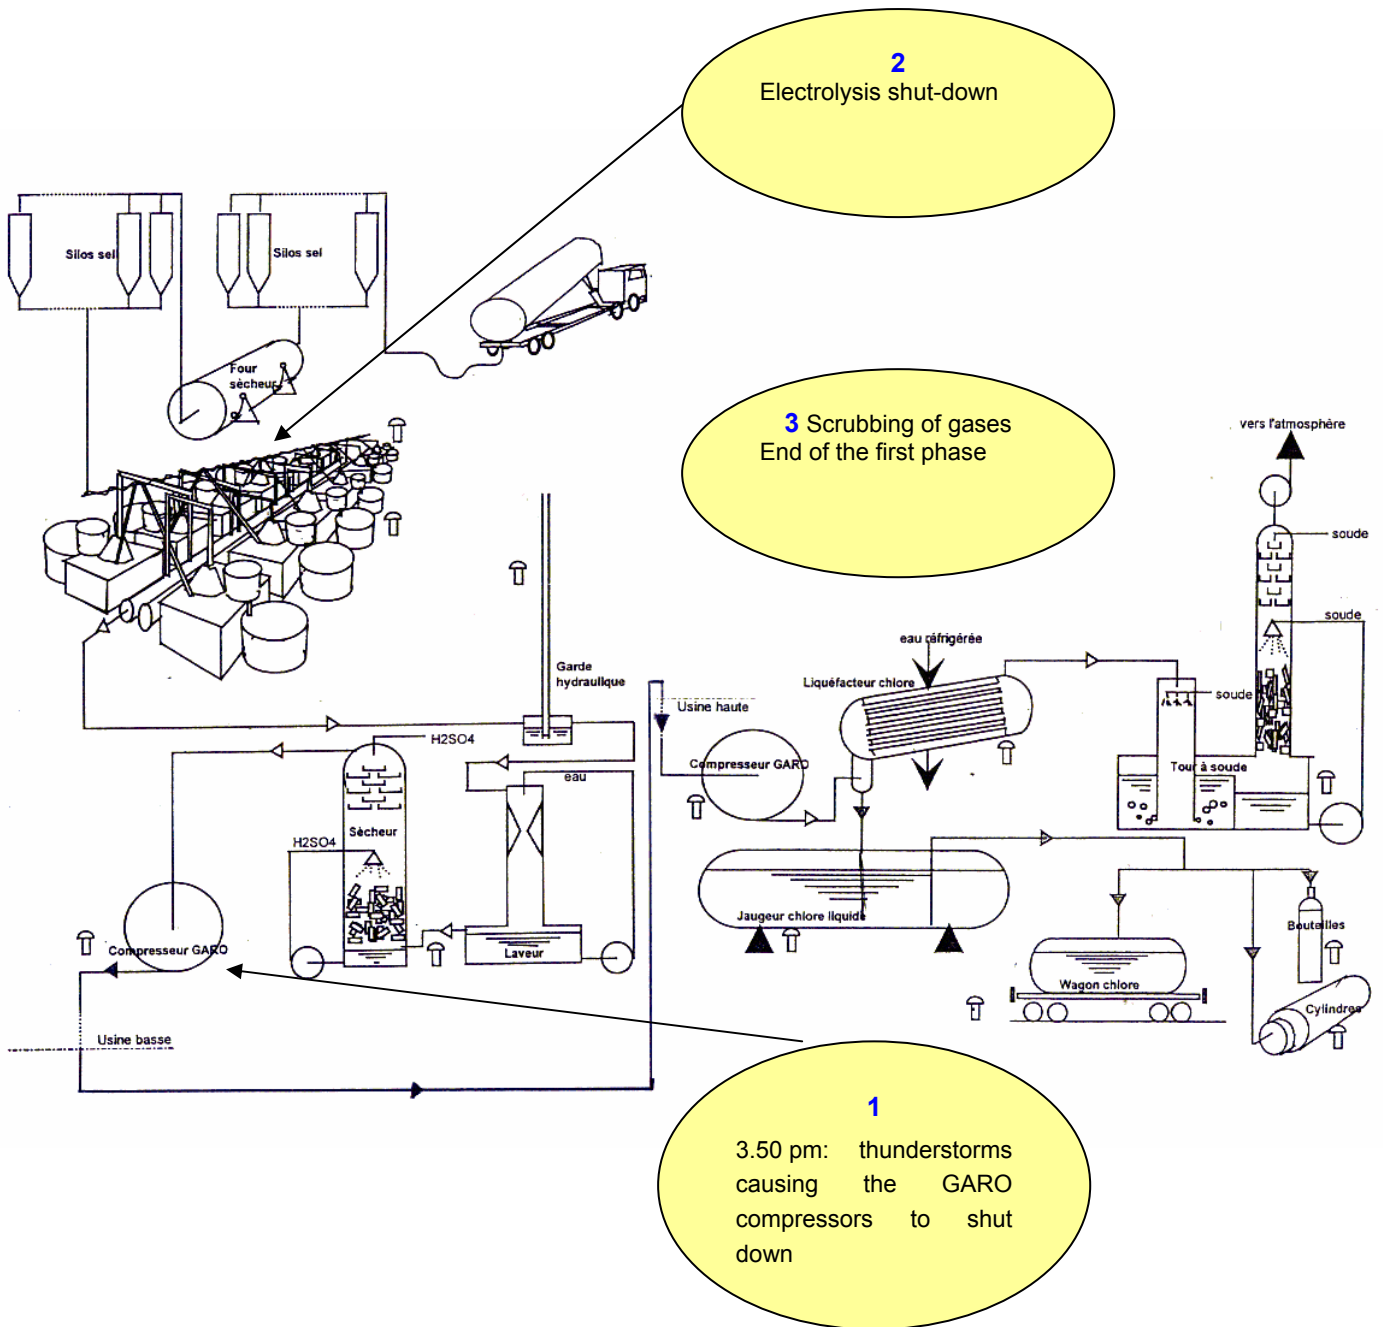
There was a thunderstorm in the afternoon: it caused the shut-down of the chlorine expedition compressors in the chloroducs (chlorine pipes).

Quite normally, this caused the automatic shut-down of the electrolysis operation.

The chlorine is correctly evacuated by the scrubber. The management of the event is thus compliant with procedures.

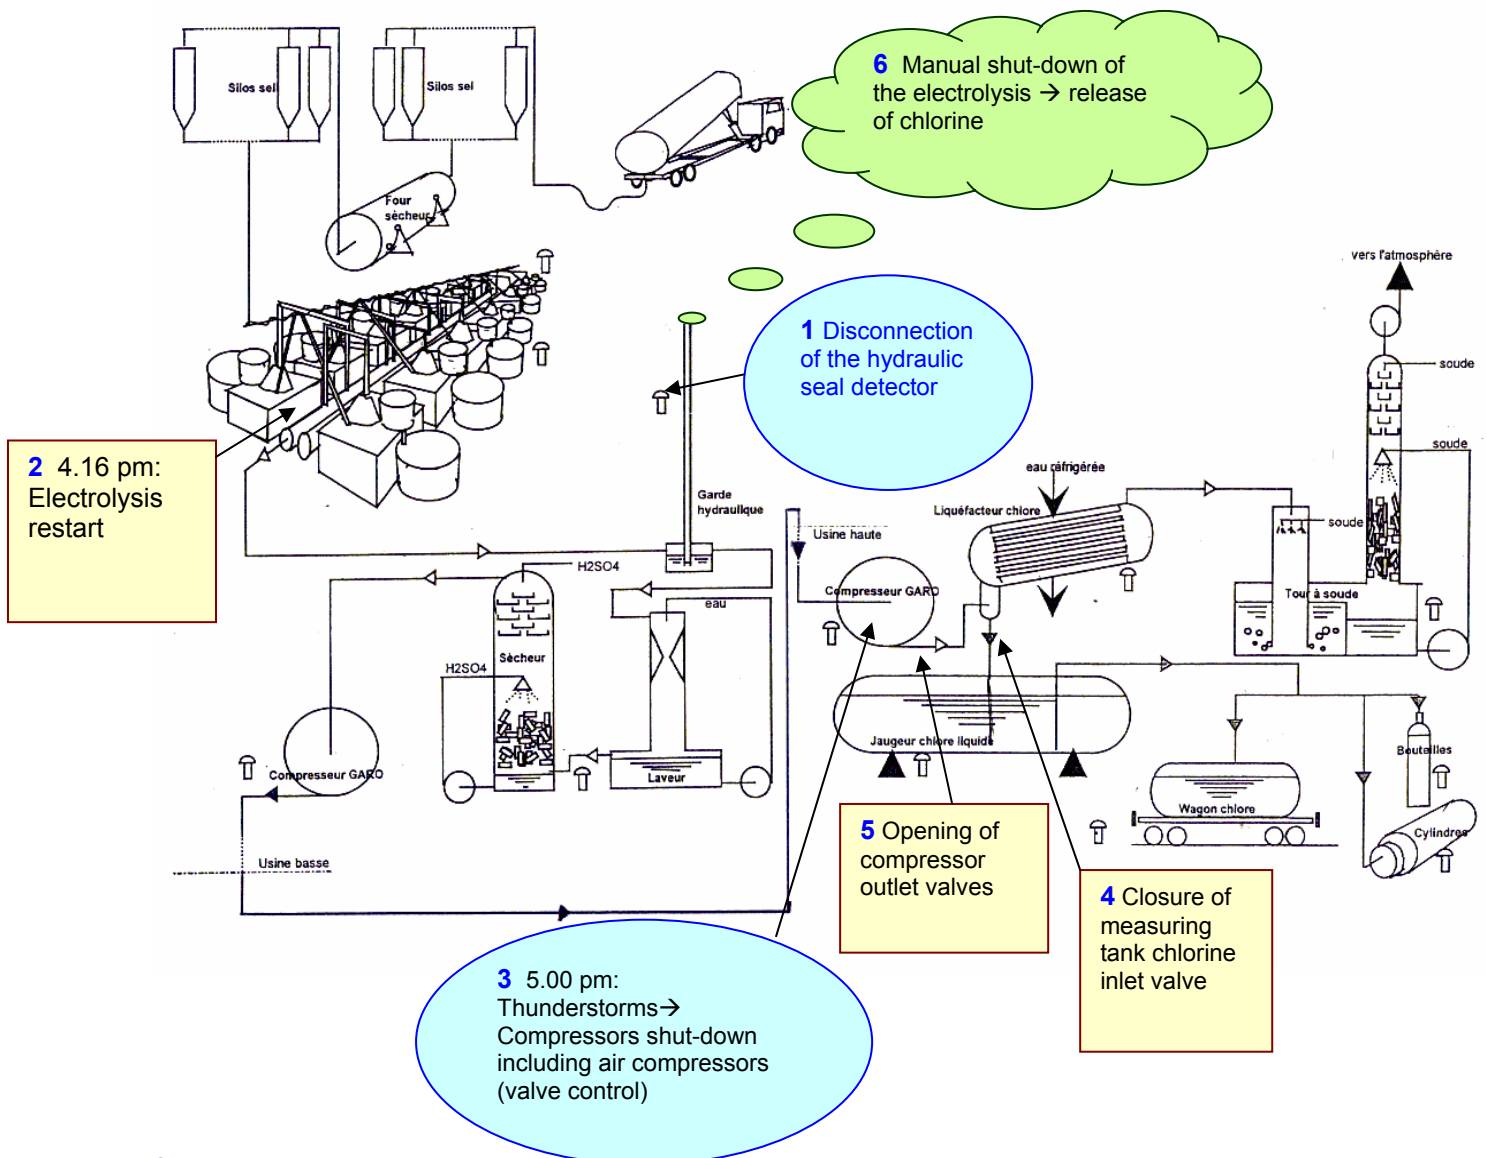
In this configuration, part of the gases passes through the hydraulic seal: the quantity is sufficient to saturate the chlorine detector located there. The electrolysis, which restarted at the end of the first stage of the event, is automatically stopped due to the detector tripping.

The thunderstorms continue and this time cause the plant's compressors to trip: this concerns the compressors up line from the liquefier, and the air compressors which control the control valves.

The operator is finally lead to cause the manual shut-down of the electrolysis operation (there is no longer automatic shut-down as the detector was disconnected). This takes a short amount of time during which the electrolysis still is producing chlorine. A release of chlorine thus occurred (18 kg).

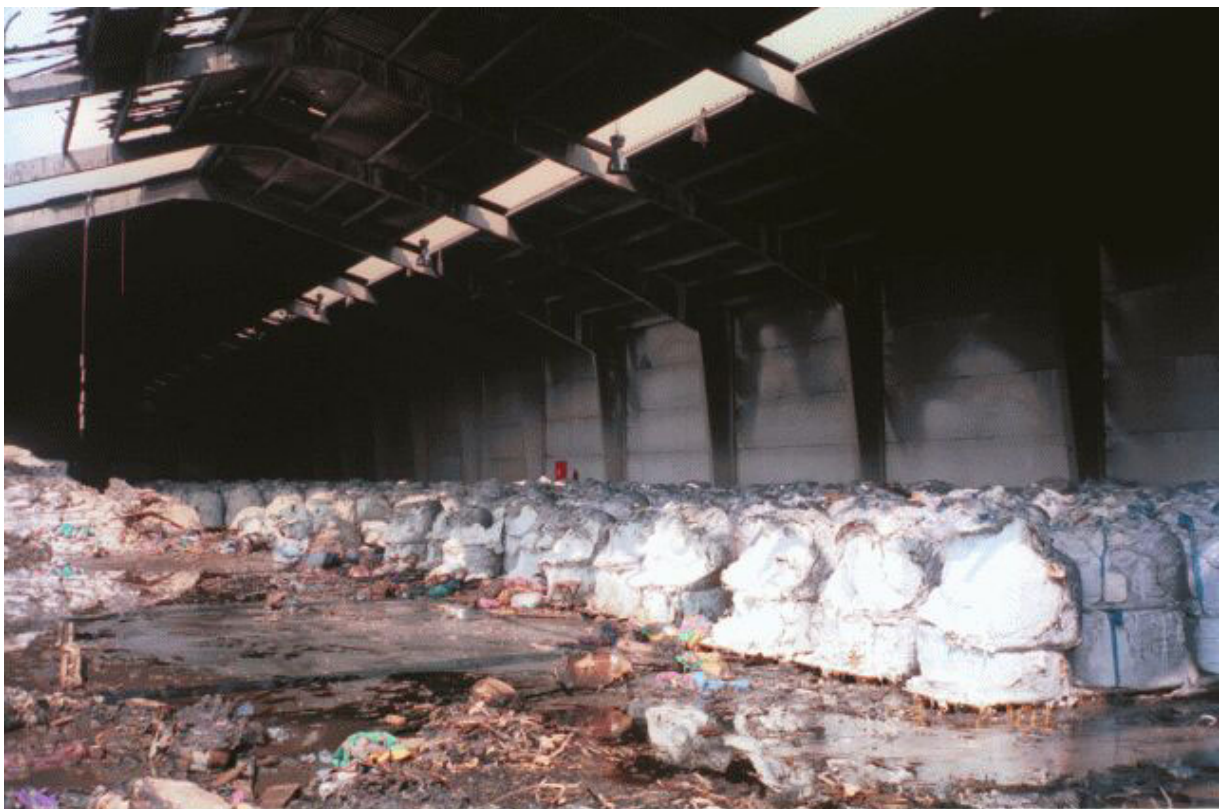
Since warehouse C was a non-dangerous goods storage little attention was given to the retention of the contaminated firewater. In first instance the contaminated water fled into the loading pit of warehouse C, but due to the limited capacity of the loading pit after a while the water ran through the rainwater drain into the municipal sewer.

The fire spread to warehouse B in which dangerous goods were stored, although that the authorities didn't know that fact.

Because of the difficulties with the extinction the chief of the fire brigade decided to push the smouldering goods out of warehouse C into the loading pit. Hence the capacity for firewater retention diminished even more.

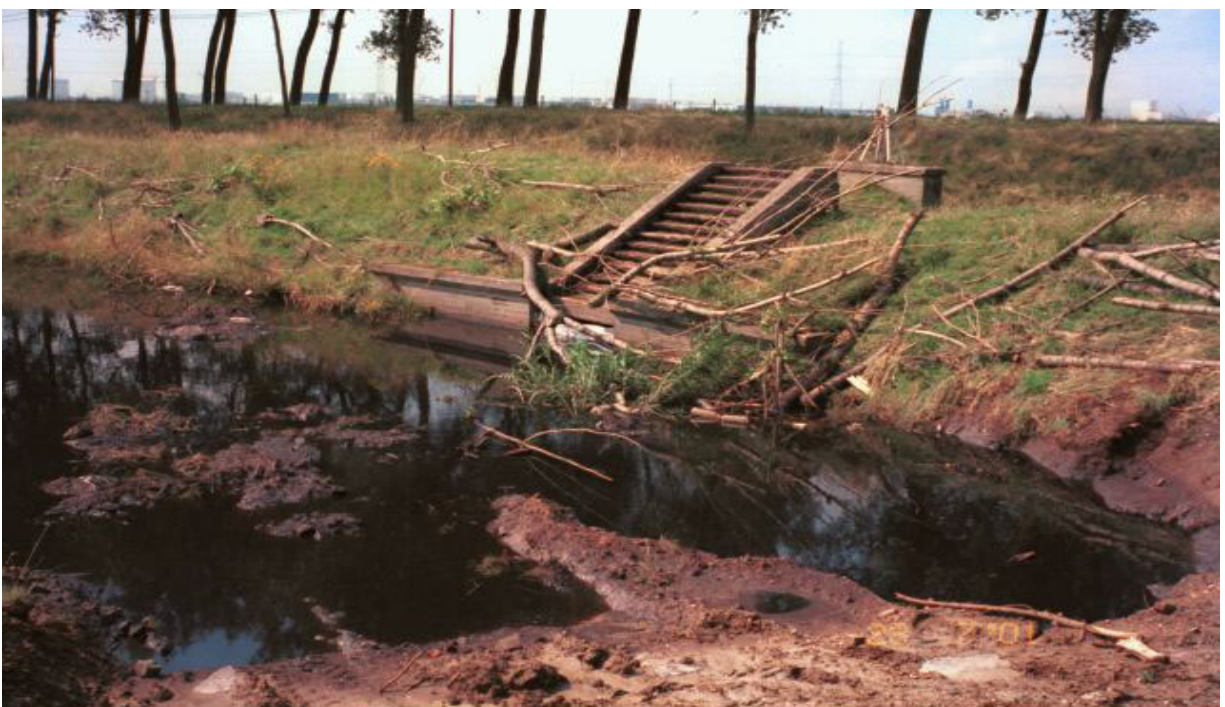
In the surroundings following observations were made: discharge in a brook, fish mortality, colouring of the surface water. A sample was taken of the surface water.

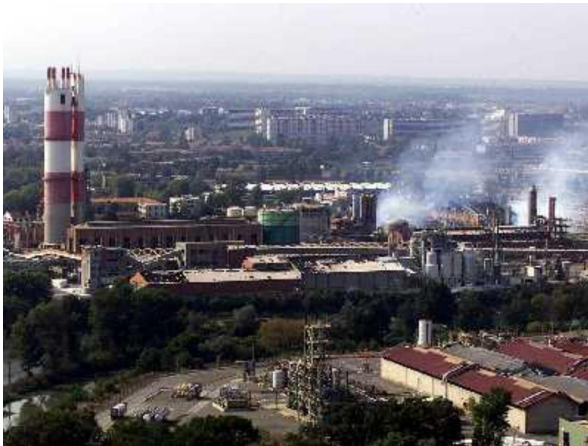
**View of the AZF plant**

At 10.17 am, a severe explosion occurred in hangar 221 (2,400 m<sup>2</sup>) located in the plant's nitrate sector. The explosion, felt several kilometres away, corresponded to a magnitude of 3.4 on the Richter scale. Significant dust fallout from the installations and a crater were observed outside the plant.

A large cloud of dust from the explosion and red smoke drifted to the north-west. The appearance of the smoke is linked to the emergency shutdown of the nitric acid manufacturing installation. Before rapidly dissipating, the cloud containing ammonia and nitrogen oxides sickened witnesses who complained of eye and throat irritations. The atmospheric pollutants released after the explosion lead to the formation of nitric acid (HNO<sub>3</sub>), ammonia (NH<sub>3</sub>), nitrogen dioxide (NO<sub>2</sub>) and nitrous oxide (N<sub>2</sub>O) from ammonium nitrate. As a precautionary measure, the Haute-Garonne Prefecture requested that the population of Toulouse confine themselves to their homes. This measure, the efficiency of which was limited owing to the damage to numerous homes, nevertheless reduced the number of traffic problems after the accident.

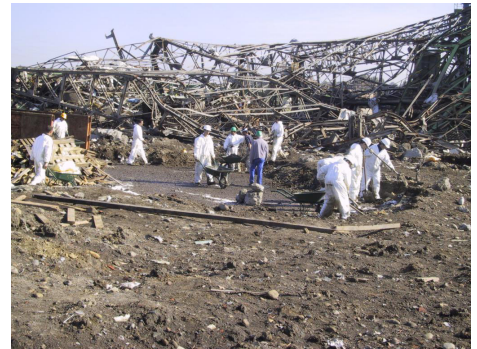
Site clean-up operations

According to the health services and considering toxicological and epidemiological knowledge on the exposure-hazard relationship, it appears that there are no disquieting consequences concerning the health risk associated with the release of asbestos (cancers, fibrosis). However, labour protection regulations must be carefully applied for individuals working on site cleanup operations.

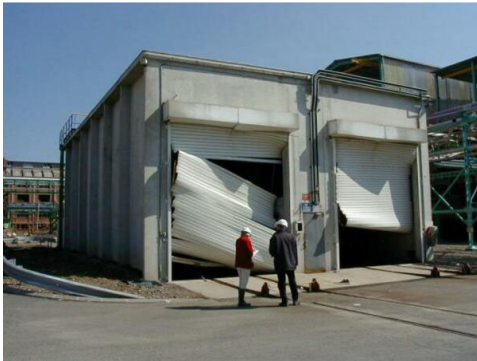
**Building housing the chlorine stocks and tankers**

For GRANDE PAROISSE, the pressurised ammonia storage tanks located 300 m from the explosion were relatively protected by a building which suffered extensive damage but which acted as a screen. The liquid ammonia storage tank located more than 600 m suffered no direct damage. The building sheltering the chlorine storage tank more than 500 m was damaged, although the railcars located inside were not touched. Finally, the railcars containing chlorine and ammonia located to the south of the site and at more than 400 m, were protected by buildings whose structure resisted the shock.

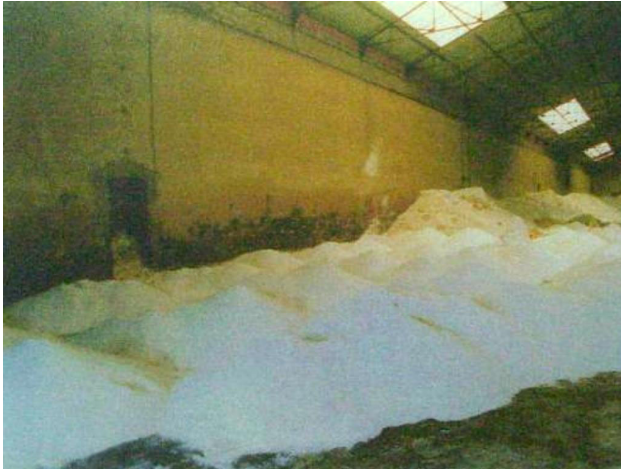
Hanger 221 was used to stock industrial and agricultural nitrates considered "below grade" owing to their grain size and off-spec chemical composition. At the time of the accident, the hanger contained 300 to 400 tons of ammonium nitrate. From the various workshops, this rejected material is brought to an inlet area by three subcontractors. It is then pushed by transport equipment into the building. This

On the eve of the explosion, 15 to 20 tons of ammonitrate with an additive in qualification phase was brought into the building. On the morning of the explosion, products derived from the packaging of the ammonitrates and the manufacturing shops were also transferred into the building. The last addition of material by bin coming from another storage zone was made less than 30 min before the explosion.

**Bulk storage of ammonitrates**

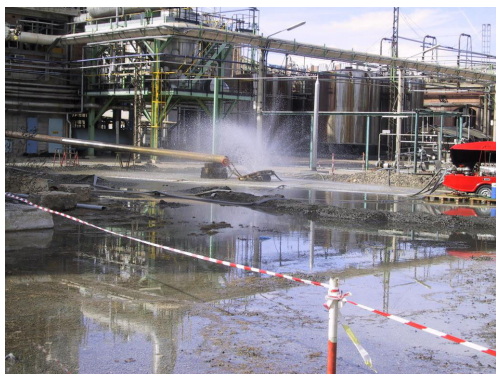
**Dilution of NH<sub>3</sub> by water curtains**

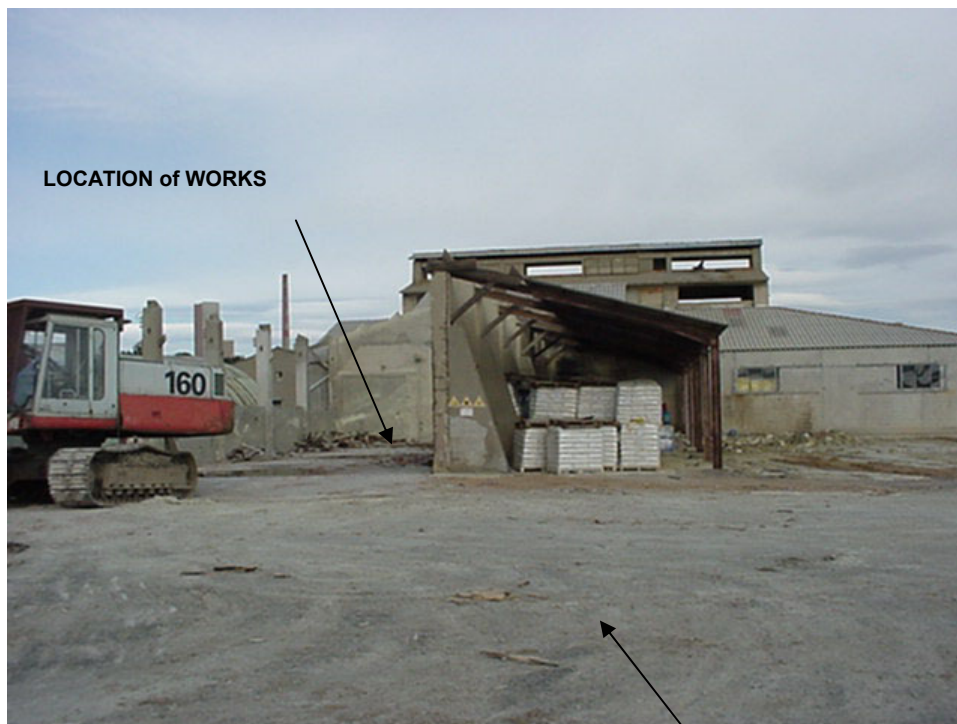
**LOCATION of WORKS**

**LOCATION of STORAGE AREA**

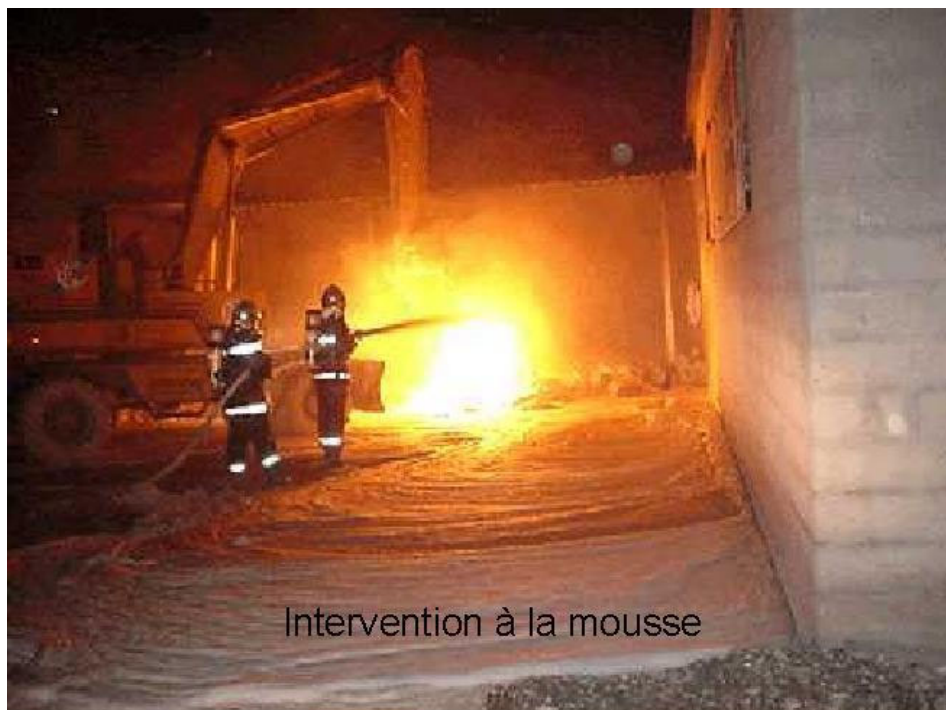
The firemen rapidly began to spray down the fire (7.45 p.m.), but without success.

The fire was brought under control at approximately 10.30 p.m., after several minutes of using a water-foam concentrate mixture, consecutive to the initial attempt to extinguish it by applying water.

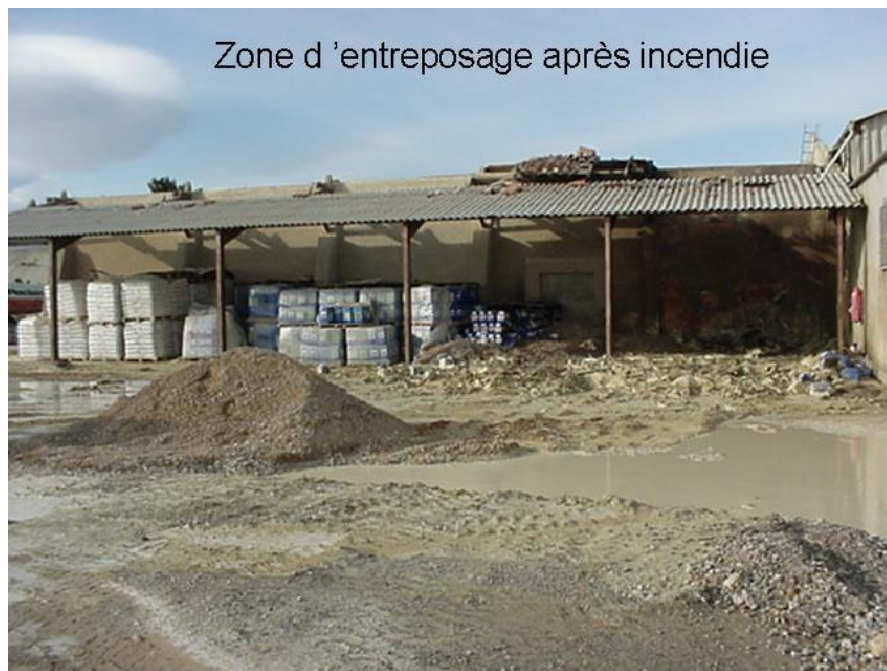
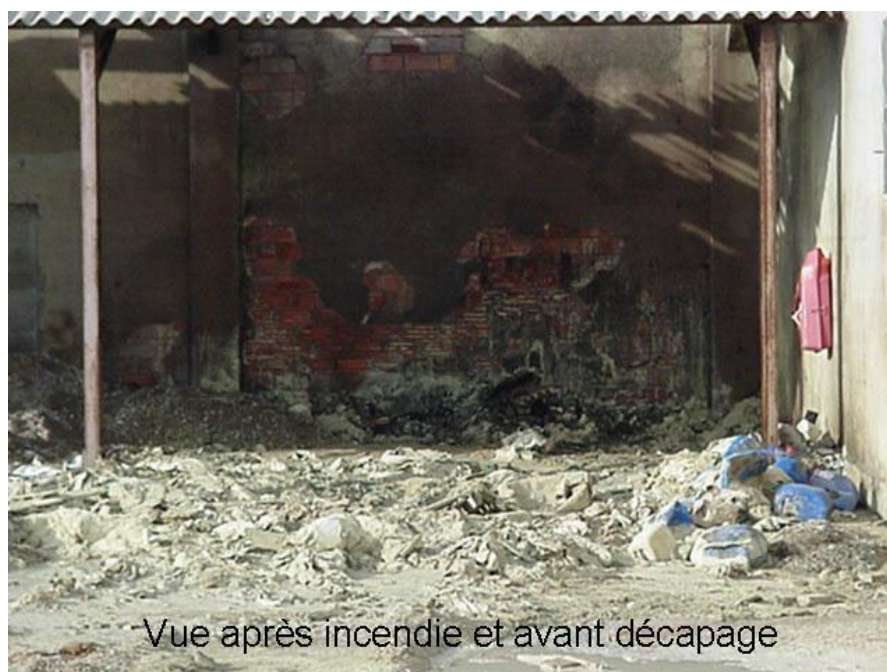
Twenty-four tonnes of phytosanitary products of the 50 tonnes being stored were destroyed; the materials involved in the fire were:

Product loss is estimated at 38,000 Euros; the cost of incineration is estimated at 185,000 Euros.

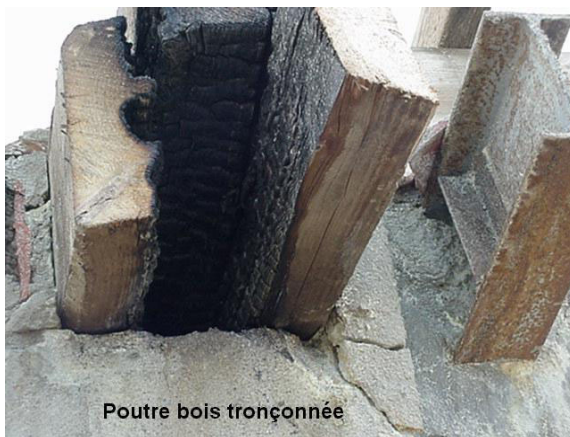
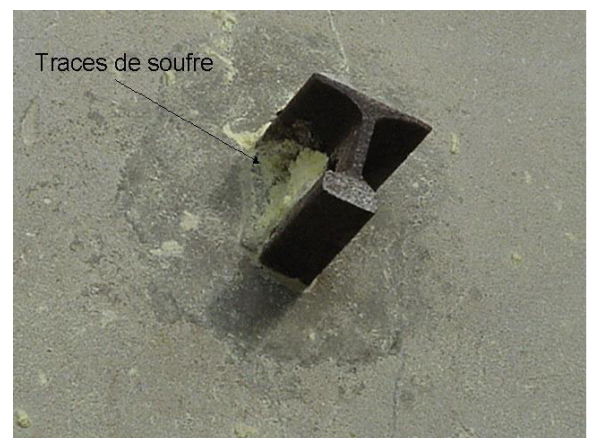
The heating phenomenon was probably amplified due to sulphur residue present in the cracks and cavities in the frame and the wall.

Burned particles fell onto the plastic sheeting, causing the fire to spread more easily to the packaging and then to the materials being stored and the pallets.
