**« LESSONS LEARNT FROM INDUSTRIAL ACCIDENTS »**

**Registered installations French Inspectorate / IMPEL**

**Seminar – DIJON, November 2003, 4<sup>th</sup> and 5<sup>th</sup>**

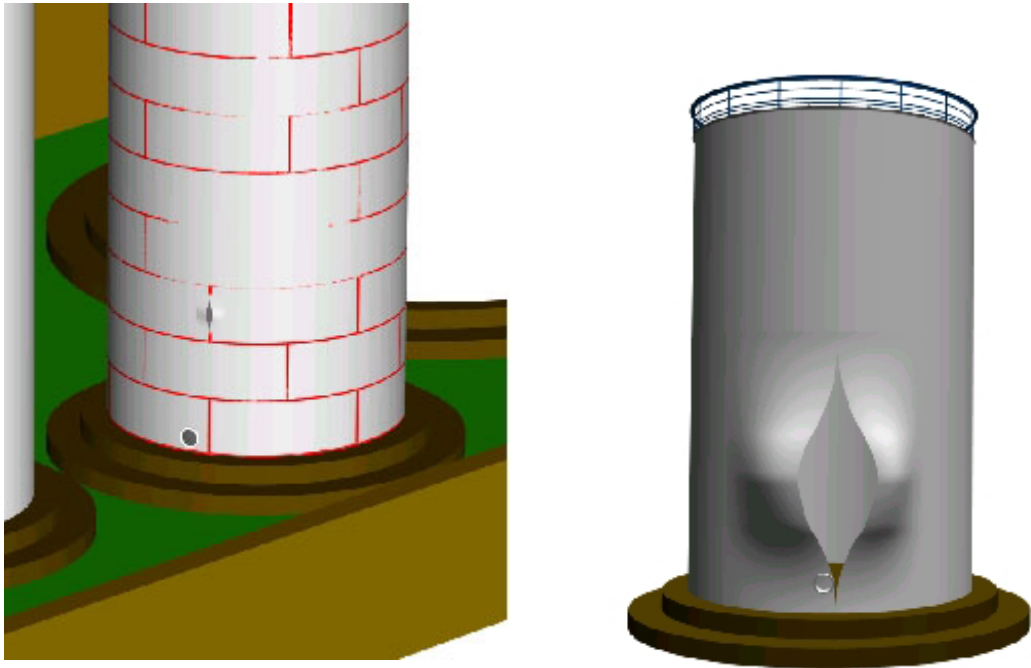
- × Steam pressure rose to 7 bar; steam expanded in the tank, involving turbulences inside it and developing pressure waves. At this time, the tank was 96%-full.

- × Due to weakest spot in the hoop, the tank failed because of an inferior quality of one of the welds. In fact, the tank was able to withstand the extra pressure caused by expansion of vapour but not the pressure waves.
- × The tank fails in a few seconds and the product flows through the tankpit.

- × Direct operational activities are excluded as cause. It is clear that the accident is due to the failure of the steam-coil. Indeed, 10 cm piece of coil is from thinner material and is internally corroded.
- × Tank could take the overpressure caused by the expansion of steam but it collapsed due to dynamic pressure.
- × Furthermore a weak weld was found in third ring of the hoop.

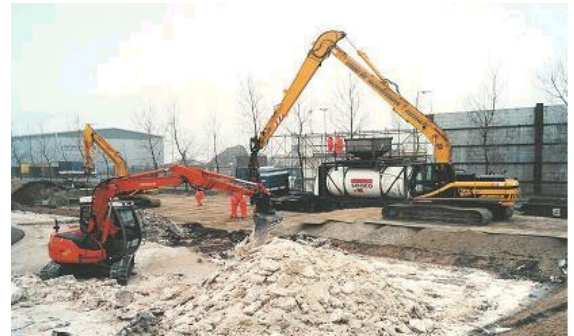
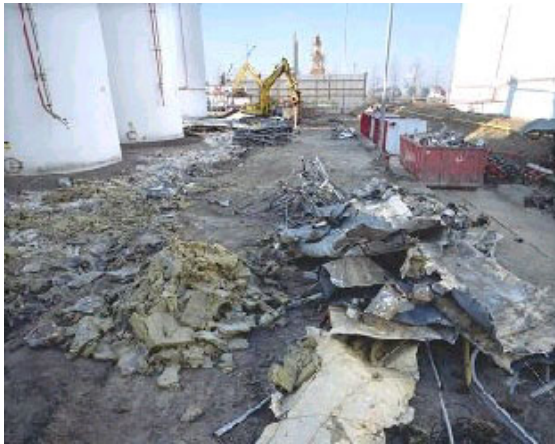
- × 1 - Empty surrounding tanks and clean up outside tankpit : the liquid is stored in iso-containers.
- × 2 - Removal of solidified product by digging off solidified o-Cresol.

- × 3 - Create access to remains and strip remains in order to enable the inspection of these parts of the tank by a technical investigation service. A selection of evidences had to be carried out.
- × 4 - Removal of remains of tank. Moreover, other 6 tanks were also dismantled. The total amount of contaminated soil is 17.000 tons.

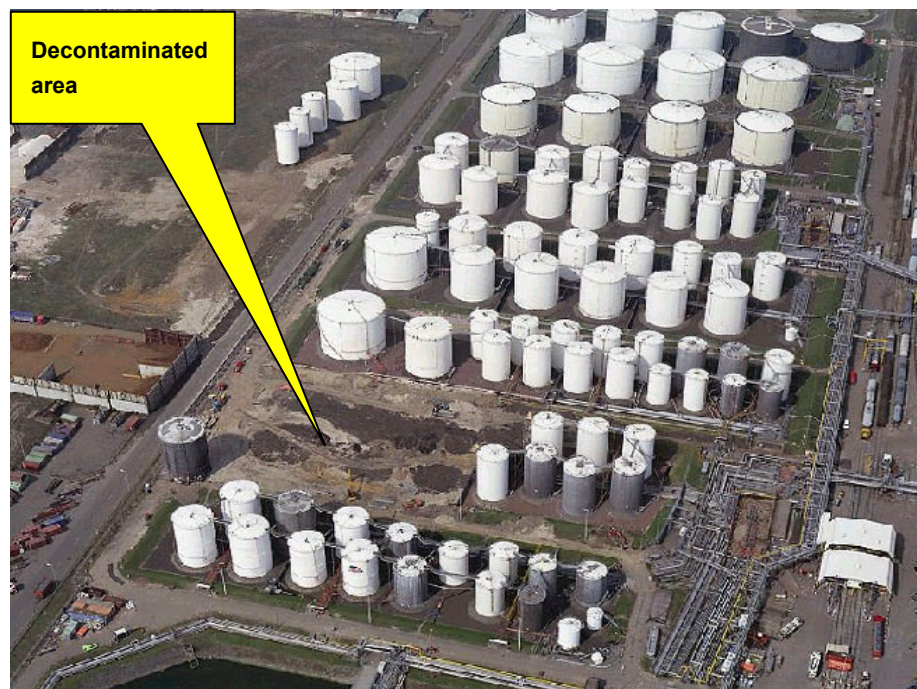
The picture gives an idea of the site 4 months after the accident.

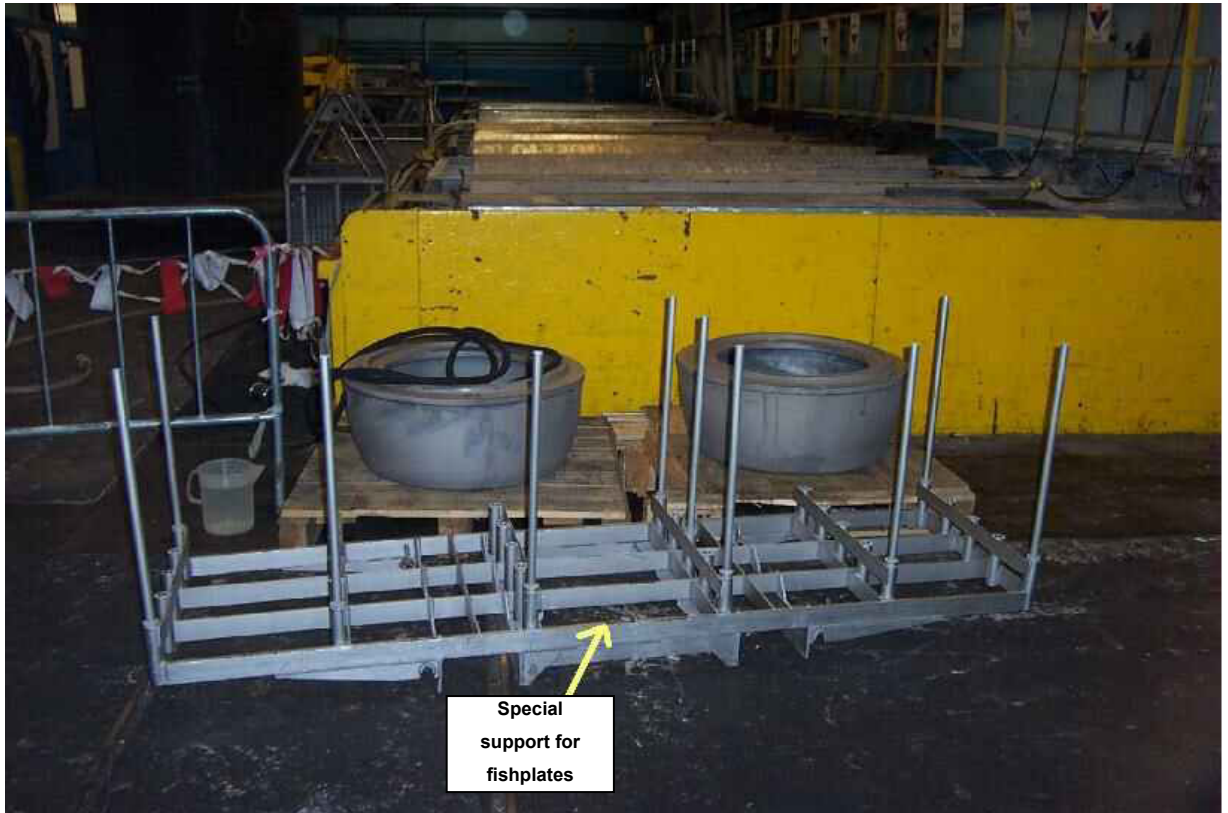
On March 20th, around 10:30 am, an operator was stripping aluminium aircraft fishplates (parts designed to connect the wing to the fuselage) in a cold aqueous solution of 15% pure nitric acid and 5% fluorohydric acid (by volume)<sup>1</sup>. The 4 parts, weighing 200kg each and measuring 2.50 m long, were placed on their special support and immersed into the treatment bath using the travelling crane. Upon attempting to remove the parts from the bath 10 minutes later, the operator noted that one of the two hoists did not operate. A maintenance technician intervened using a platform on the traveling crane's electrical control cabinet, located above. His action on the synchronization of the hoists did not repair the faulty equipment. The part support structure became unbalanced and the 4 fishplates became blocked in the bottom of the tank preventing the partly immersed load from being lifted out of the fluoronitric acid solution.

At the request of the labour inspectorate, a verification of the travelling crane was conducted by an approved organisation, different from the organisation that habitually performs the operation. A brake failure on hoist No. 2 was diagnosed. This malfunction, followed by the blocking of the load in the acid treatment bath during intervention by the maintenance department, caused the subsequent exothermic reaction and gaseous emissions.

- periodic verification of the hoists (internally and by an approved organisation),
- installation of a visual and audible alarm when the normal operating temperature is exceeded,
- installation of a system to ensure gravitational bath drainage of nitric and fluoronitric acids into an underground tank, thereby preventing a runaway,
- use of a trolley with telescopic forks and a rotating hook to mitigate possible failure of the basket handling hoists,

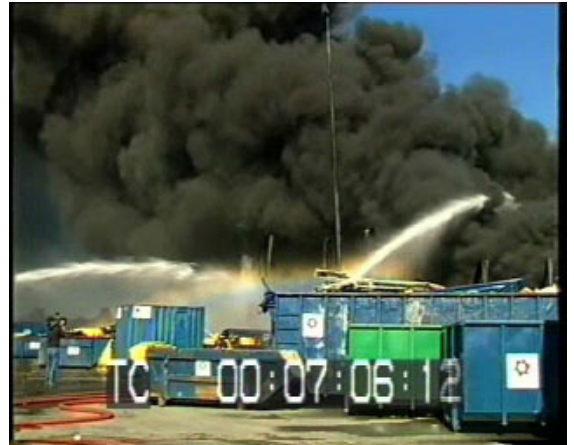
When the accident occurred, the fire-extinguish installation failed :

- ✓ Hi-ex inside air installation seemed to be inappropriate for the kind of chemical stored
- ✓ Ventilation-grids did not close automatically
- ✓ Insufficient amount of foam
- ✓ Adding foam by the fire-brigade did not work out;

Fire-extinguish installation was approved by an acknowledged private inspector.

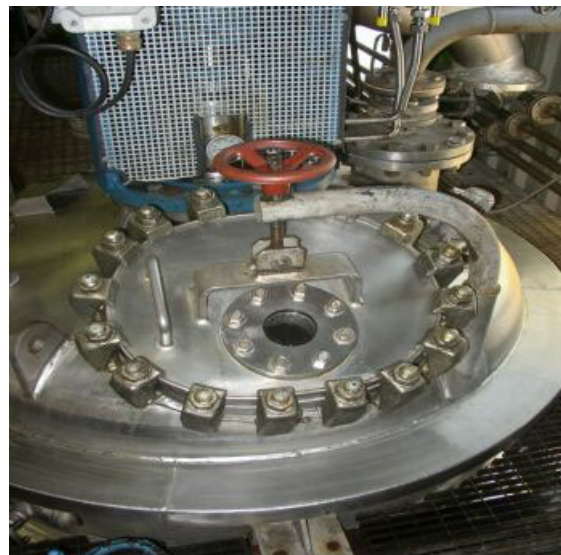
**On January 29 at 10 am**, the foreman cooled reactor R404 for its subsequent examination. An hour later, the foreman noted that the inside of the reactor was "a bit tarnished and a bit humid with a residual trace on the bottom". **At 5 pm**, following this assessment, the shop supervisor requested that the reactor be washed again. Analyses of the methanol wash solution confirmed that the previous washdowns were inefficient: synthetic and intermediate product was detected.

**On January 29, 2002 at 6.45**, an explosion occurred on R404 during the additional washdown operation that was requested during the day. A manhole had been opened to conduct the requested rinsing operation.

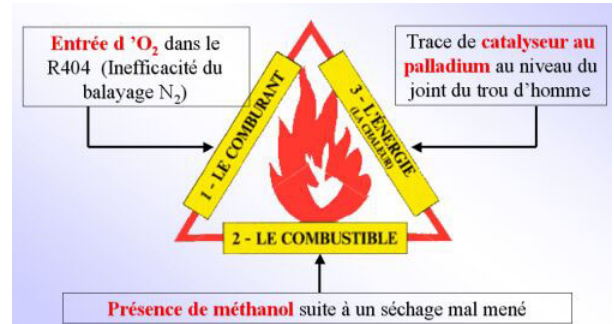
The last reaction that took place in the reactor was a hydrogenation reaction involving a Palladium catalyst, which is a substance that spontaneously ignites in contact with the oxygen in the air when it is dry. The presence of traces of this catalyst in the reactor is suspected, particularly around the reactor seal.

The combination of these 3 elements (Combustible – Oxidant - Energy) lead to the explosion.

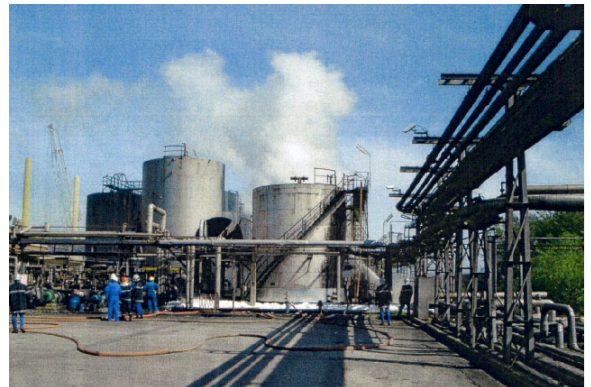
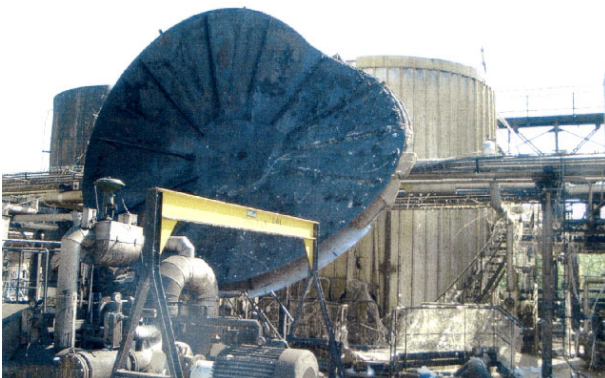
The accident occurred Saturday, May 18, 2002. At 3.30 pm, there was an explosion in the bitumen tank zone (there was no eye witness). The explosion took place on a tank containing a bitumen additive. The roof of the tank was thrown next to the tank. The explosion was followed by a fire in the tank (with flames rising to heights of 10 meters). The internal contingency plan was put into action. The operator was able to bring the fire under control within the next 10 minutes, using 2 fire nozzles. No one was injured.

The accident claimed no victims or significant property damage, except for the tank itself.

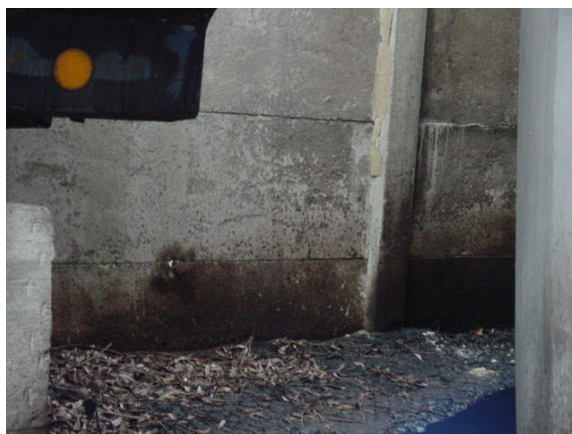
At the top of the tank that overflowed, the inspectors were able to see that the fuel oil overflowed over the containment walls. The walls themselves were not watertight either.

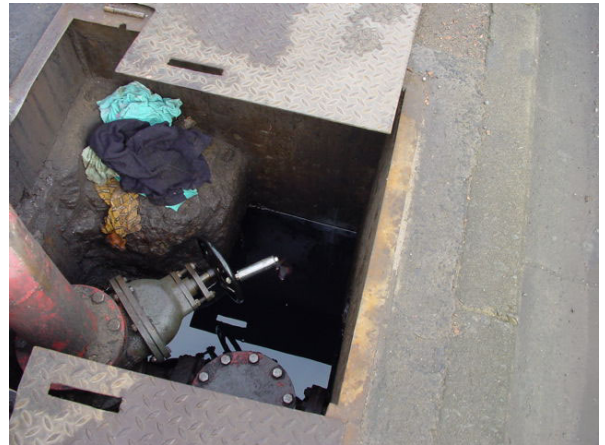
Indeed, apart from the fact that the tanks were very closed to the containment walls, the valves enabling the permutation of the tanks were located in rather deep peephole, so that the access was uncomfortable.

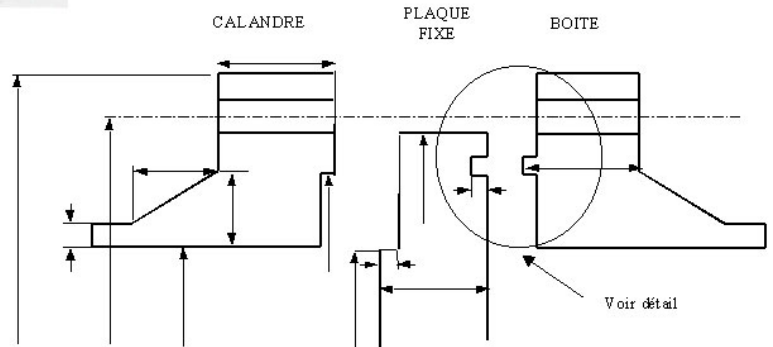
According to the initial reports and appraisals, the leak was caused to a fault in the exchanger: the latter showed a dimensional circularity fault on the throat of the gasket housing. This made reassembly of the device very delicate during the maintenance shut-down prior to the accident. The various parts were apparently poorly fitted together.

The seal, obtained by cold tightening of the metal parts between themselves, would have ruptured while increasing toward high temperatures. The accident occurred during this transition.

In addition to the repair stipulated by the Institut de Soudure (*Welding Institute*), the operator has finally implemented a rehabilitation program for the zone in question by following the recommendations of American standard "API RP 570 – section 11 – Assessment of fire damage".

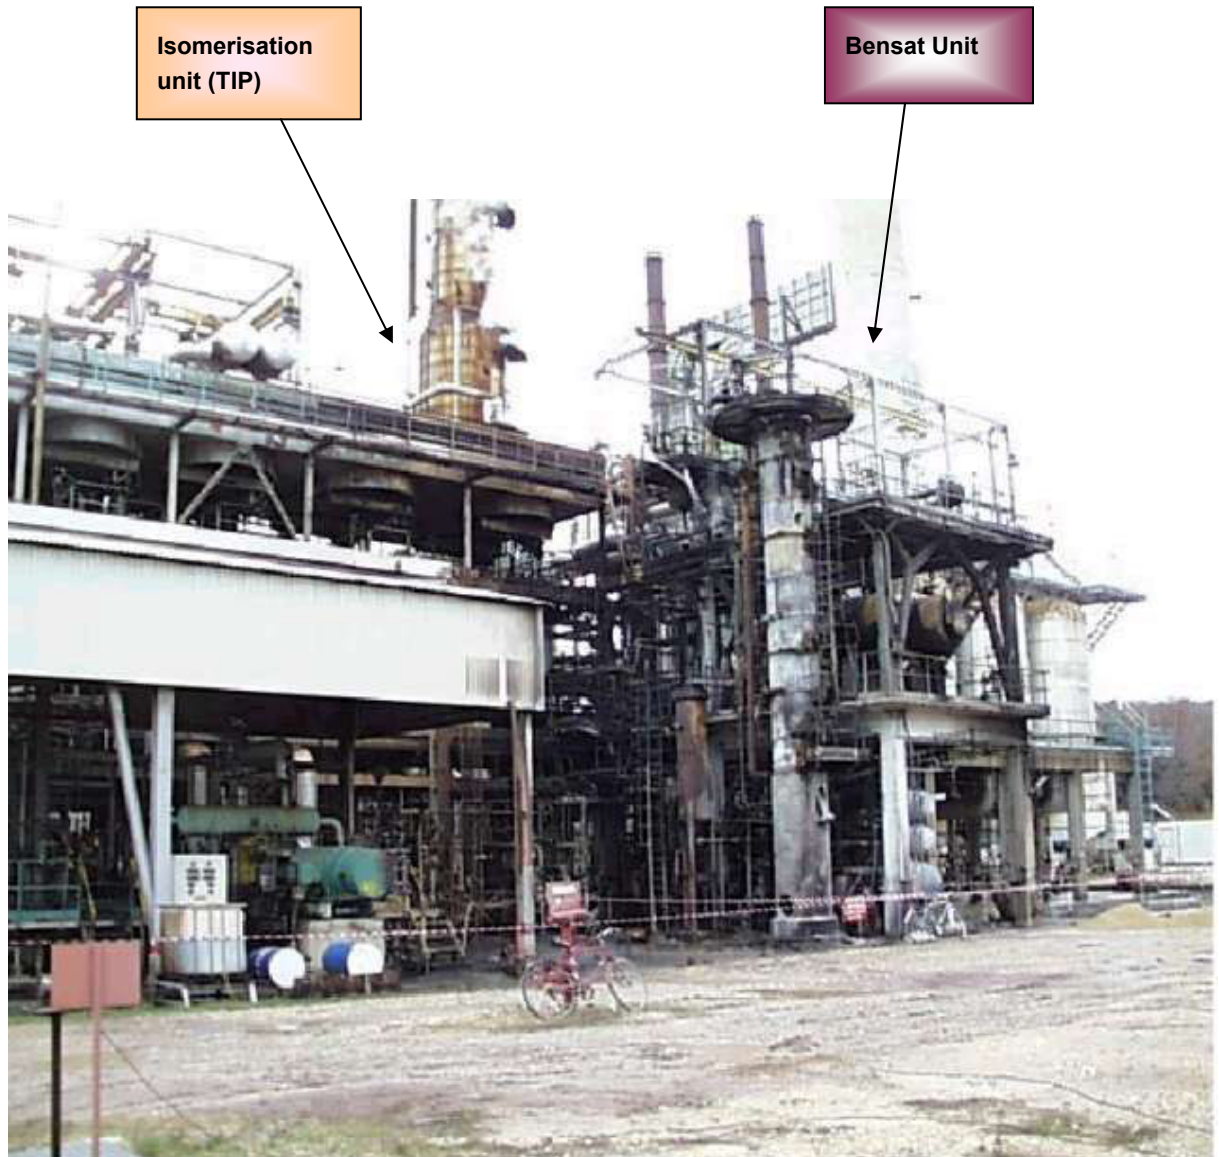
time, a strong burst was heard, followed by a jet-fire starting from the compressors area of the TIP unit (at the bottom of K2901B compressor), impinging the near bensat unit (14 m apart).

A big quantity of highly flammable gas mixture was released and immediately found ignition. Under the effect of the jet-fire, parts of the bensat unit failed causing the release of gasoline and hydrogen, which led to the extension of the fire.

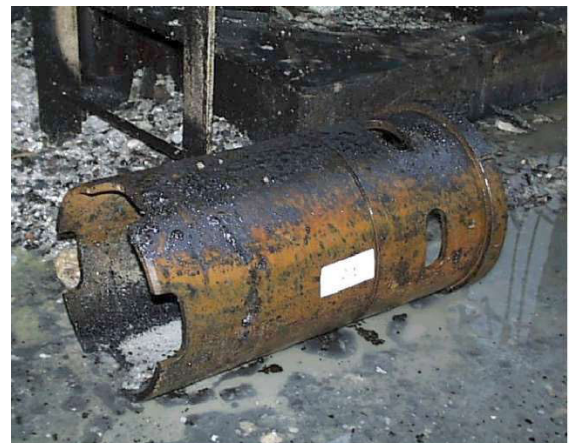
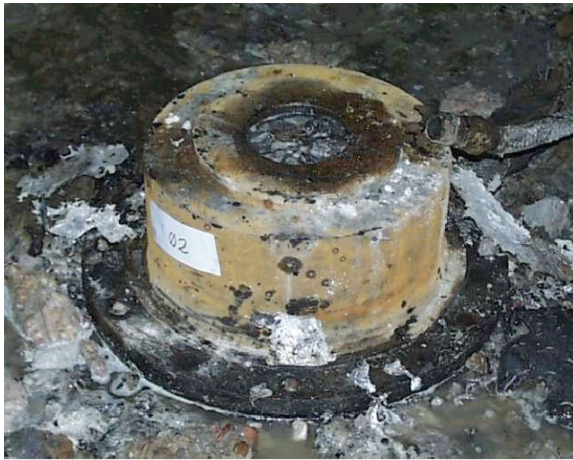
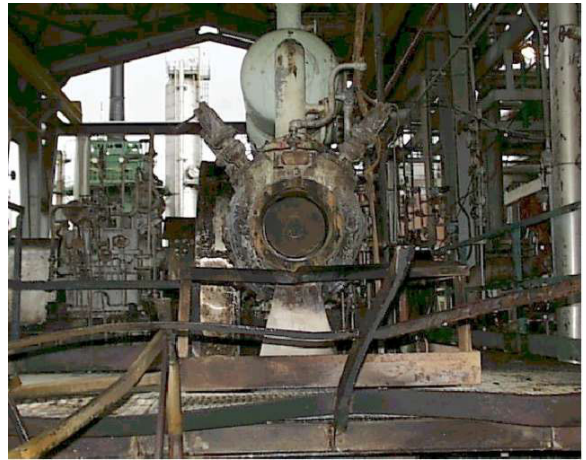
- ✓ About 3 tons of gas mixture rich in hydrogen and about 6 tons of gasoline were released.
- ✓ The cylinder liner and the bottom-head of the compressor were found at distances of respectively 8 and 14 m from the compressor. Some of the structures near the compressors area were damaged by the fire and the direct impact of parts of the compressors.

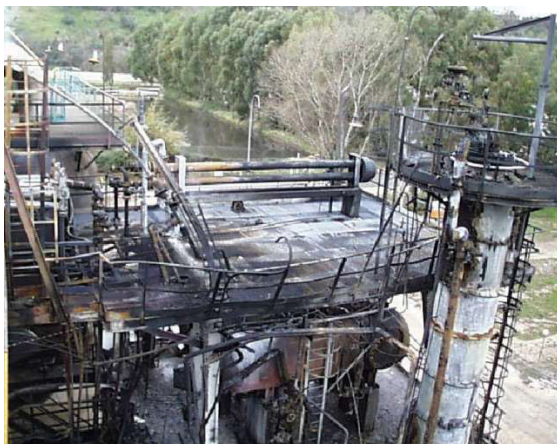
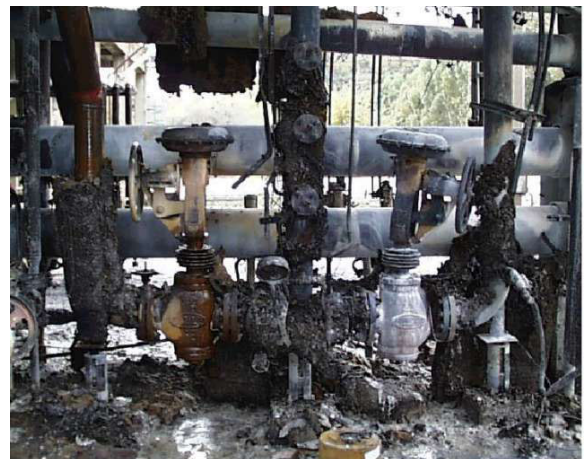
✓ Most of the structures invested by the jetfire were protected by a fire-proofing layer; they were damaged but didn't have mechanical failure. Pipe connections and process units lost their sealing and released some gasoline and hydrogen that contributed to the extension of the fire and the destruction of the unit.

✓ About 0,3 tons of gas mixture and 6 tons of gasoline were released.

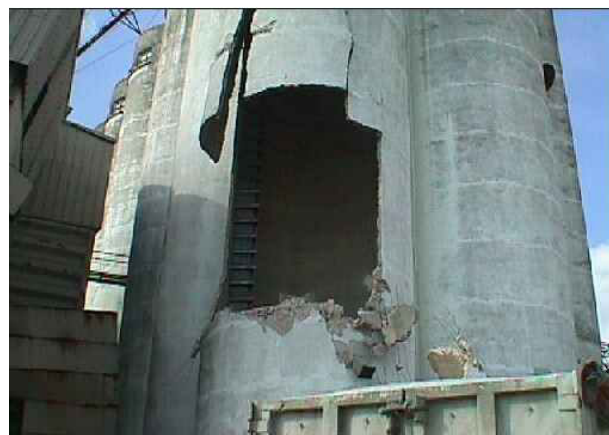
On September 20, 2002 around 11.50 am, a driver of a truck being loaded by the side unloading system of C2 noted that pieces of concrete were falling into the trailer bed. He informed the silo operator performing the unloading operation and both employees immediately moved away from the area. A few instants later, a block weighing approximately 3 tons fell into the truck. 300 t of wheat spilled onto the ground, destabilizes the drier and is blocked by the wall separating the cooperative and the yards of the residences next door.

The ageing of the reinforced compounded by corrosion of the reinforcement is at the origin of the Vailly cell rupture and that of the cracking at Jussy, built in 1960 and 1963, respectively. The expert assessments conducted showed that, since 1975, the structure of the recently built cells was reinforced with two levels of steel hoops as opposed to one before. In addition, in the Vailly silo accident, the installation of a side drainage system on the cell attributed to the weakening of the structure, thus aggravating the phenomenon and causing the structure to collapse.

- ✓ That the site be secured
- ✓ An expert evaluation in order to evaluate the overall stability of the silo and the possible measures required to repair or demolish the structure
- ✓ That a new Acknowledgement of Declaration be obtained prior to placing the installations back into service.

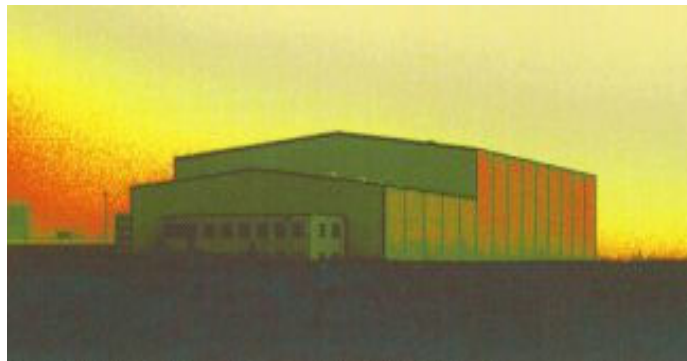
The warehouse prior to the fire of January 28, 2002.

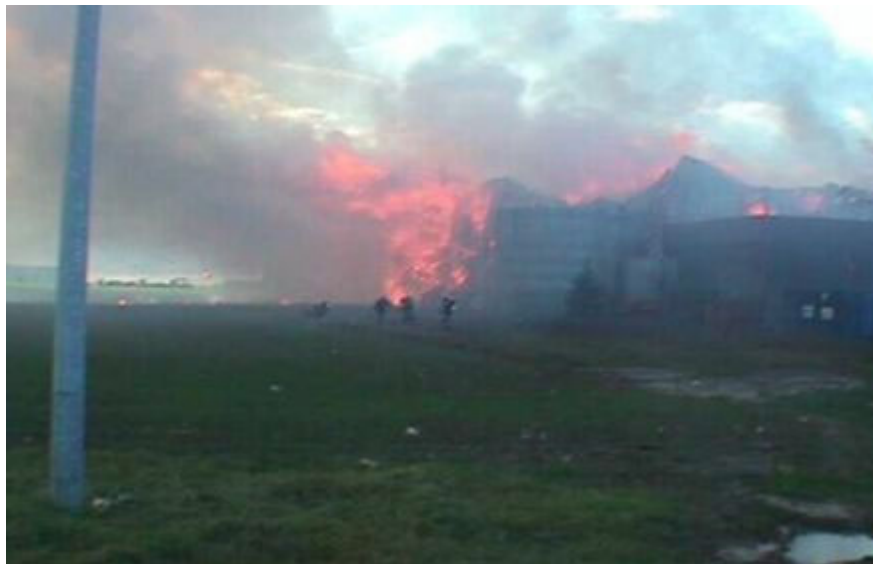
At **11 am**, the external structure of the warehouse collapsed inward. The racks and interior footwalks had already collapsed and did not resist the fire more than one half hour.

The collapse of the large cell's structure caused the firewall to fall and destabilise the small cell's structure. The fire resistance of the internal structures were significantly less than ½ hour. The warehouse's metal structure resisted approximately 45 minutes.

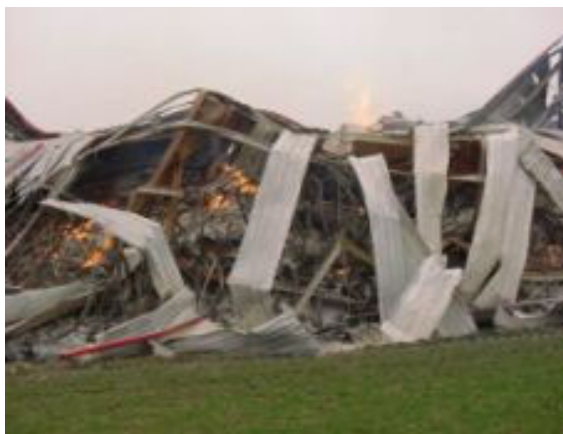
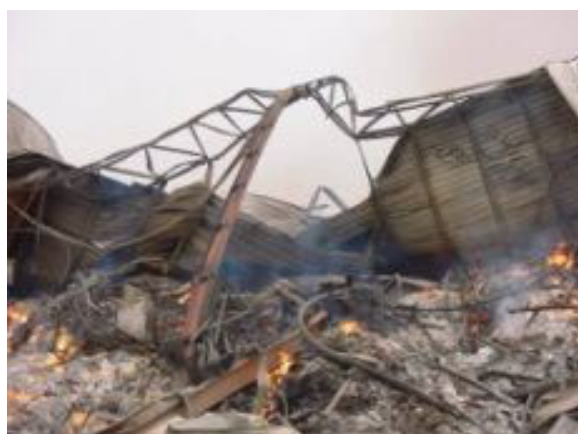
The fire destroyed the two cells of the warehouse and all that they contained: the archives of several financial establishments and part of those of Paris hospitals. The structure of the largest cell was totally ruined. Only the siding of the smallest cell remained. This is essentially due to the efforts of the firemen who protected the administrative building. As the amount of damage is not available, this information does not figure in the scale below.

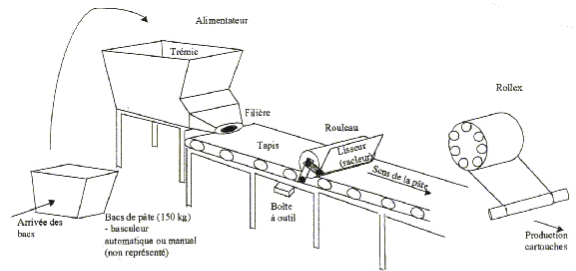
Figure 1 : Schéma représentant l'alimentateur et la Rollex de l'atelier 50

The workshop involved in the accident (workshop 50) is an automatic dynamite cartridge loading workshop (a "Rollex" type cartridge machine). The production capacity is 900 kg/h. The dynamite is brought in bins on rollers containing 80 to 150 kg. The bins are tipped into a feeder that includes a loading hopper and two screws that mix the paste and extrude it through a die. The strip of paste thus obtained is then driven by a belt conveyor and shaped by a smoothing roller, then cut up by a knife into parallelograms that are pushed and packaged into waxed paper into a keg. The dynamite cartridges are then transferred to the neighbouring workshops to be packaged into shipping containers.

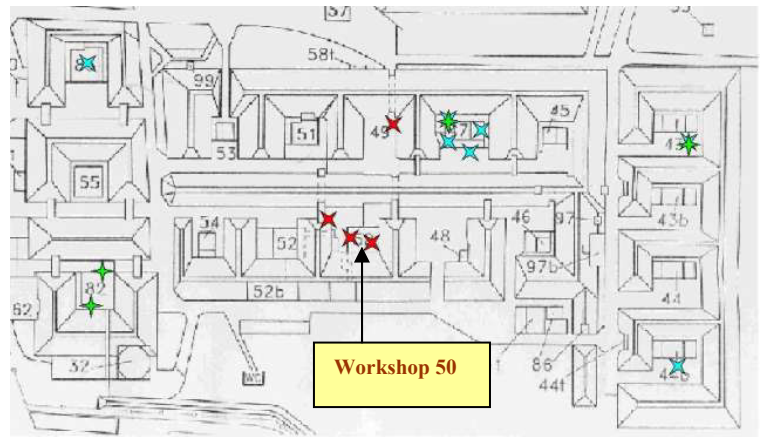
In the diagram opposite, the individuals who died are indicated in red, and the injured in blue and green.

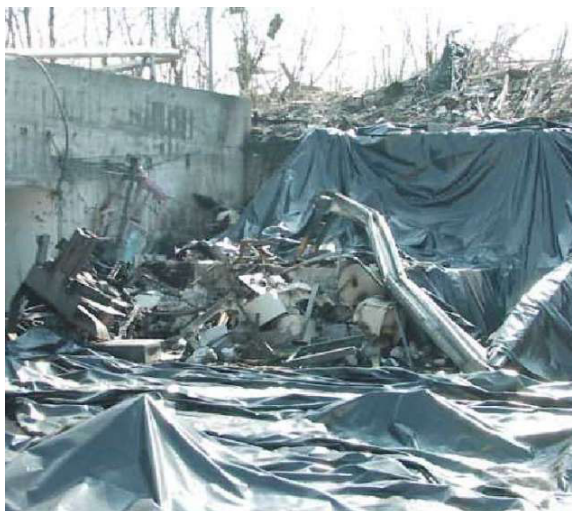
*Crater at the location of the machine – Photo DRIRE NPC*

*What's left of the machine – Photo DRIRE NPC*

Parts of the cartridge machine were found in a radius of 600 m. According to the expert appointed by the Inspectorate, considering the resulting damage, it is difficult to accurately quantify the amount of charge involved: it could be in the neighbourhood of an equivalent of approximately one hundred kg of TNT, although less than an equivalent of 300 kg of TNT.

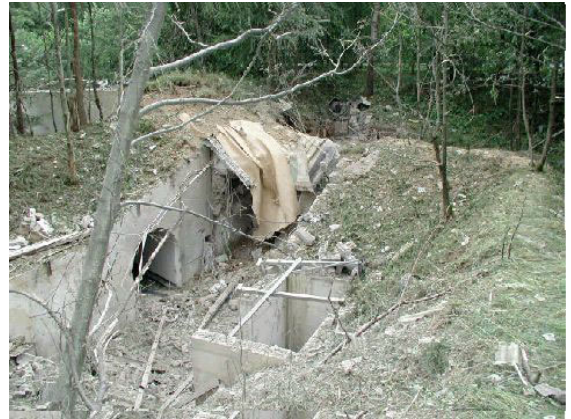
On July, the 30<sup>th</sup>, 2002, at 12:35 h, the accident took place in the building where the Rollex-Machine was placed. About 90 kg explosives were involved. In the moment of explosion only one employee was working at the machine.

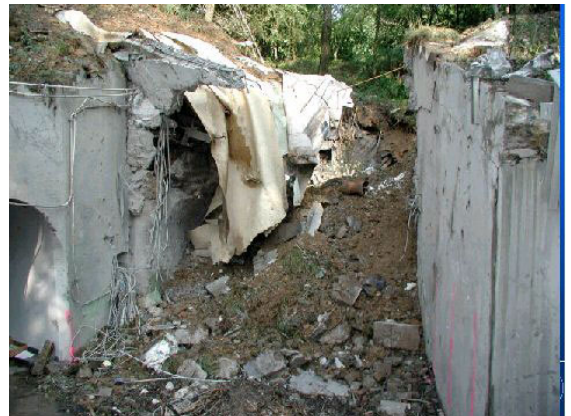
One employee surveying the process was killed: The body was found in a distance of 20 m from the place of explosion, his arms were ripped off and the body showed heavy injuries at his back as well as various fractures.

Additionally, the accident led to heavy damages by blasting debris and overpressure up to a distance of 120 m from the place of explosion.

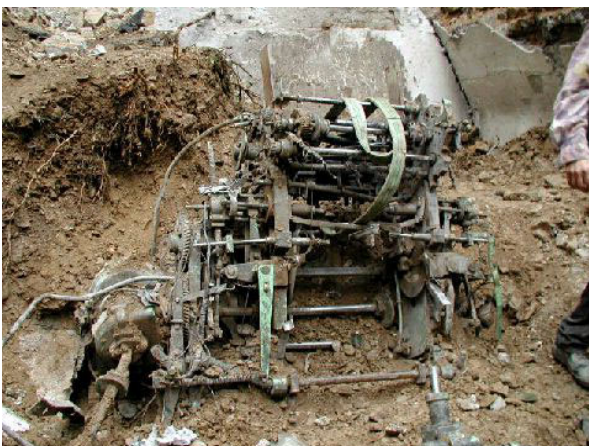
- ✓ The ceiling of the building was completely demolished.
- ✓ The Rollex-Machine was encumbered by earth.
- ✓ Building fragments were being distributed within a radius of about 20 to 30 m.
- ✓ Some fragments were thrown to a distance of 150 m.
- ✓ Other fragments of the Rollex-Machine were found inside the destroyed building and in a distance of about 15 m from the place of explosion.
- ✓ The estimated cost of damages is about 0,5 Millions of euros.

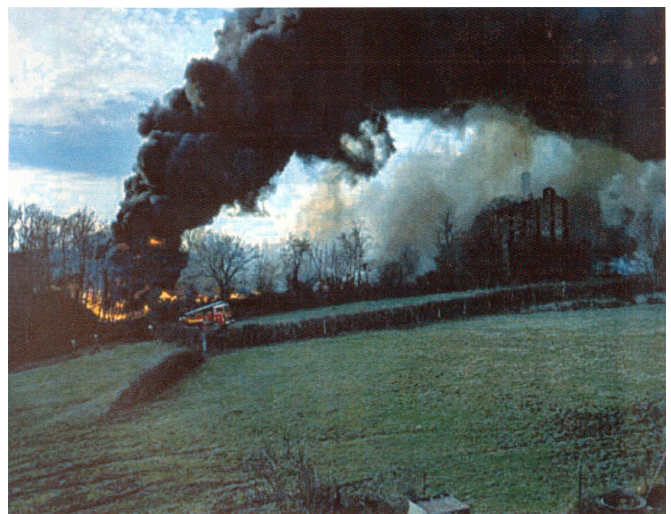
The fire was surrounded at 6 pm, although the firemen monitored the area for more than 2 weeks. The accident mobilised a large number of firemen: 70 on the 1<sup>st</sup> day, 35 the 2<sup>nd</sup> day and 12 on February 8. Owing to insufficient local water resources, the emergency services had to procure water from the Loire River side canal approximately 2 kilometres away.

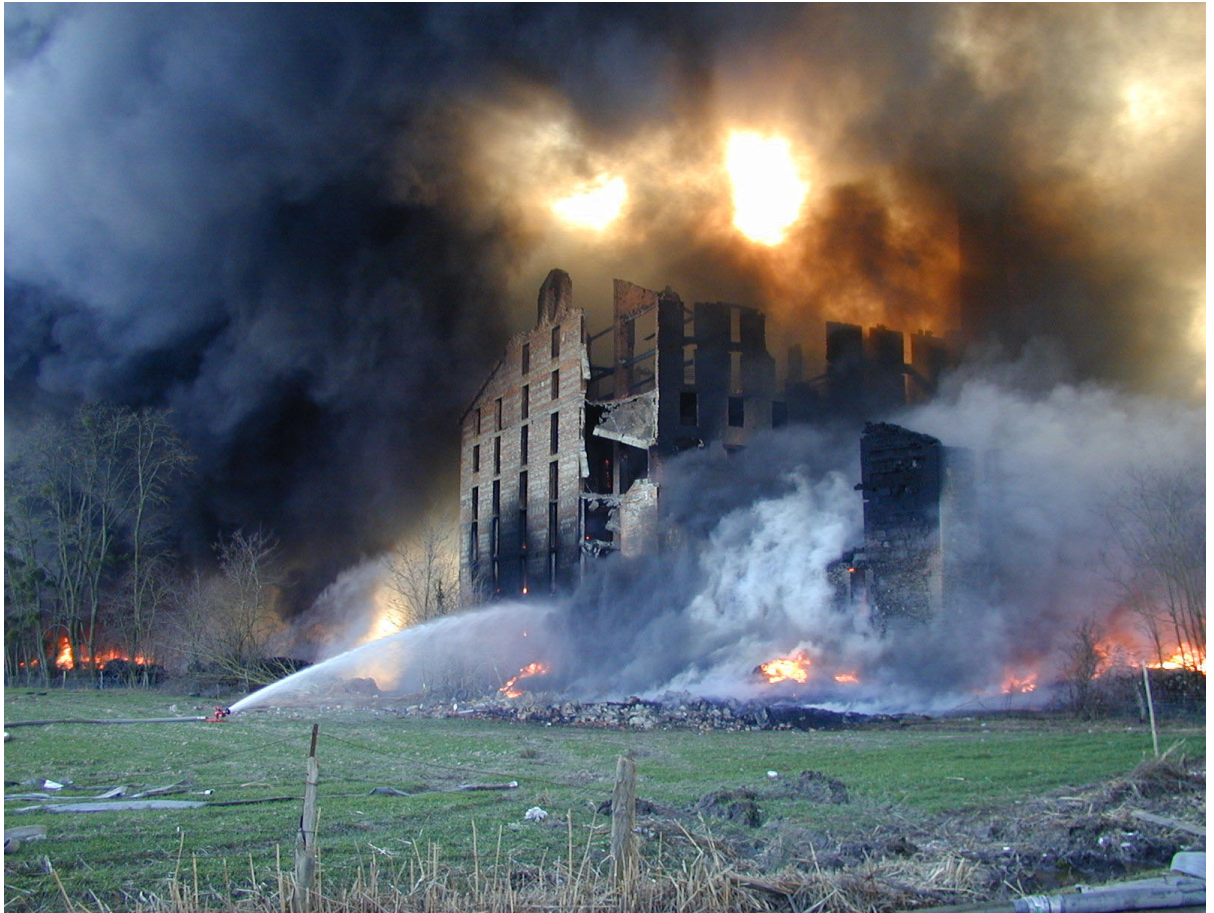
Once the fire was brought under control, the plume of residual smoke progressively went away until it was reduced to just a few fumaroles. The fire smouldered in this manner for 9 months. Final extinction was achieved by removing the residues or tires that were still incandescent and soaking them in a bin containing water. This action took 24 hours.

- ✓ Extinguishing, in October – November 2002, of tires still incandescent by dumping them in a bin full of water,
- ✓ Demolition of the damaged building,
- ✓ Processing of combustion residues and rubble from the demolition of the building, while privileging their storage on site.

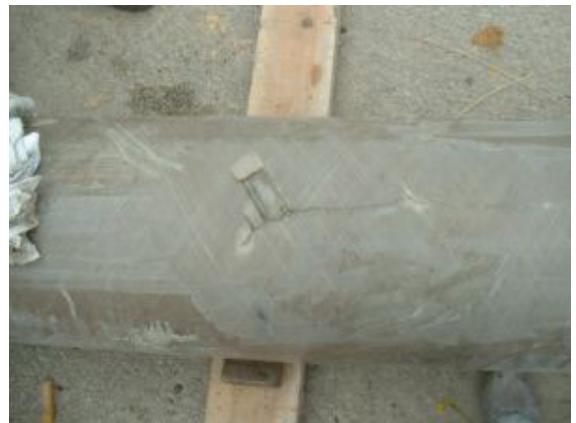
Four days later, on **Sunday, August 11, 2002 at 8.05 pm**, a new leak occurred and was immediately detected by the monitoring system. The rated output is 440 m<sup>3</sup>/h (diluted sulphuric acid), at a pressure of 3.9 bar (these conditions are significantly below the maximum operating conditions and much below the test conditions). The leak was located on the outside of the Le Havre plant, on an underground part of the pipeline, near a section that passes underneath some railroad tracks behind a LPG storage and filling station. The leak was evaluated at between 100 and 200 m<sup>3</sup>.

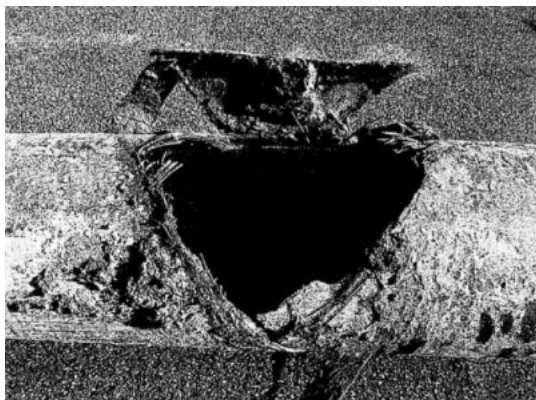
All of the faults observed on the pipes are similar in the following respects:

- ✓ the main direction of the cracking: longitudinal along the invert (lower generatrix),
- ✓ location: near a specific zone, namely a slope or angular change (45°, 30°, 22°, 11° elbows or high point).

It was clearly shown that the damage to the installation was due to a **stress corrosion mechanism in an acid environment**. Stress corrosion is a cracking mechanism that requires the participation of the following three elements:

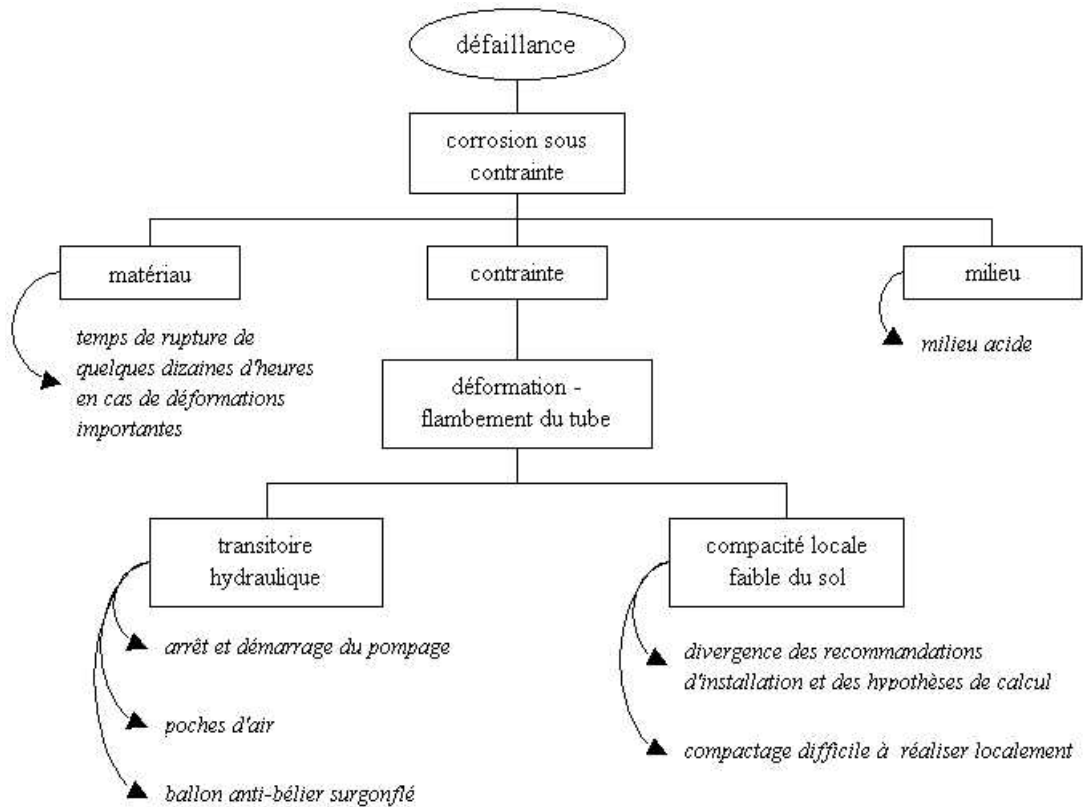
In summary, the safe-T-tree of the incidents that occurred on the pipeline in August 2002 is as follows:

The failures occurred near or at high points and near a change in direction, which confirms the role played by hydraulic transitions. Certain failures occurred in a zone where it was difficult to correctly compact the soil (nearby pipeline and concrete well). Finally, the majority of the failures (6 out of 8) occurred in the first two kilometres, i.e. in the zone where hydraulic stresses are greatest.

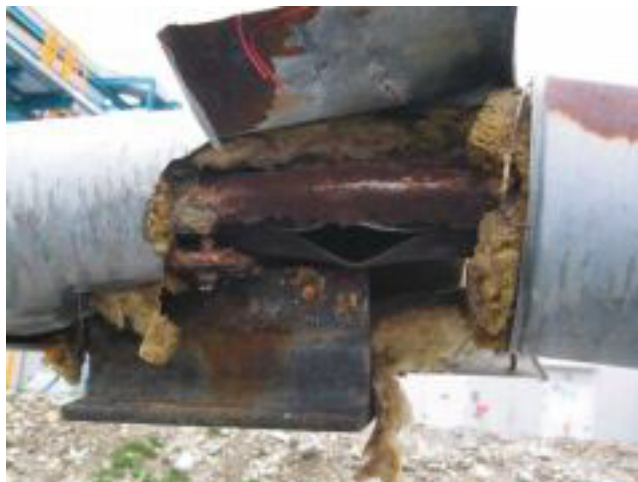
On December 16, 2002 at around 9.00 am, the OLONE shop's shift personnel noted an incorrect supply of cyclohexane. The filters were changed, the pumps checked and the ND100 mm pipe visually inspected and the ADN shop was queried. The next day, the disturbances continued and a visual inspection of the ND50 mm manifold was organised. The cyclohexane leak was located by its odour: the leak occurred on the expansion loop of the DN50 mm manifold that supplies the ADN shop.
