Meeting IMPEL / ICPE Inspectors  
on industrial accidents

Lyon, April 1999, 27<sup>th</sup> and 28<sup>th</sup>

## Summary

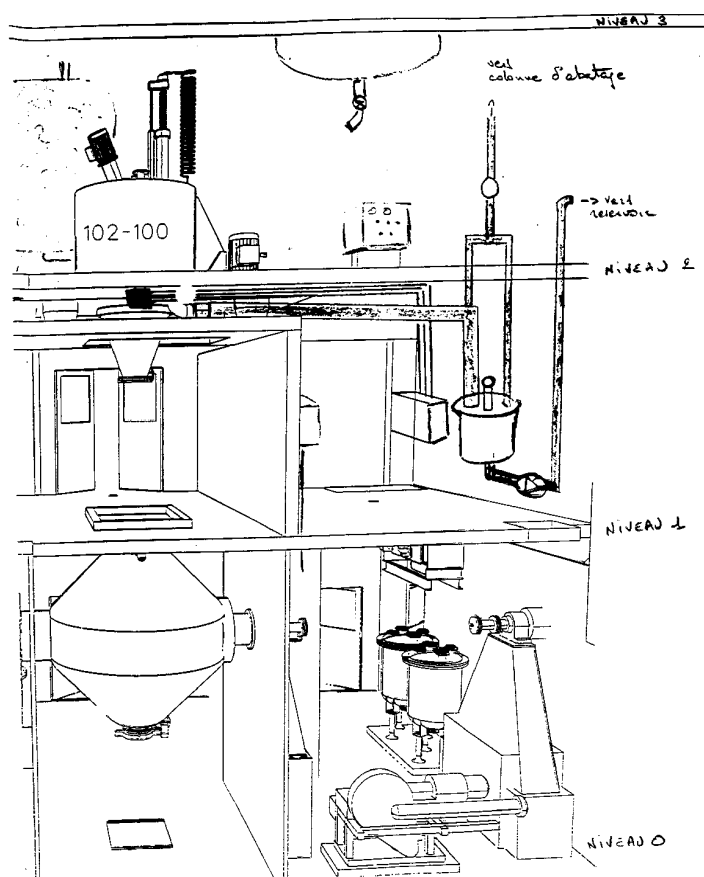
The installation which is associated with the manufacturing reactors includes a dryer (3,000 l) connected by pipe with hydraulic seal to a plastic 300-liter solvent collection tank located 2 metres below in a room without a retention system and for which the electrical equipment are explosion-proof. The collection tank, designed to resist a pressure of around 45 mb, is fitted with a cover (60 to 70cm in diameter) and a high level sensor which is slaved to a transfer pump. The solvent (sea water) is stored in a container prior to evaporation and recycling or disposal.

qualification procedure. As a consequence, during the "lack of inerting pressure" emergency shut-down tests, leaks were reported on the cover which was secured by 4 bolts. The pressure of 45 mb could not be obtained. The decision was made to add an additional 4 bolts.

The accident occurred during the 1<sup>st</sup> fabrication operation. Due to an electrical malfunction on a terminal strip (lug poorly tightened), the tank's drainage pump did not start and thus lead to the overfilling of the tank. The tank's hydrostatic pressure resistance was insufficient (cover not leakproof). The vapours most certainly self-ignited due the toluene's dielectric characteristics.

- the presence of 7 bolts instead of the original 4; the location for an 8<sup>th</sup> bolt is provided but is replaced by a clamp. The fastening system had been modified at the time of installation acceptance (qualification). The pressure of 45 mb could not be reached (leaks at tank cover), the centrifuge could not start; the cover mounting system was reinforced to improve the tightness of the assembly (a missing bolt was replaced by a clamp). The fabrication process was launched 12 days later, with the temporary repair having been forgotten...
- anomalies in unit operation. The procedure during the accident dictated that the operator make a log entry (time – action taken). The log was completed in advance up to 10 am (centrifuging and sampling considered as completed), even though the accident occurred at 8 am.

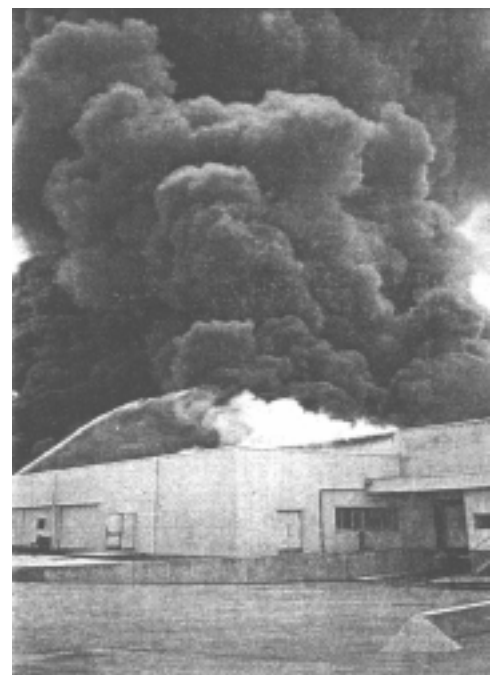
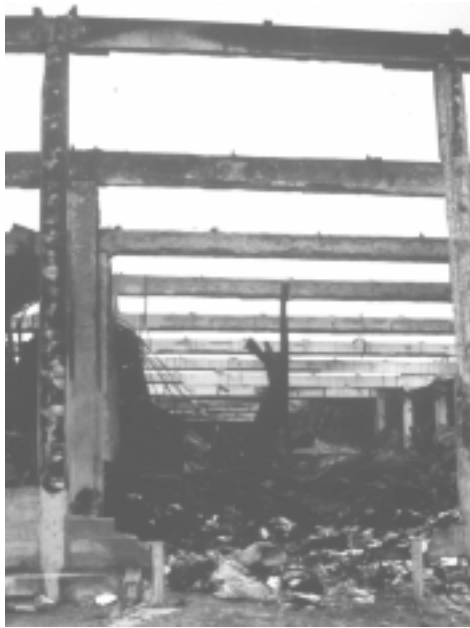
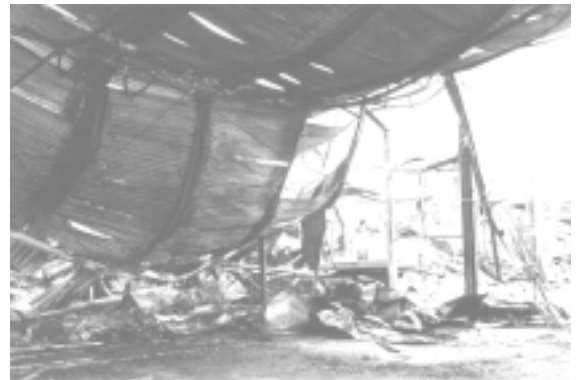
Despite the progressive stream of reinforcements, the 15,000 m<sup>2</sup> of the processing building and the refrigeration units (F22) were destroyed in less than 2 hours. The fire brigade confirmed several factors which explain why fire spread so rapidly and the difficulties experienced in fighting it:

- A delay in sounding the alarm (call to 18) due to the lack of an audible alarm, following late detection of the fire (lunchtime) and an inadequate means of communication (telephone of work areas without outside access, switchboard closed).
- The construction principle retained, a box (sandwich panels) within another box (siding and roofs), without a smoke exhaust system, initially confined

the heat and radiation inside the double enclosure and restricted the evacuation of hot gases.

- Insufficient, even non-existent, partitioning with the extensive use of polyurethane foam-based sandwich panels (walls and ceilings). These panels are M1 fire-rated although cannot withstand temperatures above 300° C and thus increased the thermal load and generated dangerous gases and volatile materials which fed the flames and spread through the walls "like blow torches".
- The metal elements of the structural steelwork collapse in fire and the use of a asphalt-coated steel sheeting on the roof causes the bitumen to melt, run and burn.
- Inaccessible false ceilings in certain areas insulating large volumes under the roof and freezing chamber of very large volume worsening factors.
- Combustible loads are highly variable (packaging

- The thick smoke made it difficult to accurately locate the fire source, although the refrigerants, glycol water and R22 in this case, were without impact.
- Furthermore, the destruction during the fire of plastic rain water downpipes which were not reinforced by a metal sleeve tube may have allowed fire prevention water to return directly to the water table via the rain water network when it is connected to a percolation well.

- Sensitise, inform and train employees (safety measures include: internal exercises, exercises with rescue services, etc.),
- Use the burning permit procedure during projects,
- Install audible and visible alarms (flashing lights, etc.),
- Enable workshops direct access to 18 (emergency assistance).

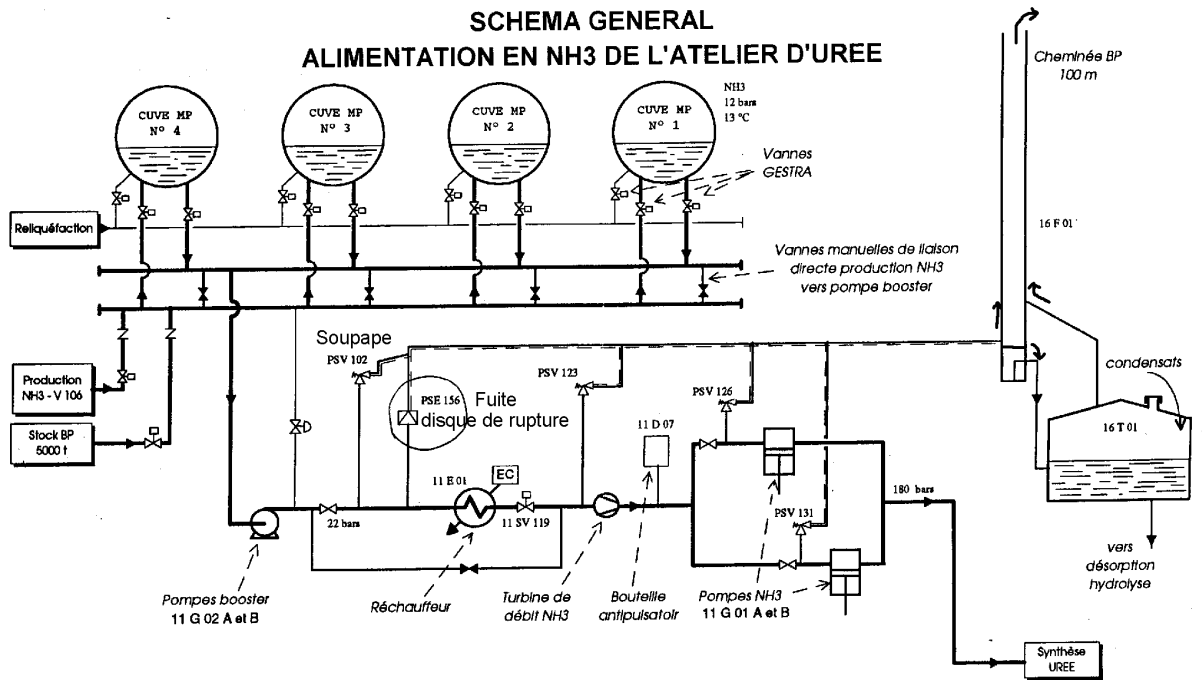
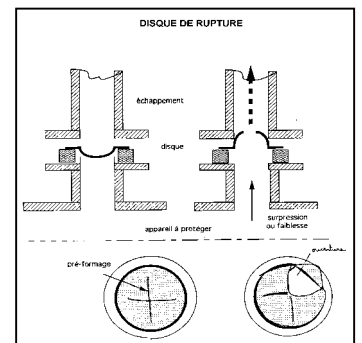
At 4:50 am, a decrease in the ammonium flow occurred on the supply line of the urea synthesis unit following an alarm on the normally open contacts of 2 GESTRA valves located at the low point of the low pressure liquid ammonia tanks. After a quick inspection, the Watch Officer decided to open the manual direct supply valve to re-establish the flow which reached a minimum level one minute later. A new round at 5 am, slightly before the end of the night watch, did not signal any anomaly.

At 5:03 am, a hammering noise is heard coming from the reservoir's seal cover (ammonia water tank) which collects the condensates at the stack's low point. The noise is heard 4 times up until 6:20 am. At 5:13 am, an ammonia alarm which sounded in the plant for a period of

15 minutes is interpreted as the result of an excessive drop in the level of the ammonia water tank. The other ammonia detectors at the site and including those at the property line were never triggered.

At 5:20 am, a watchman reported the formation of frost (a sign of an ammonia leak) downstream from a valve at the output of a NH3 pump which feeds the urea production unit. The equipment is located on the exhaust manifold common with the various valves equipping the installations and connected to the base of the stack. The leak is considered to be small and resulting from the re-establishment of the NH3 circuit after the direct passages were opened. A vapour heating unit is installed on the valve to defrost it.

As the unit's supply seems to be correct the hypothesis of a ruptured bursting disk is proposed then abandoned in favour of the hypothesis that the valve was not tight following its opening as a result of the disturbance caused by the operation of the GESTRA valves.

The operator performed a thorough technical analysis of the accident and the installations were modified (removal of the bursting disk, installation of sensors and automatic shut-down devices). A safety assessment was conducted on all of the site's ammonia circuits.

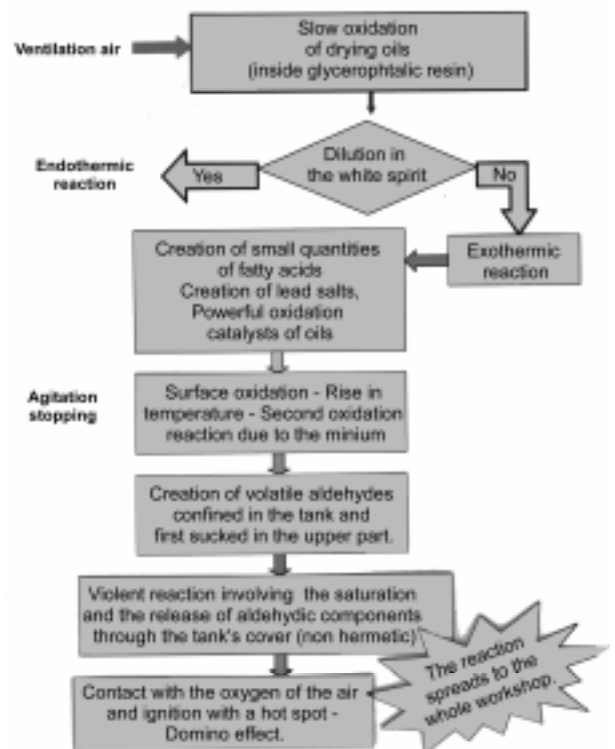
The rescue efforts of the fire brigade nevertheless limited the consequences of the accident which could have reached an overhead glycerophthalic resin depot located 15 m from the main workshop. A retirement home is also located just 70 m from the establishment's property line and at 120 m from the fire.

The installation of sand dykes around the factory and the blockage of the rain water networks avoided pollution of surface waters. The next morning, a specialised company evacuated the firefighting water confined within the site. Infiltration into a cesspool polluted the ground water.

Paint fabrication was stopped and the production buildings of the main facility must be demolished and rebuilt. The material damages were evaluated at 25 MFF, raw material losses at 5 MFF and the subcontracting of certain product production for several months at 5 MFF.

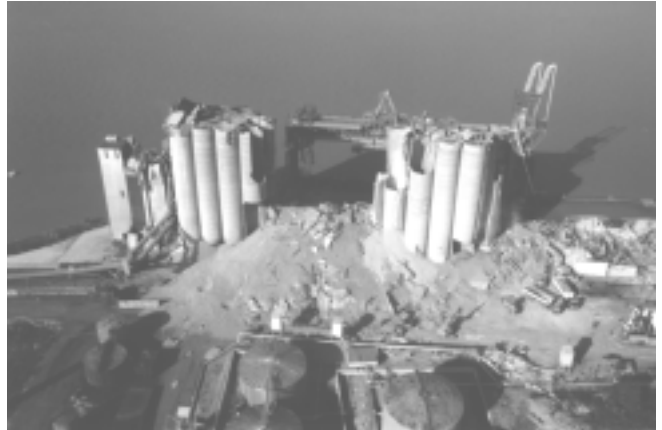
Significantly large projectiles (metal, concrete and glass elements) were observed at a height of 100m (2 times the height of the handling tower).

Pieces of concrete measuring several meters were found up to 50m from the silo and small-sized debris (weighing less than one kilogram) were thrown up to approximately 140m.

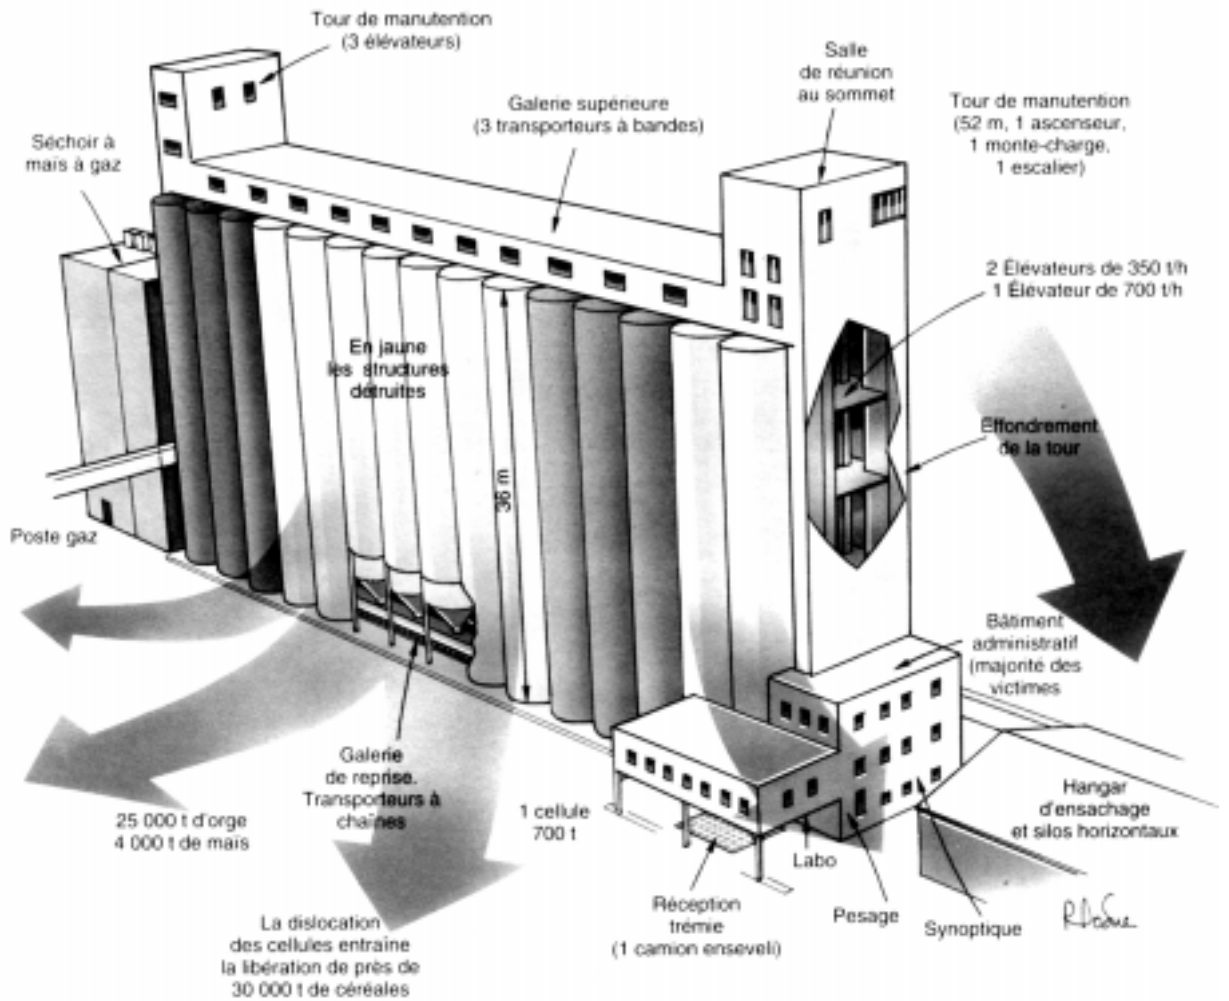
The explosion discharged in the under-cell area, either at the foot of the handling tower or, more probably, by the intermediate stacks located at the junction between the two sections. In this second hypothesis, the propagation of the explosion via the intermediate stacks would have enabled the flame to accelerate, particularly due to their geometric configuration, by inducing significant pressure effects. Under these conditions, the pressure waves emitted at the lower outlet of the intermediate stacks could be sufficiently intense to destroy the adjacent storage units and, in large part, the concrete curtain wall separating the under-cell gallery from the outside. These openings at the under-cell gallery level, slightly prior the passage of the flame, could have formed venting surfaces thereby limiting the level of overpressure reached within the under-cell gallery itself.

The destruction of the under-cell gallery's curtain walls could have thus been caused by pressure waves generated by the top to bottom propagation of the explosion or by the collapse of these structures. These series of events is coherent with the fact that the destruction of the under-cell space's concrete curtain walls occurred near the end of the explosion process, as was reported by the witnesses.

The collapse of these structures may have been facilitated by any structural weaknesses (the wall of an exterior cell had partially collapsed in 1988 being witness to an insufficient or poor positioning of concrete reinforcements on many cells). This event and falling equipment inevitably caused short-circuiting, particularly within the transformer building located on the half-story of the administrative and technical buildings. This could have been the cause of the localised fires following the explosion.

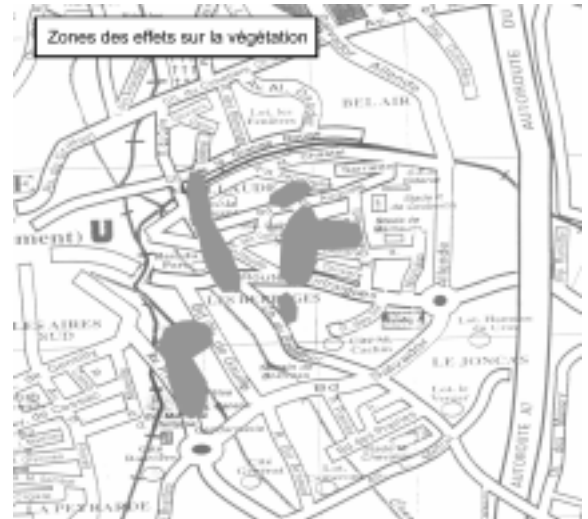
- 20 metres of wall had been blown away,
- 1,000m<sup>2</sup> of roof destroyed,
- windows were blown out at distances up to 150m,
- barrels being projected 150m were observed.

- roofing and internal walls were damaged in the personnel dwellings located nearby,
- the population was also effected by the accident: 20 people suffered from shock, although all were released during the day or the next day. One individual, pushed to the ground by the blast, suffered a double fracture.
- the loss of vegetation in the immediate area and downwind from the blast was observed over approximately 700m. (It should be noted that, since the accident, the situation has improved in this respect).

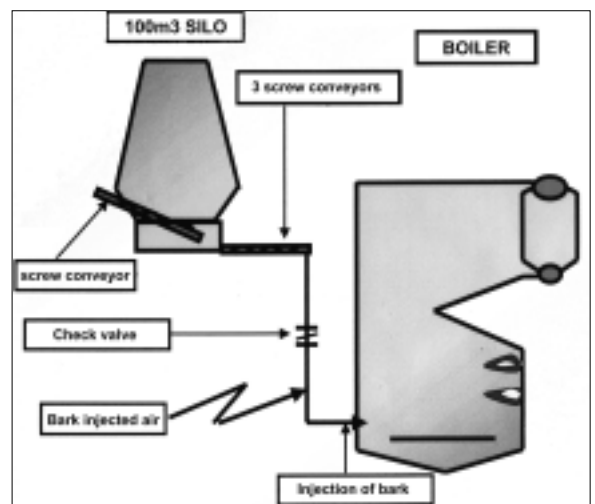
The INERIS analysed this accident: the probable cause which led to the accident was more likely due to the reactivity of dust further to their spontaneous heating in the presence of a hot air inlet, than to ignition caused by a spark. The report's quantified data provides detailed information and gives detailed concentrations of dust and dust ignition energy values in various configurations.

- dust deposit attached to the inside walls of the silo,
- a return of hot air coming from the boiler enables the spontaneous heating of this deposit,
- following the restart of bark supply to the silo, the level sensor becomes dirty and the feed of bark is automatically stopped,
- the operator who went to repair the level sensor prepares to come down via the ladder,
- the deposit of dust detaches suddenly, creating a cloud of dust which ignites and explodes.

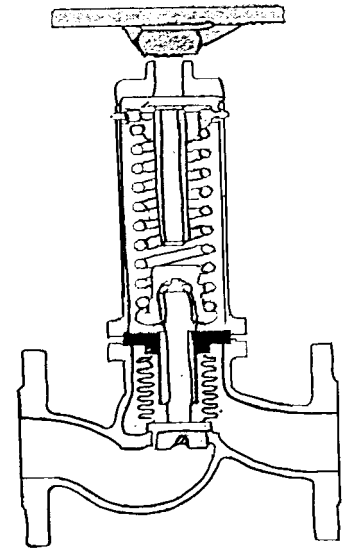
In the case of the accident, the leak was due to a crack in the boot. As a result, there was communication between the LPG loaded section of the valve and the part connected to the atmosphere (the spring's envelop).

On this basis, the local inspectorate conducted additional inquiries and arrived at the conclusion that the fault was caused by the formation of ice on the lower part of the boot. The observation of the part showed that it buckled and was subjected to very high stresses (estimated from 80 to 100 bar). The scenario which could have occurred is as follows:

- The boot fills with water (as was seen coming from the exterior or from condensation): the water's access toward the boot was made possible by the design of this type of valve.
- The particularly cold weather caused the boot to freeze and thus the increase in the volume of water trapped inside by approximately 10%. The resulting stress on the metal caused the plastic deformation of the boot. After a thaw period, the phenomenon could have happened again which would have caused increased deformation of the various parts of the boot until a crack was created.

As soon as it was established that the valve was at fault, an inspection programme initiated by the Ministry of the Environment and Land Transportation concerned. Within the framework of this programme, the inspectors of the installations concerned were required to identify the installations potentially concerned. The operators of this type of installation were asked to take the necessary corrective measures immediately, such as the modification of the valve or its replacement.
