Meeting - LYON, June 2000 , 6th and 7th

« LESSONS LEARNT FROM INDUSTRIAL ACCIDENTS »

ICPE / IMPEL Inspectors

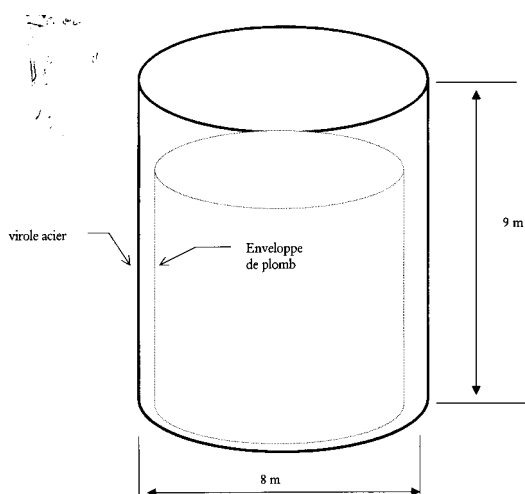
The tank in question was made of a steel casing lined with lead sheeting to ensure a hermetic seal in relation to the structural casing. This tank, measuring 9 meters high by 8 meters in diameter, was correctly dimensioned to contain phosphoric acid at atmospheric pressure. The retaining basin consisted of a slab (thickness: 15cm) and retaining walls (thickness: 15cm at the base, 10cm at the top). The entire structure was made of reinforced concrete. The mechanical resistance at the slab-wall intersection was ensured by two metal brackets made of 10mm steel round stock placed every 20 centimetres. This dimensioning should have resisted the hydrostatic pressure exerted by the tank.

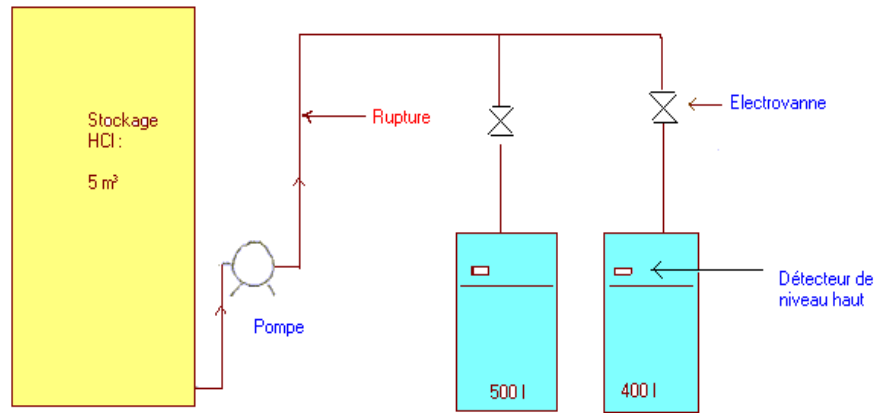
L'installation :

The leaks were caused by the rupture of a 3-piece connector. The latter was broken during previous operations and had been rewelded by the plastics technician. The weld was insufficient and the repair was not reported to the operator.

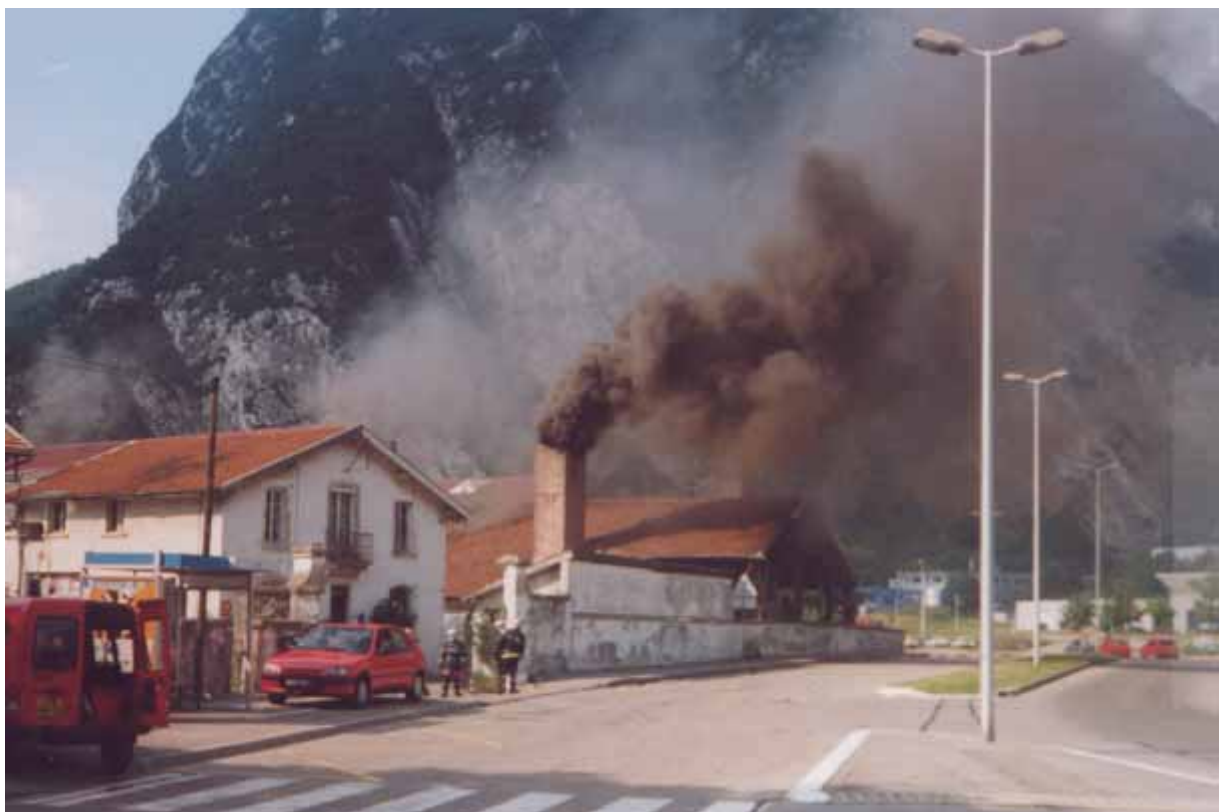
On July 13th, 1999, at around 5:00 pm, a fire was reported in the 2 basement level of the Sico facility, in the finished product warehouse, consisting of aerosol containers. The fire brigade was called immediately.

A fork-lift driver saw a flash appear under his fork-lift truck and the surrounding atmosphere catch fire. Although only slightly burned, the driver was able to immediately leave the area. Several explosions occurred (BLEVE, "boiling liquid expanding vapour explosion" caused by the aerosol containers); thick smelly black fumes began flowing from the roof and chimneys of the warehouse building which led to the evacuation of 59 inhabitants.

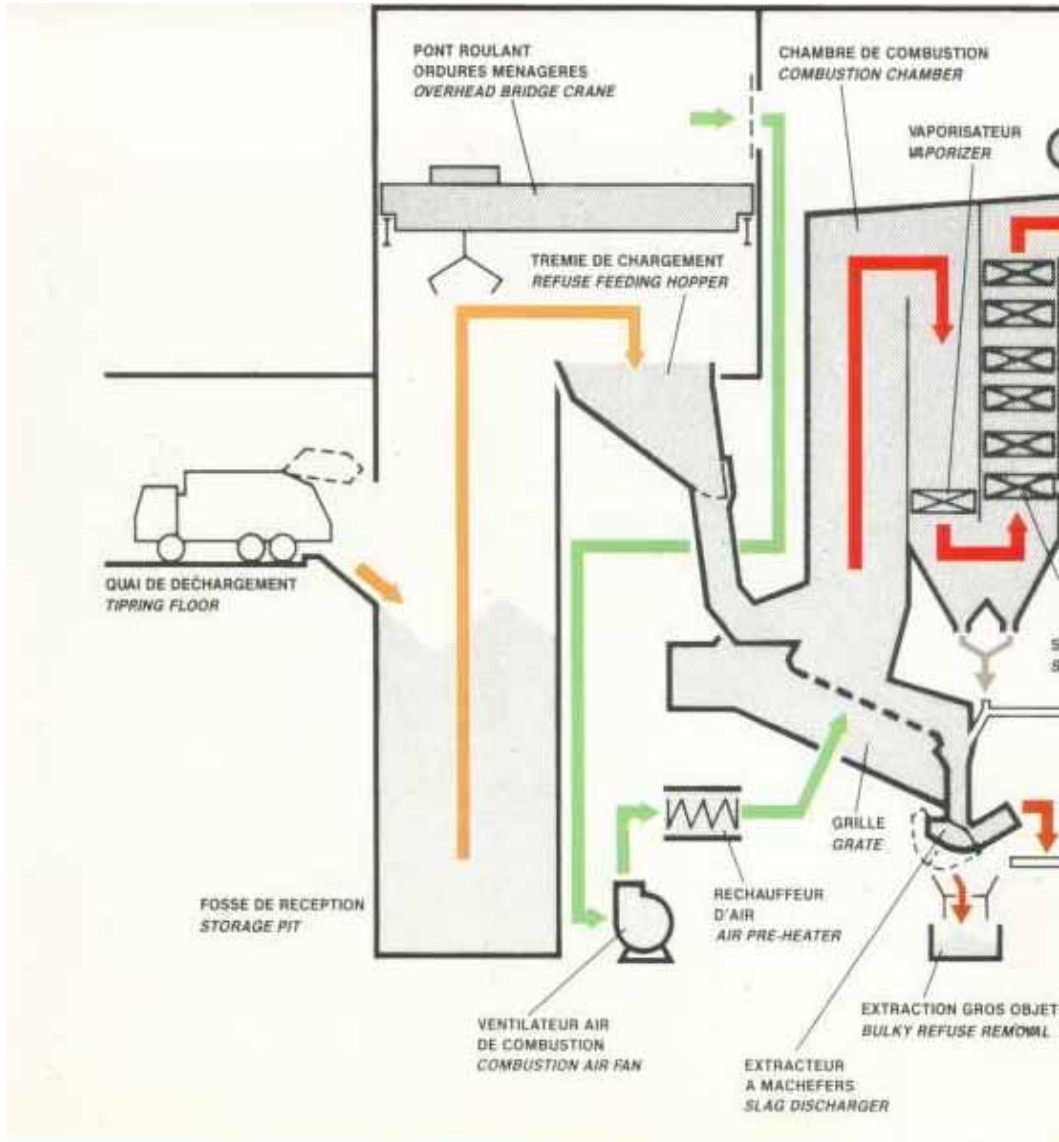
Water leaks were noted during the general shut-down of the installations for routine maintenance between July 4th and 8th. Such phenomena was apparently a common occurrence in view of the stresses to which the metal parts are subjected (expansions which cause cracks). To remedy these repeated anomalies, the operator removed the water circuit on oven No. 1's shroud filled the shroud with "insulating" concrete. The same operation was performed on oven No. 3 in order to observe the resistance of this new process as the shut-down of this oven was scheduled for shut-down due to technical reasons in two months later.

The quality of the concrete introduced was not checked. The purge vent was left open during drying to avoid any increase in pressure and was to remain in this position.

The installation was restarted July 8th. The operator reported that operations continued until the date of the accident without any incident. The explosion occurred at the level of the shroud filled with concrete 1 (exterior sheeting ripped, interior sheeting compressed toward the oven, indicating that the explosion occurred inside the shroud). On the latter, the vent valve was closed. More in-depth observation revealed that the interior sheeting was also ripped; the flames from the oven burned the technician. The first analyses lead us to believe that the explosion was linked to a brutal vaporization of water in a closed volume.
